AMD Geode™ CS5535 Companion Device Silicon Revision A3 Specification Update

This document discusses known issues of silicon revision A3 of the AMD Geode™ CS5535 companion device.

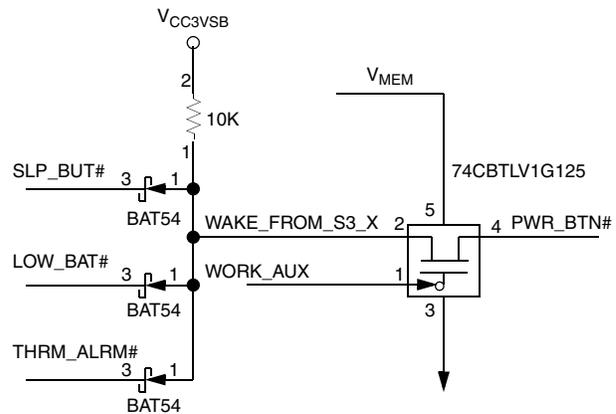
Wake from S3 Workaround

Implications: GPIO[27:24] (SLP_BUT#, THRM_ALRM#, and LOW_BAT#) inputs can not be used as wakeup events when in ACPI S3 state.

Resolution: Use the PWRBTN# input. If it is necessary to distinguish multiple wake events, external circuitry can be used to OR them together. The external circuitry must be powered by VIO_STB and V_{MEM} as shown in the figure below. The individual inputs should still be connected to the appropriate CS5535 inputs for software to determine the source.
