**journal**

April 1987

ALPHA MICRO SERVICE DIVISION

Volume 9, No. 4

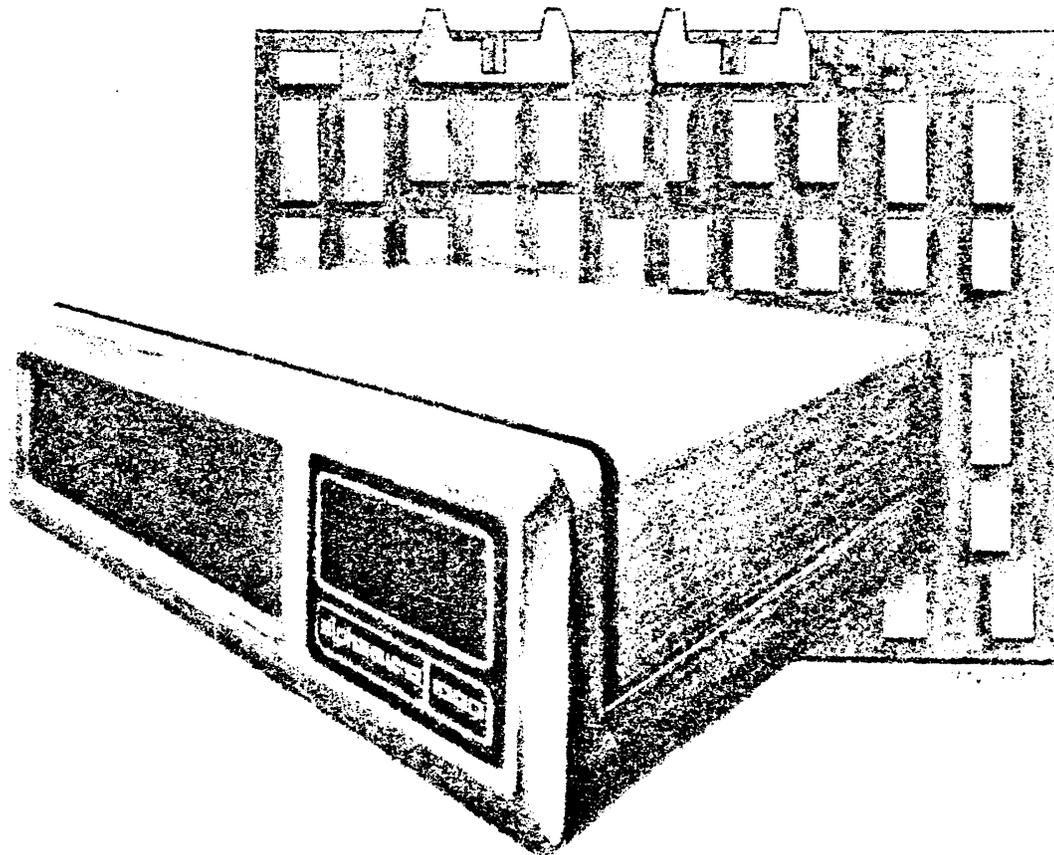
RFK-00167-03

Once the DC power input connector on the AM-1000's main logic board, part number CNR-00025-02, has been damaged due to heat or a poor connection, you must

replace it to keep from having the same power related problems again.

Both the new cable and a replacement connector have been bundled together into a retrofit kit and can be ordered through Order Administration by this part number:
