6.1.31 AM-1000 Hard Disk Cleaning Procedure

Winchester 60MB Motor Control Circuit Board Enhancement

AM-610 Enhancements

AM-1000 Winchester Drive Assembly Modification

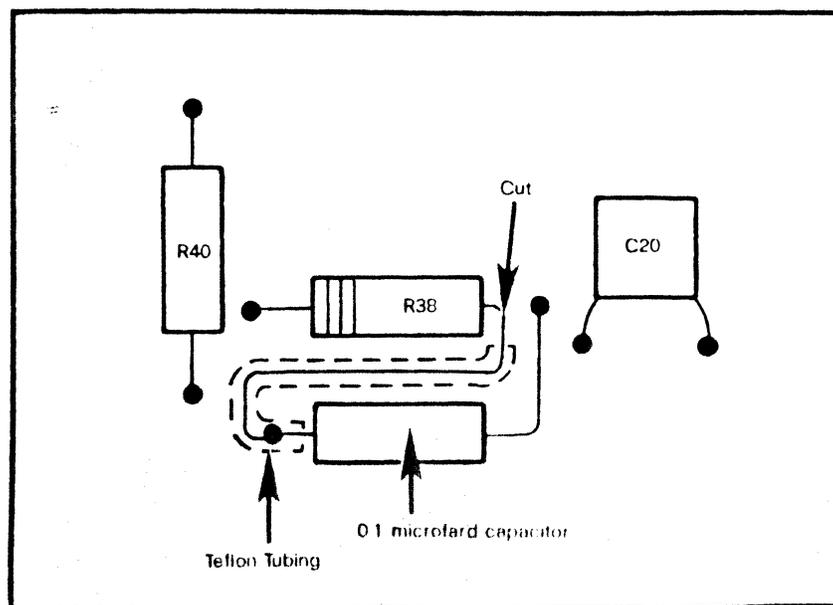
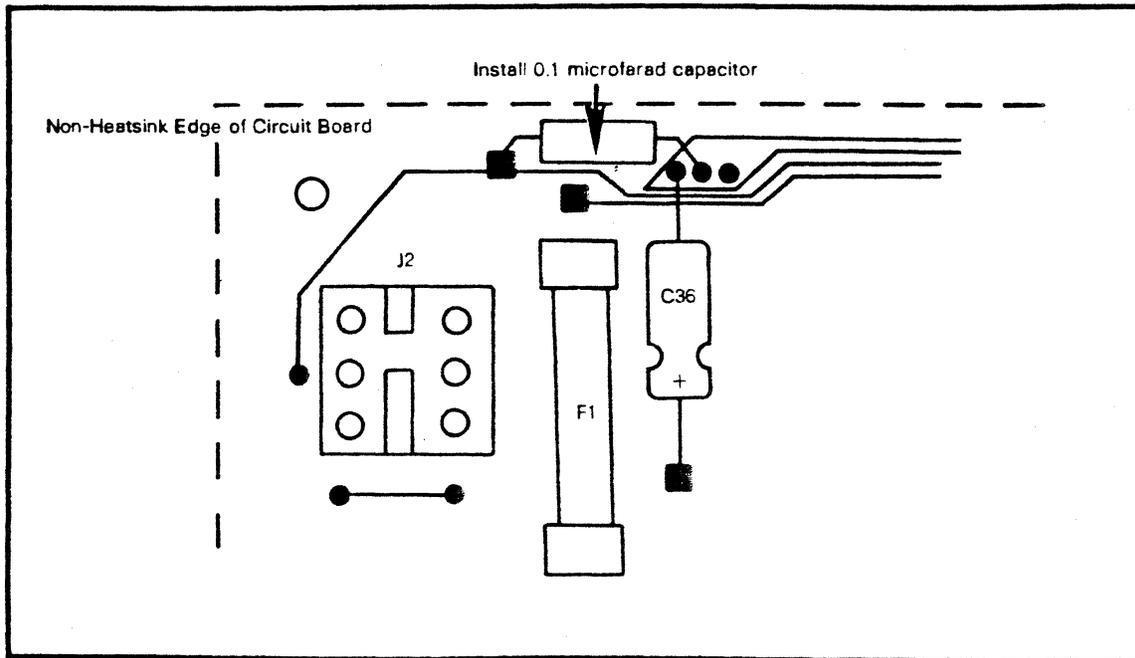
60MB Winchester Drive Motor Control Board (Component Side)

The following procedure is designed to reduce current spikes on the +24V produced during a "Switch Mode" operation, increase performance reliability under increased temperatures and to improve noise immunity to power line noise spikes. The last part of this enhancement procedure is designed to reduce electronic distortion in the servo position signal.

1. Change the resistor located R59 from a 27K ohms 1/4w (5%) to a 36K ohms 1/4w (5%) resistor.
2. Change the resistor located R63 from a 100K ohms 1/4w (5%) resistor to a 10K ohms 1/4w (5%) resistor.
3. Locate the 100 picofarad MO/CER 50v 5% capacitor at C24. Replace this capacitor with a 390 picofarad MO/CER 50v 5% capacitor.
4. Remove the 2M ohm 1/4w resistor at R40 and replace it with a 620K ohm 1/4w resistor.
5. Install a 0.1 microfarad MO/CER capacitor in series with resistor R38. Refer to the illustration below.

6. Locate the F1 fuse in the upper-left hand corner of the component side of the motor control circuit board. Install a 0.1 microfarad capacitor as shown below.
7. On resistor pack RP25, install the following jumpers:
Pin 2 to Pin 3
Pin 5 to Pin 6

8. On resistor pack RP26, install the following jumpers:
Pin 2 to Pin 3
Pin 5 to Pin 6
9. After all of the above steps are completed, add "FCO 1-5" to the revision block on the drive motor control circuit board.

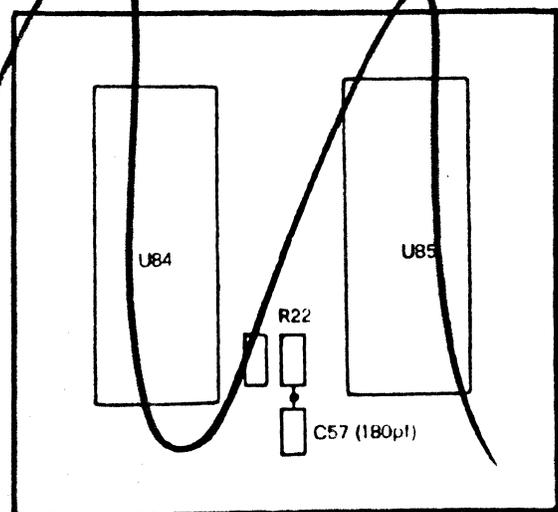
AM-610 VCR Interface - Component Side

In an effort to continually enhance the performance of our products, Alpha Micro releases modifications and enhancement procedures that further improve the performance of our products. The enhancement procedures to the AM-610 VCR Interface described below are designed to be implemented on Revision B03 and earlier circuit boards.

1. Remove the 180 picofarad capacitor (C57) between U84 and U85. (See below.)

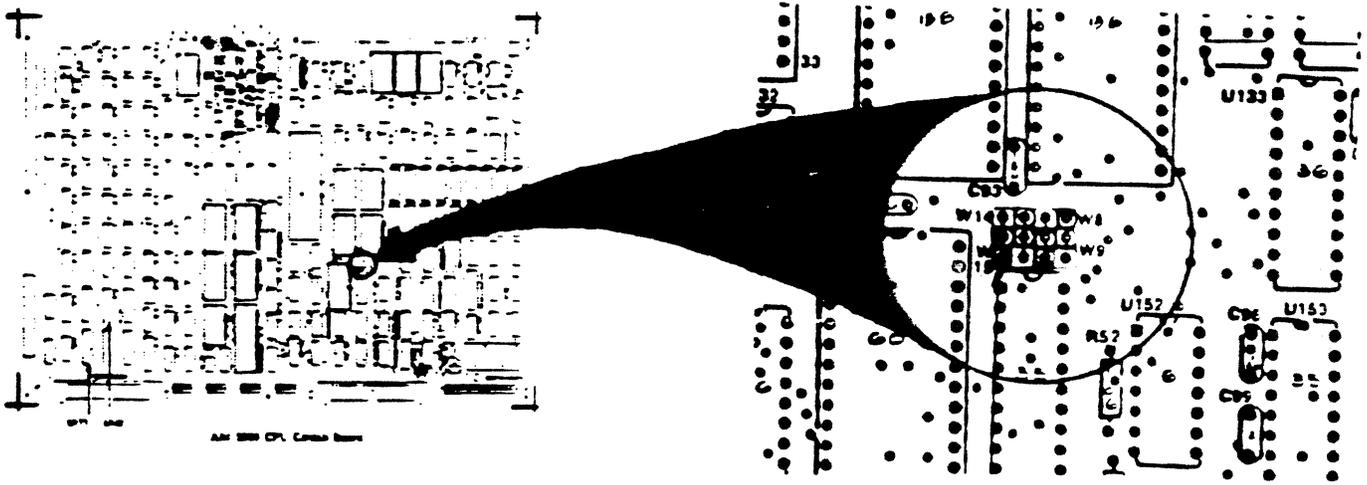
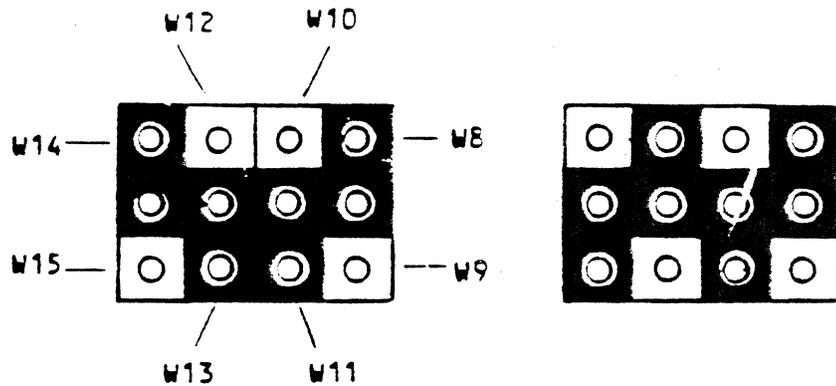
Boot Device Jumper Selection

When the VCR is used as the alternate boot device, a built-in time delay allows time for valid data to be received from the VCR. If the VCR is not being used and it is desired to bypass the 25 to 30 second delay, all that is required is to change the boot jumpers.

Figure 1 shows the location of the boot jumpers on the AM-1000 CPU circuit board and the jumper configuration required for different boot devices. Notice that Boot Device ID code 9 is the only configuration identifying the VCR. Assuming that the system contains a Winchester disk as the primary booting device, all that needs to be done to bypass the VCR delay is to reconfigure the boot jumpers to Boot Device ID code A (Floppy/Winch).

Reminder: If it is desired to boot the system using a VCR tape, the jumpers will have to be returned to the position shown for Boot Device ID code 9 (VCR/Floppy/Winch).

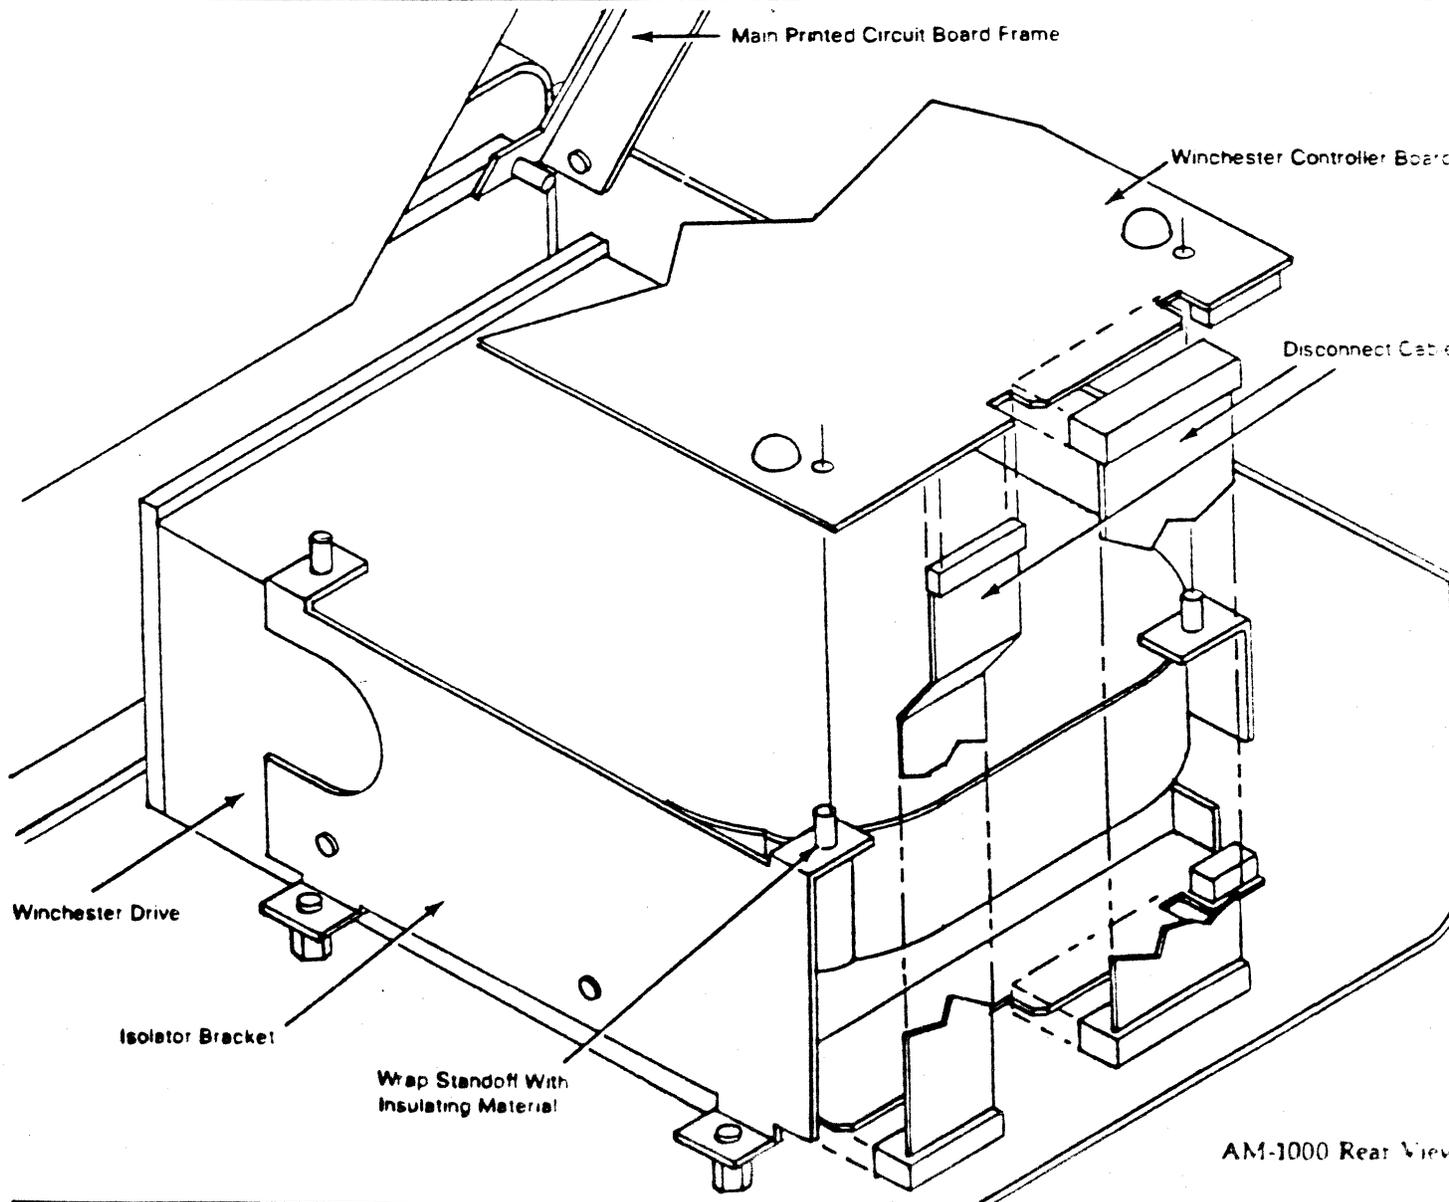
The following modification will prevent a possible shorting of the disk controller circuit board because of contact with the isolator bracket which may cause device errors, error code 1 or random or intermittent errors.

1. Remove the top cover from the AM-1000 chassis.
2. Facing the rear of the AM-1000, raise the main printed circuit board frame.
3. Locate the Winchester drive and drive controller circuit board on the right-hand side of the AM-1000 chassis.
4. Disconnect the cables from the controller board and remove the circuit board.
5. Locate the rear left standoff on the isolator bracket. Wrap this standoff with kapton tape or an equivalent insulating material.
6. Replace the controller circuit board and connect the cables. Lower the main printed circuit board frame and replace the chassis top.

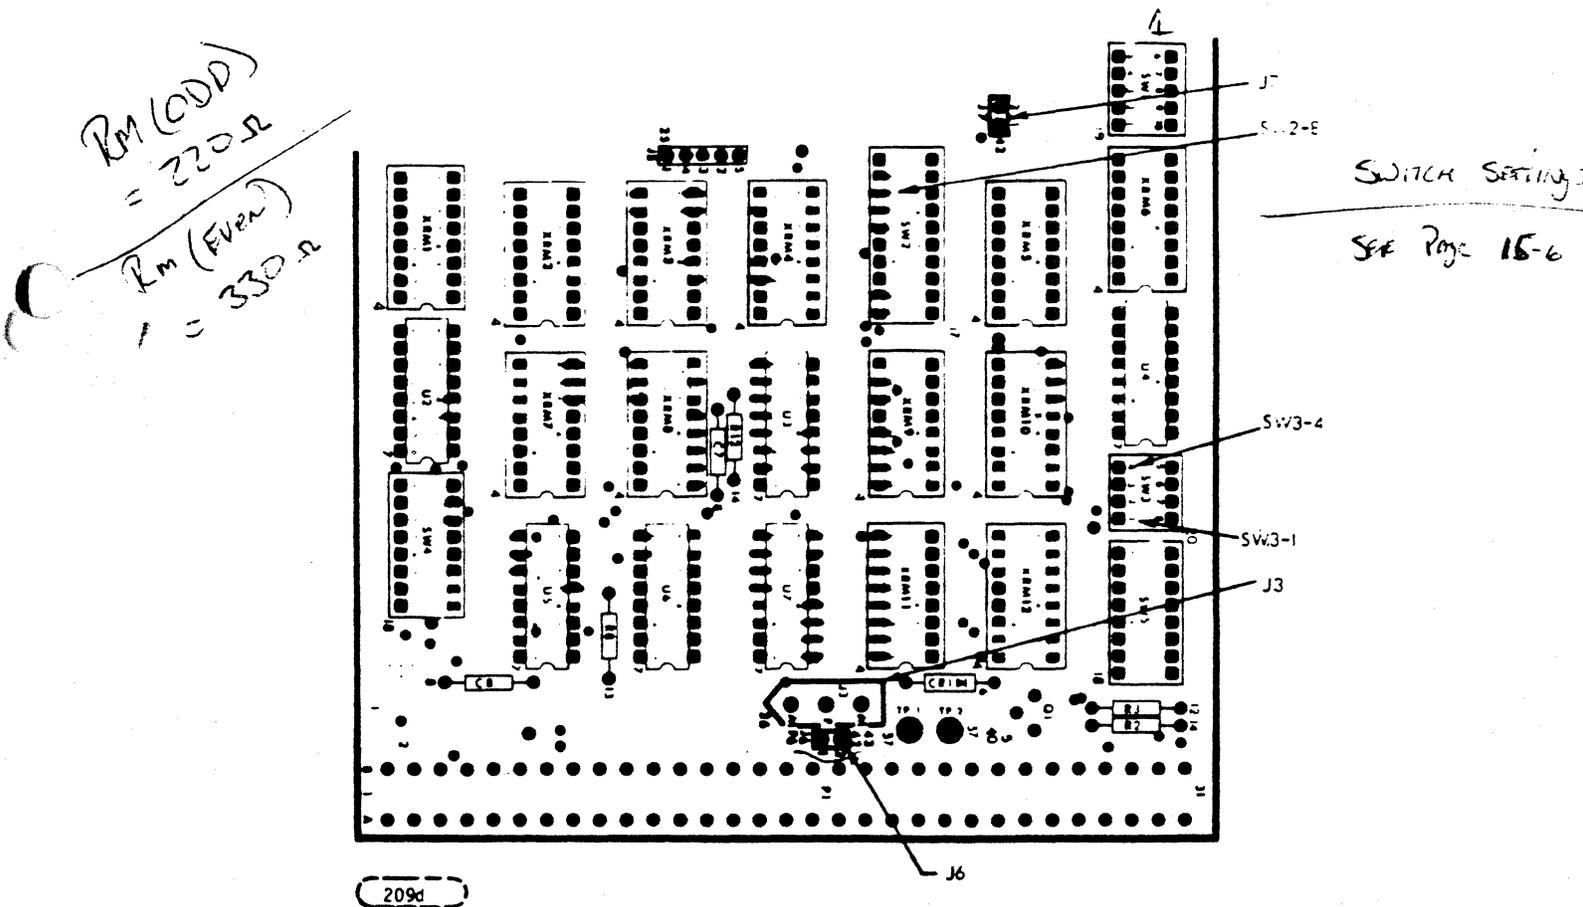
FIGURE 5-2. TERMINATOR CHIPS

The last unit in the chain must be terminated. This can be accomplished by:

- connecting a special terminator plug (Refer to Figure 5-2), or
- installing terminator chips on the I/O board. (Refer to Figure 5-2).

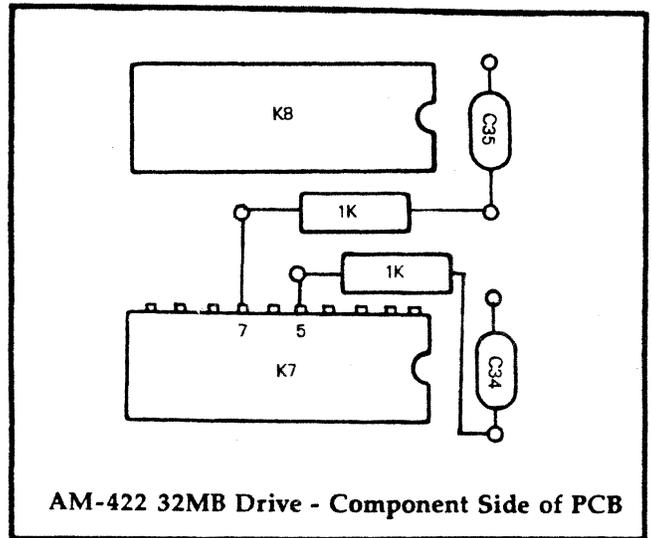
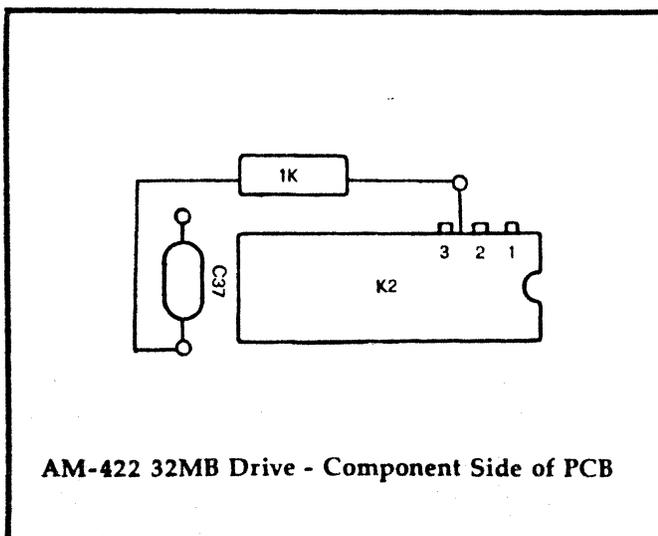
This modification is designed to reduce electronic distortion and improve noise immunity which may cause the 32MB Winchester drive to require resetting more than once in order to spin up. A second indication of electronic distortion may be the inability to mount the 32MB subsystem after the main system power is turned on. This modification will help to insure the proper operation of the motor controller printed circuit board on this drive.

On the component side of the board, install three 1K pull up resistors as follows:

1. Install the first resistor with one lead connected to the feedthrough above K7, pin 5, and solder the other lead to the lower capacitor lead at C34.
2. Remove the wire located at the feedthrough above K7, pin 7 and wrap this wire around the lead of the second resistor. Then, install this resistor with one lead connected to the feedthrough above K7, pin 7, and solder the other lead to the lower capacitor lead at C35.
3. Install the third resistor with one lead connected to the feedthrough located above K2 between pins 2 and 3, and solder the other lead to the lower end of the capacitor lead at C37.

4. Mark the board with the latest revision in the area between F and E, above R23 and R22.
