FORTUNE SYSTEMS CORP.
SERVICE NOTICE INDEX

SERVICE NOTICE

NUMBER 0001

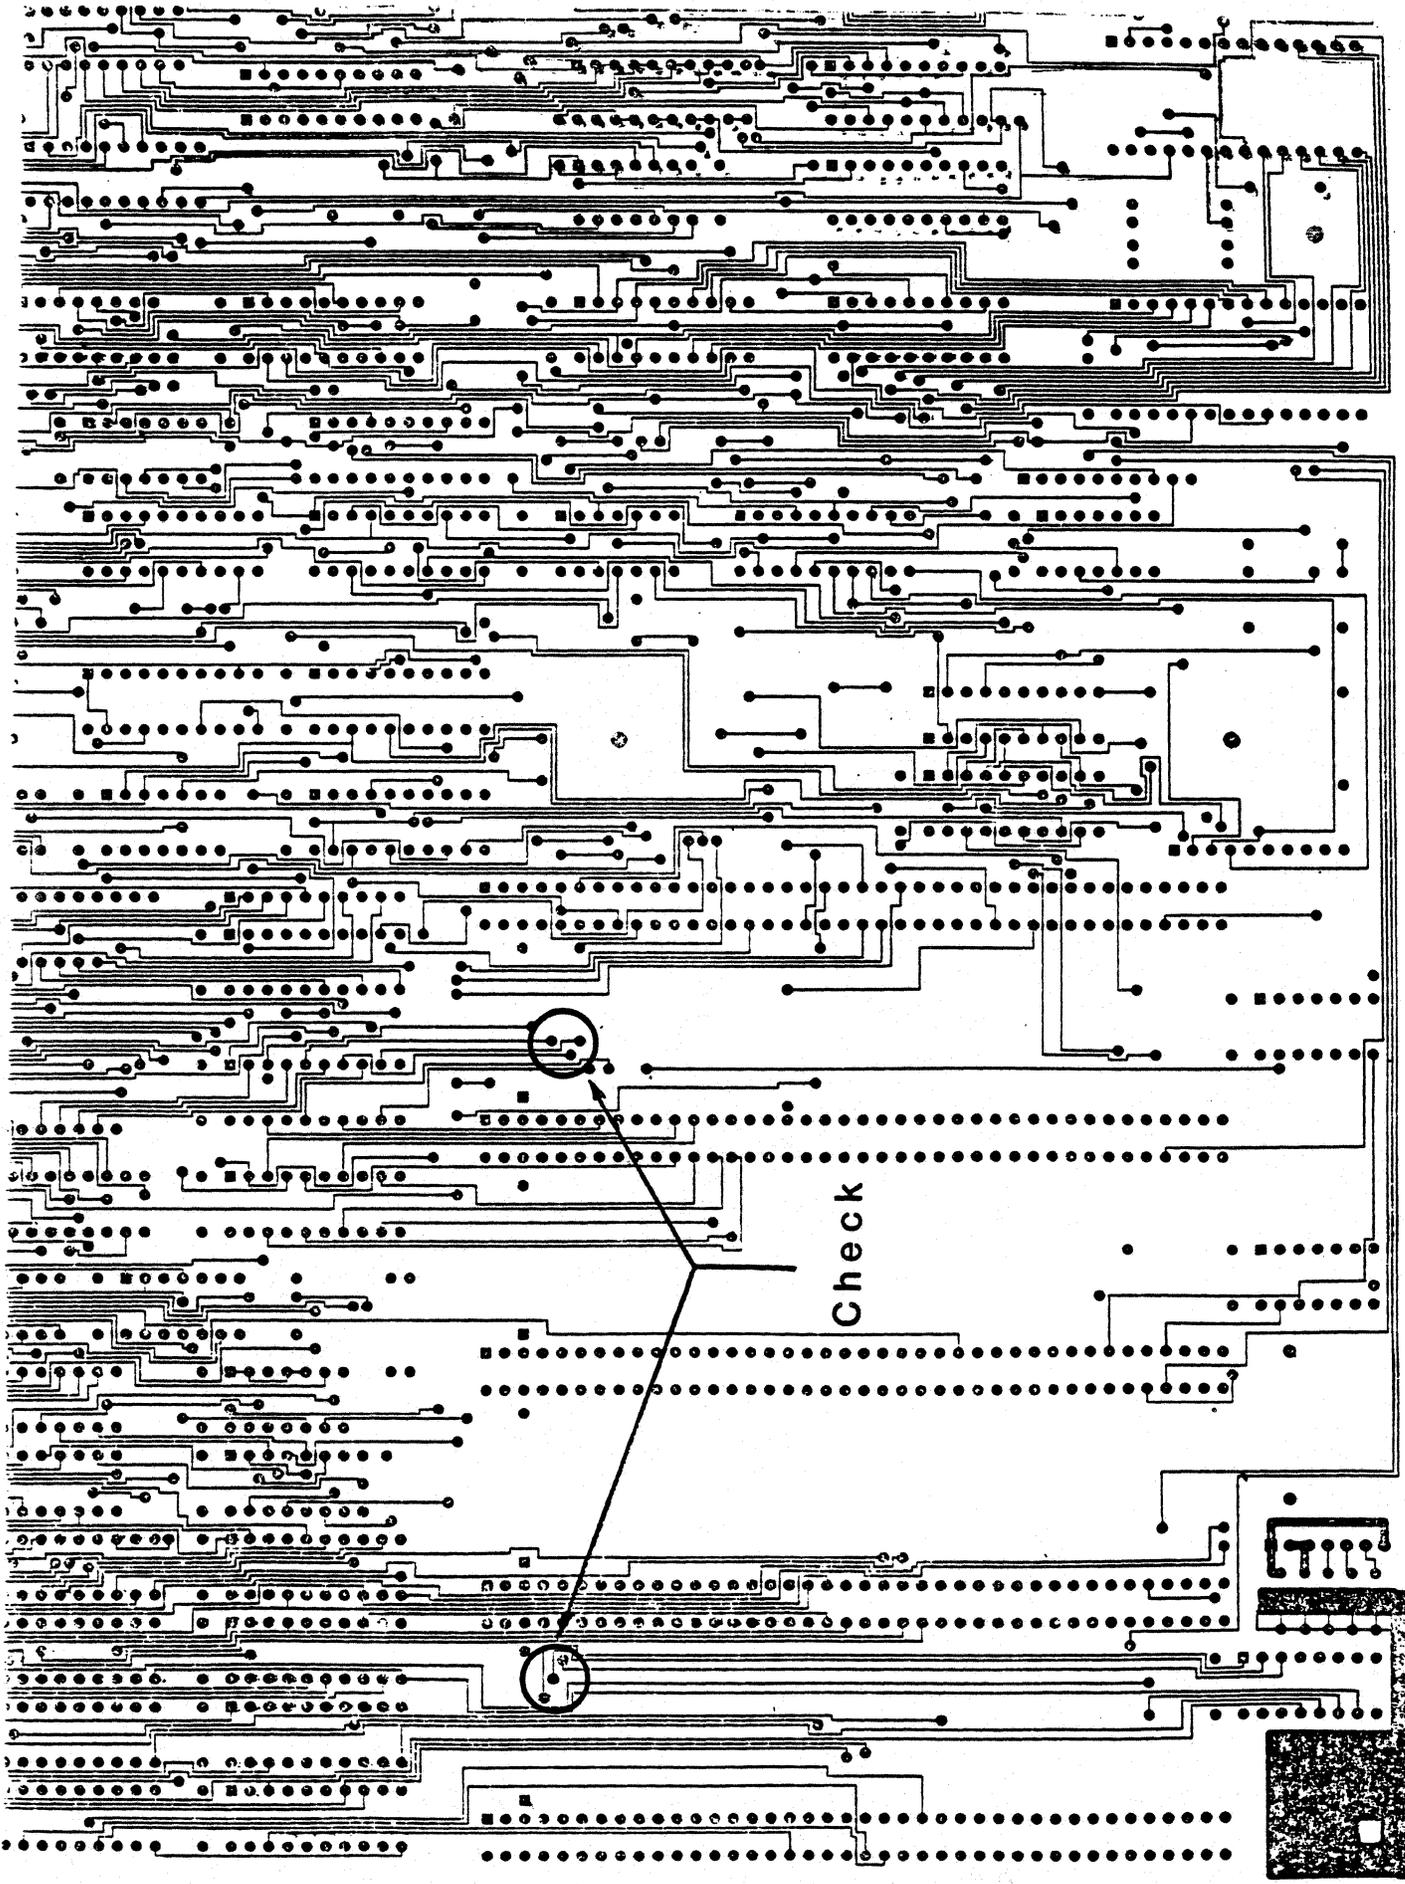
. Bottom Left Corner - Etch Side - Under I/O Option Slot Connectors

PROBLEM: Motherboard Failure

SOLUTION: If a system problem is isolated to a motherboard check the six solder pads, shown in the two circles on the following page, for solder shorts from these pads to adjacent traces. Remove all excess solder with an exacto knife being very careful not to damage the motherboard.
