INFORMATION BULLETIN LOG
CUSTOMER SERVICE

PRODUCT PERQBULLETIN NO. 001SUB-ASSEMBLY MOTHER BOARD/IO BOARD

PART NO. MOM-001/IOB-001MODIFICATIONS FOR LASER PRINTER
OPERATIONSERIAL NO. ALL

MODIFICATION
FOR LASER PRINTER OPERATION

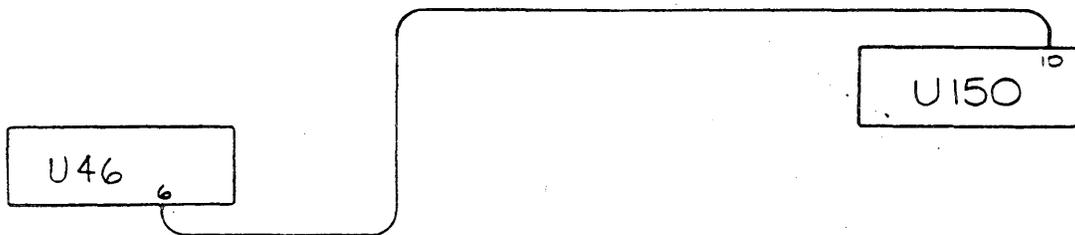
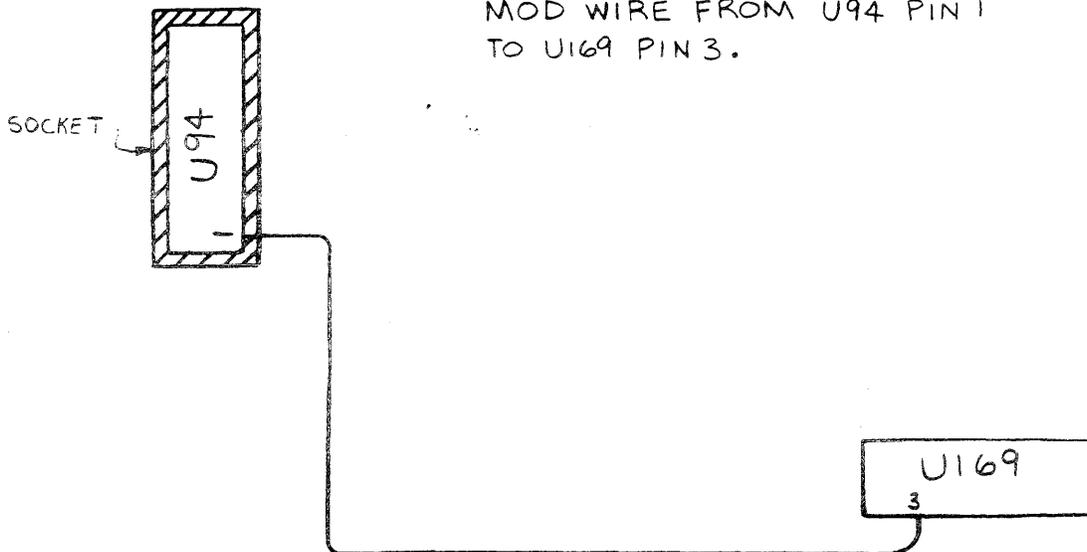
TITLE DETAILED ECO WORK
OF ECO * 00066

It has been discovered that state machine (U93, U94) has been found to be mis-stepping when executing the software, thus causing files to be overwritten on the disk drive.

MOD WIRE FROM U46 PIN 6
TO U150 PIN 10.

MOD WIRE FROM U72 PIN 6
TO U169 PIN 3.

MOD WIRE FROM U94 PIN 1
TO U169 PIN 3.

1. Add a mod wire from U46, pin 6 to U150, pin 10.
2. Add a mod wire from U72, pin 6 to U169, pin 3.
3. Add a mod wire from U112, pin 10 to U112, pin 18.
(The IC will not be present and you will actually be connecting pin 10 to pin 18).

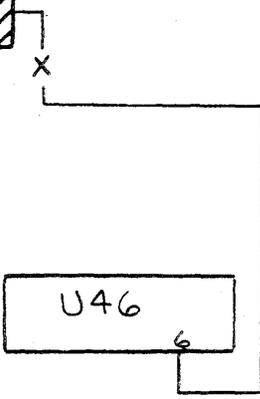
TITLE DETAILED ECO WORK OF ECO # 00066

CUT TRACE THAT GOES FROM U93, PIN 1, TO U46, PIN 6. CUT TRACE CLOSE TO U93.

1. Cut trace that goes from U93, pin 1, to U46, pin 6 on the component side of the board.
2. Cut trace that goes from U93, pin 1, to U150, pin 10.
 - a. "G" boards component side.
 - b. "F" boards non-component side.
3. Cut trace that goes from U169, pin 3 to U150, pin 10.

NOTE
MAKE CUT FOR 10B-F BOARD, ON SOLDER SIDE. MAKE CUT FOR 10B-G BOARD, ON COMPONENT SIDE OF BOARD.
