# Local Bus Compatibility Issues

Systems Engineering

Steve Reames

25-Jul-94

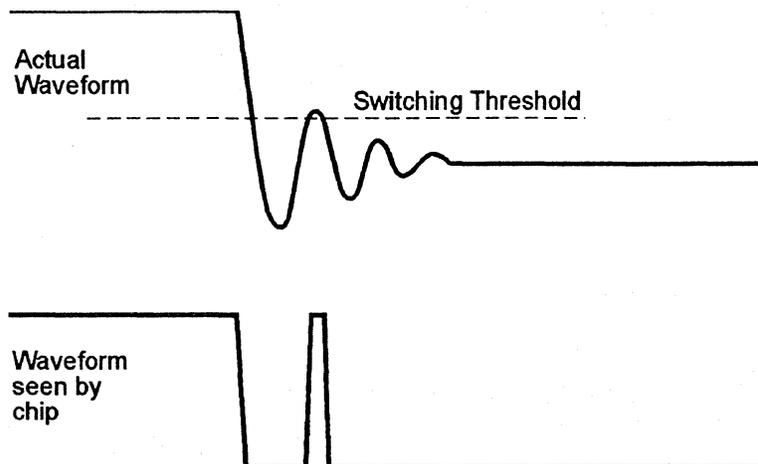
During a read cycle when DIOR- is asserted, it is possible for the ringing to create a short duration deassertion pulse (figure 1). This pulse occurs early in the read cycle. Inside the ATA interface portion of KONI or NEKO is a FIFO buffer that contains the data to be read. The extra pulse on the DIOR- line advances the FIFO pointer by one. This results in losing one word of data. The host system read operation receives one word too few, and the remaining bytes are shifted. A typical data sequence might look like . . . W7, W8, W9, W11, W12 . . . Notice that word 10 is missing from the returned data. This also means that the host will try to read one more word from the drive than the drive has remaining. Depending on the implementation of the BIOS, this may lock-up the system or simply return an extra byte of garbage at the end of the sector.

Figure 1 – Typical ringing on bus and its effect

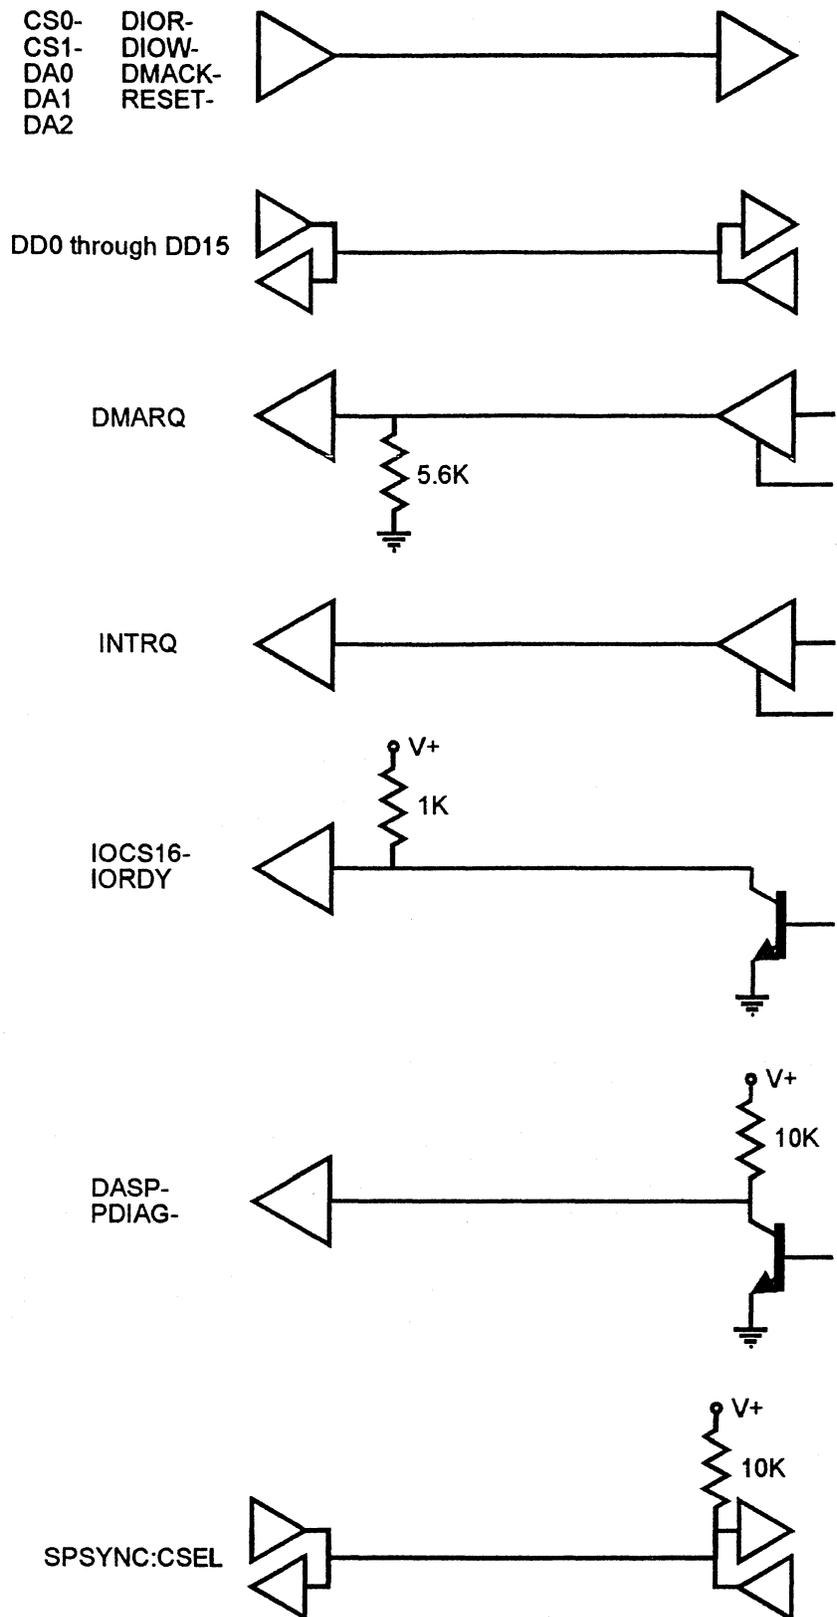
System measurements have shown the ringing problem is strongly associated with DIOR-, DIOW-, and CS0-. From the ATA specification, we can group all of the bus signals into seven basic structures (Figure 2). The ringing will be similar on signal lines with the same bus structure. Although problems have not yet been seen on some of the signals (such as DA0, DA1, or DA2), they are likely to have problems in the future because they are of the same bus structure as the problem lines. The effects of ringing will be different between signals depending on their function. The first group (DIOR-, DIOW-, CS0-, CS1-, DA0, DA1, DA2, DMACK-, RESET-) are control signals from the host to the drive. The signal DMARQ can be included in this group since it is a control signal from the drive to the host with a similar bus structure. DIOR- and DIOW- are symmetrical in their operation and will benefit from a similar fix. CS0-, CS1-, DA0, DA1, and DA2 are usually used in a combinatorial logic decode circuit in the drive. Any fix applied to these lines must either involve none of them or all of them. Although DMACK- and DMARQ have not shown any problems at this time, this is most likely because DMA at high speeds has not been used much at this time. This will change in the near future, so designers should consider implementing any fix to these lines also. Ringing on the RESET- line has no detrimental effect from a practical viewpoint, so this line can remain unterminated.

Figure 2 – The seven basic ATA bus structures

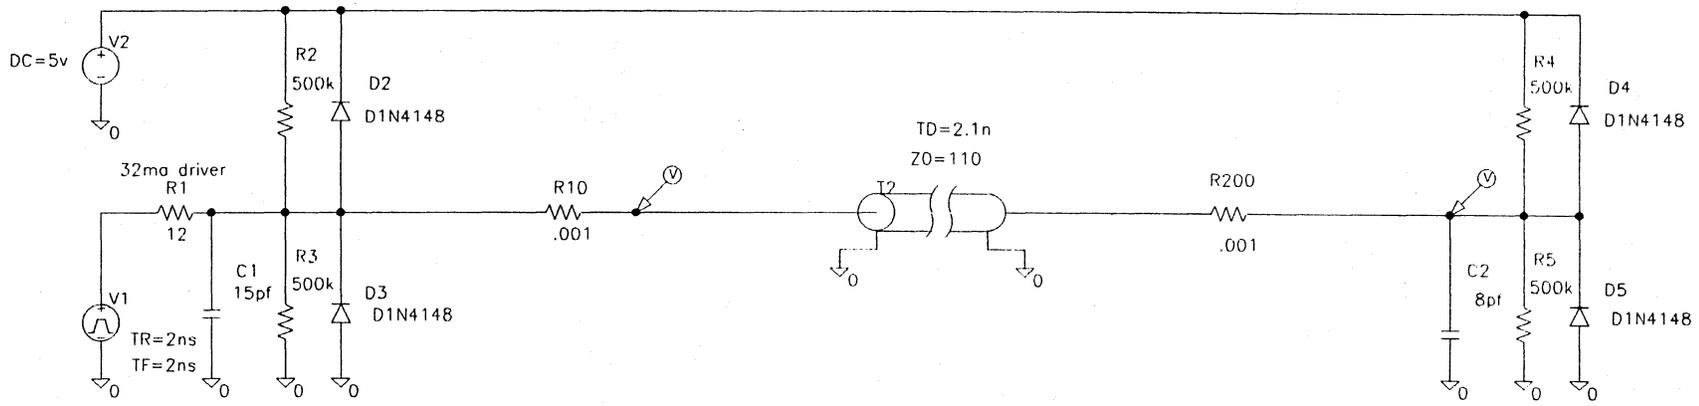
Figure 3

To study the effects of different solutions on these lines, a SPICE model has been constructed (figure 3). This model includes a host driver, 18 inches of ATA ribbon cable, and a disk drive. The resistors R100 and R200 are not currently in the system, and are part of the recommended solution. To model the system as it stands currently, both R100 and R200 are set to .001 ohms (SPICE does not permit zero-valued elements). Voltage monitoring is placed at the output of the host and at the input of the drive. The voltage at the input to the drive is the important signal for our purposes. The resulting waveforms are shown in figure 4.

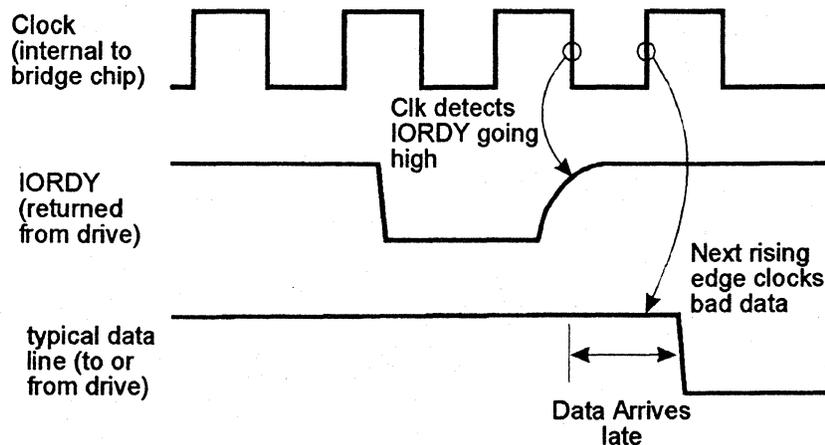
The problems seen with the PCTECH bridge chips are a bit more complex to describe. The problem only appears when a read cycle occurs and the drive finds it necessary to delay the host read using the IORDY line. Eventually a byte becomes available, and the drive asserts IORDY, telling the host that data is present on the data lines. The current Quantum drives (using KONI or NEKO) have a zero nanosecond specified setup time from data to assertion of IORDY. This means that the data is placed on the bus at exactly the same time as IORDY is asserted (figure 7). The current versions of KONI and NEKO violate their data setup times and occasionally deliver data as late as 15 ns after IORDY goes high.

Figure 7 – Late data problem with PCTECH bridge chip

The PCTECH chip samples IORDY on both rising and falling edges of its internal clock. The clock speed is usually 33 MHz. Data is always read into the chip on the rising edge of the clock. If the assertion of IORDY is timed such that the chip detects it with a falling edge, then the next rising edge – only 15 ns later – will capture the data. Since the KONI and NEKO chips can deliver data as much as 15 ns late, then the data is not ready when the PCTECH chip latches in the data. Ringing on the data lines, as described in Section 1 above, aggravates the problem. The data lines are often not stable until 30 ns or more after IORDY

is asserted. Other chips from different manufacturers only sample IORDY on rising edges of the clock so there is at least 30 ns before the next rising edge that is used to capture the data. This problem scenario has been confirmed with engineers at PCTECH.

The solution is to delay the assertion of IORDY. If the assertion of the IORDY signal is delayed relative to the data then the KONI/NEKO chip will have enough time to drive the data lines and the data lines will have more time to settle. This delay can be accomplished several different ways, but it is important not to significantly increase the deassertion of IORDY (falling edge). The downside of this solution is that it will increase the cycle time for every access that requires IORDY. This may decrease system performance by a small amount. The solution currently being implemented is a two-transistor circuit as shown in figure 8. Although the late setup of data has shown to be a problem only with the PCTECH chip, it is likely that most other systems and chips are very close to their timing margin and may demonstrate occasional failures in the field.

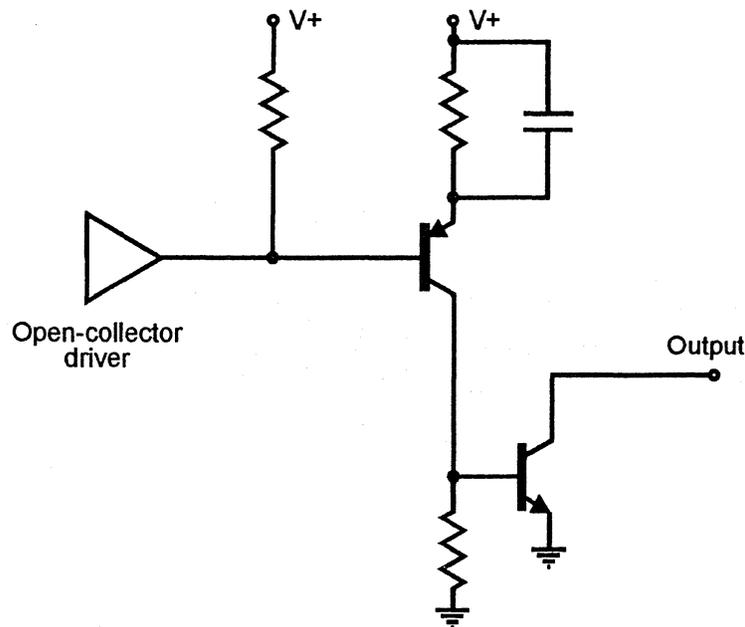
Figure 8 – IORDY delay circuit for PCTECH bridge chip

The timing margin on IORDY can be improved with both a delay circuit and adding series resistors to eliminate ringing on the data lines. The series resistors on the data lines will also help during fast DMA transfers, where the data setup time is critical but the IORDY signal is not used. Although we are not currently seeing any use of fast DMA, Compaq and others have stated that they intend to use it in the future.

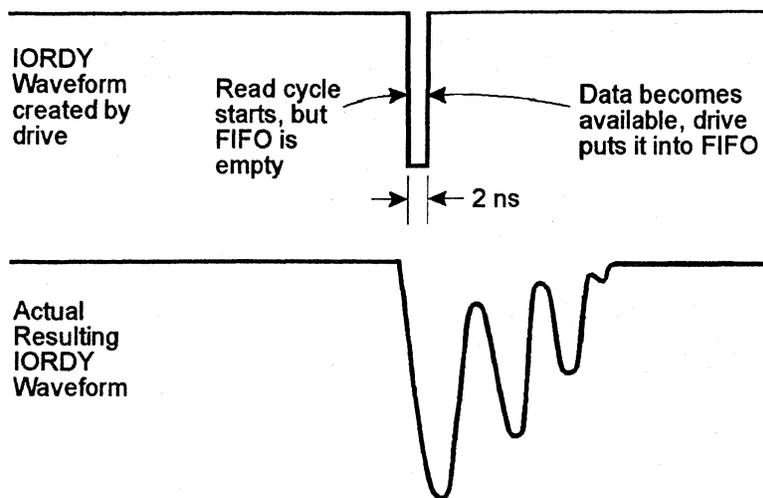
There is one more non-problem that is worth mentioning for the sake of completeness. There are certain conditions on the drive which will cause severe ringing on the IORDY line. If the host performs a read cycle to the drive, and the

FIFO on the drive is empty, then the drive will deassert IORDY in an effort to hold-off the host. Data coming off the heads is an asynchronous process when compared to host accesses, so it is possible that a byte can be put in the FIFO just a couple nanoseconds after IORDY was deasserted (figure 9). When this happens, the drive sees that data is now available, so it reasserts IORDY. Since the IORDY signal from the drive is open collector, and the pulse width is less than the round-trip delay of the ATA cable, large amplitude ringing is set up on the cable. Although the signal looks terrible, it is not a problem in reality. IORDY is not sampled by the host until much later in the read cycle, and by that time the ringing has subsided. Therefore the distorted waveform is never seen by the host. As a point of reference, this issue has been addressed in the next generation data path controller (LEO) and will not occur with the new design.

Figure 9 – Pulse sliver on IORDY causing ringing
