western peripherals

MEMORANDUM

TO: All TC-120 Customers

SUBJECT: Product Information Bulletins:

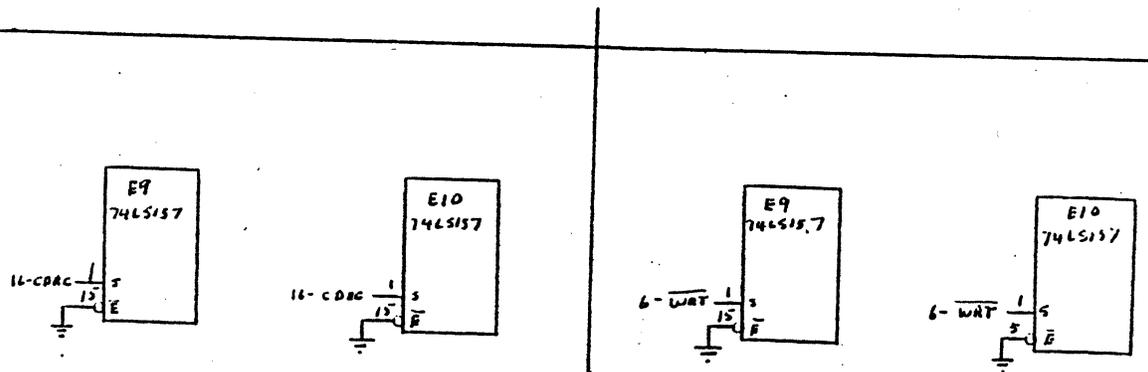
TITLE/DESCRIPTION CORRECT GATING ERROR TO SHIFT REGISTERS			NUMBER 12007
PRODUCT LINE Tape Controller	MODEL AFFECTED 120/120024	EFFECTIVE DATE September 9, 1976	REFERENCE ECO # 108/138
DISPOSITION <input checked="" type="checkbox"/> IMPROVEMENT <input type="checkbox"/> RETROFIT ON FAILURE <input type="checkbox"/> RECOMMEND MANDATORY <input type="checkbox"/> INFORMATION ONLY		EFFECTIVITY This change affects Assembly Number 120024 and updates those controllers below Serial Number 66 from Revision H to Revision K.

This change improves the gating into the data shift registers.

1. Cut etch on solder side at E9, pin 1 (cut beyond feed through)
2. Add wire from E7B, pin 6 to E9, pin 1
3. Re-label board from H to K
4. Schematics - Sheet 14
E-9 and E-10, pin 1 input is now the term \overline{WRT} from sheet 6
5. Maintain a copy of this document with affected controllers

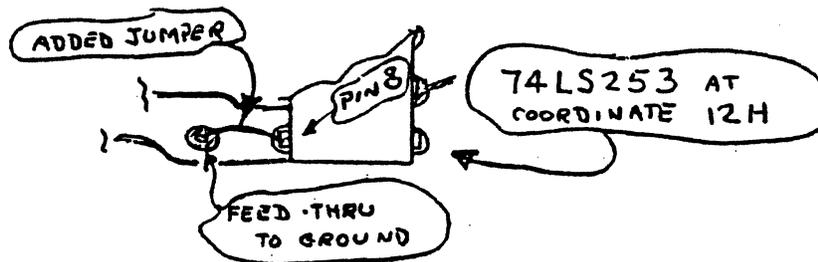
These changes reduce noise that may exist because of component location.

Add a jumper from 12H, pin 8 (ground) to the ground bus at the adjacent feed-thru as shown.

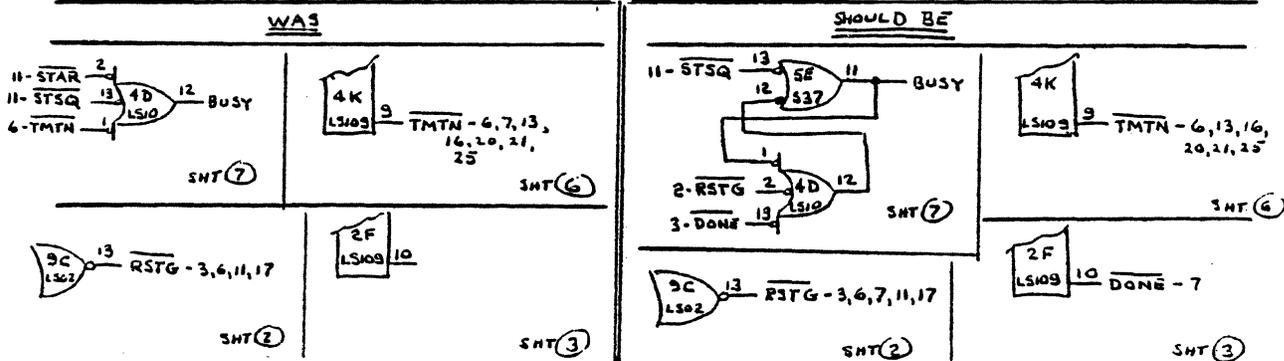
This bulletin eliminates a race condition in the SELB logic (busy)

1. On component side, cut D4, pin 13
2. On component side, cut D4, pin 2
3. On solder side, cut D4, pin 1
4. On solder side, cut D4, pin 12
5. On solder side, cut D4, pin 13
6. Add jumper from F2, pin 13 to D4, pin 13
7. Add jumper from E5, pin 11 to D4, pin 1
8. Add jumper from E5, pin 11 to feed through near 4D, pin 7
9. Add jumper from F5, pin 4 to D4, pin 2
10. Add jumper from E5, pin 13 to feed through near D4, pin 13
11. Add jumper from C4, pin 9 to feed through near D4, pin 13
12. Add jumper from E5, pin 12 to D4, pin 12
13. Re-label 120024 to revision N
120025 to revision B
14. Schematic
15. CHANGE THE SCHEMATIC AS SHOWN BELOW:

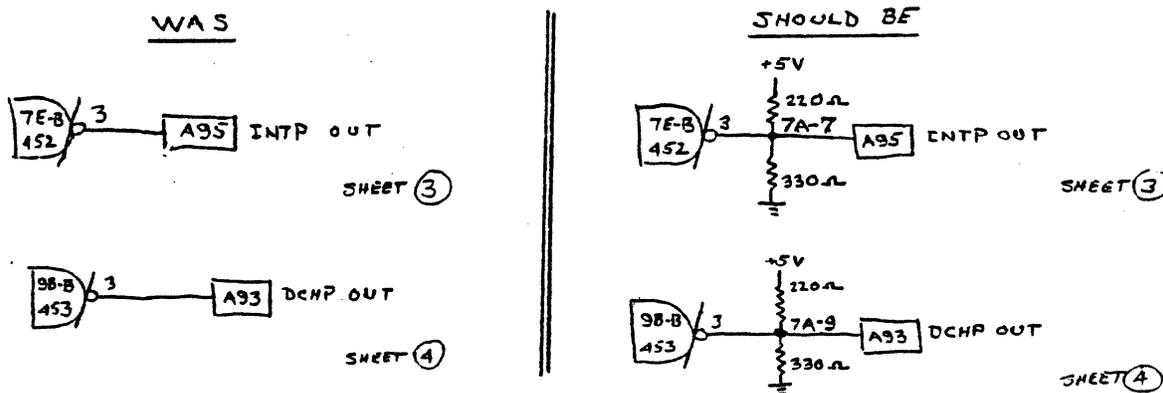
This change adds termination networks to the INTP OUT and the DCHP OUT signals.

Change schematic 120016 in the Logic Manual as follows:

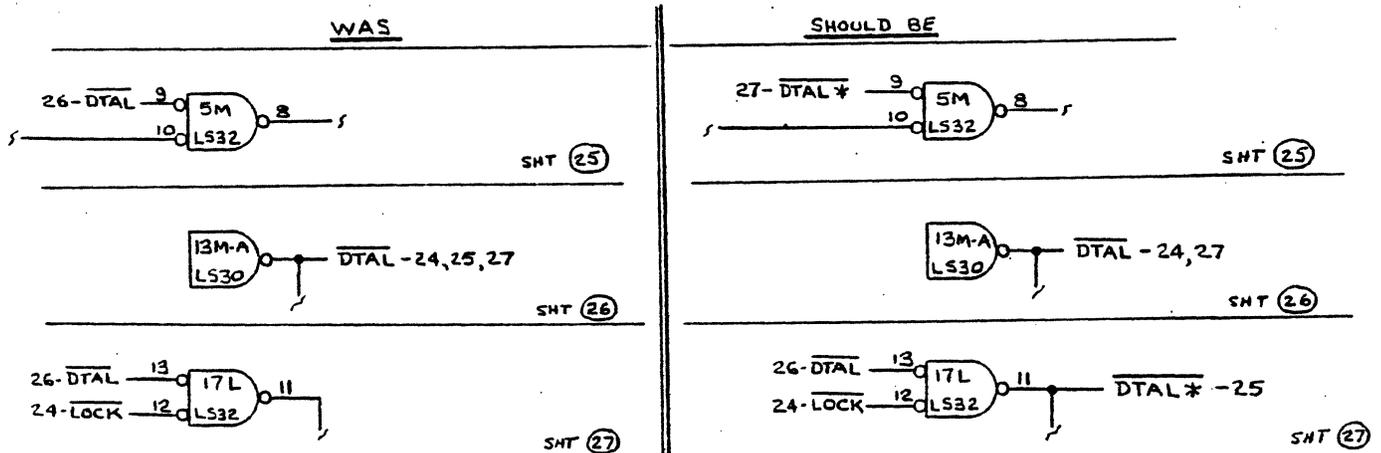
Parity errors may be incorrectly reported at load point in the PE mode.

On the component side of the board, cut the etch coming from 5M pin 9 where it comes out from under 5M between pins 6 and 7.

Add a jumper on the component side of the board from 4K pin 5 to 5M pin 9. (Note: existing wire on 4K pin 5 was installed at revision M).

Change schematic 120016 in the Logic Manual as follows:

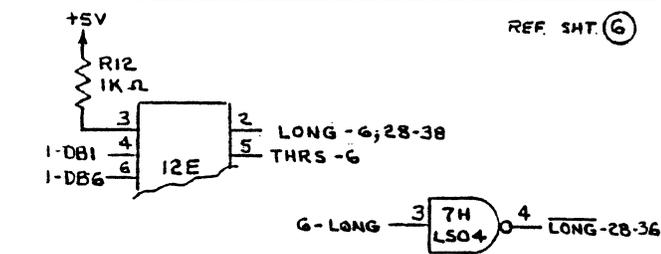
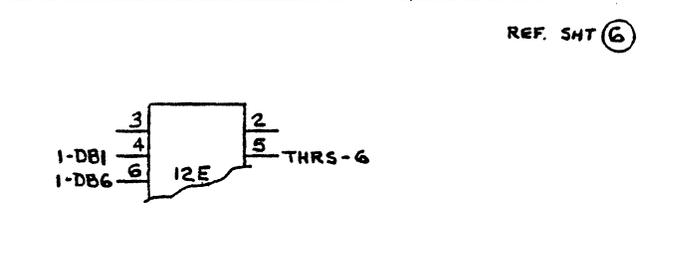
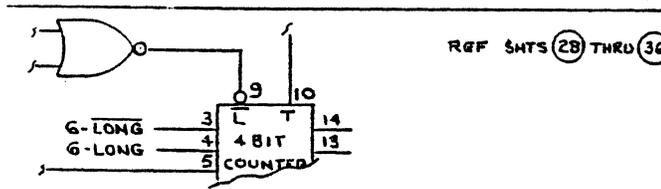
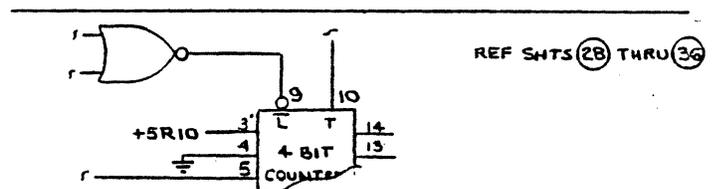
Intermittent parity errors are detected, especially at higher data rates.

This change decreases the susceptibility to read errors caused by jitter by increasing read window timing to 69% of the bit cell.

Change schematic I20016 in the Logic Manual as follows:

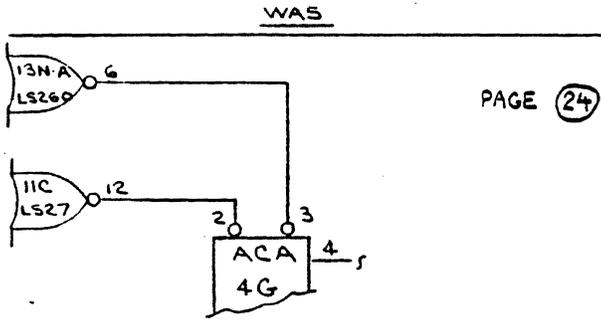
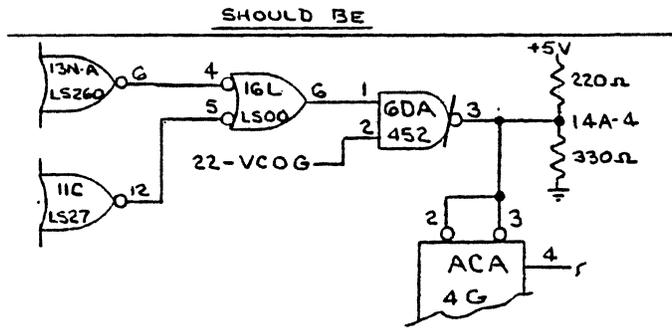
TITLE/DESCRIPTION PERFORMANCE IMPROVEMENT - 125 IPS			NUMBER 12015
PRODUCT LINE TAPE CONTROLLER	MODEL AFFECTED TC-120 & TC-128	EFFECTIVE DATE 8-2-78	REFERENCE ECO # 375
DISPOSITION <input checked="" type="checkbox"/> IMPROVEMENT <input checked="" type="checkbox"/> RETROFIT ON FAILURE <input type="checkbox"/> RECOMMEND MANDATORY <input type="checkbox"/> INFORMATION ONLY		EFFECTIVITY This change updates Assembly Number: 120024 from Rev. X to Rev. Y 120025 from Rev. K to Rev. L SN 879 and below are affected.	
<u>CHANGE PROCEDURE</u>			
Remove the controller from the equipment and perform the following modifications:			
Repair the etch on the component side of the board at the feed-thru by location 17C pin 16 that connects to 17C pin 15 on the solder side			
Remove the following jumpers:			
<p style="margin-left: 40px;">From 16L pin 6 to the feed-thru by location 17C pin 16 that connects to 17C pin 15 on the solder side</p> <p style="margin-left: 40px;">From 16L pin 4 to 17J pin 1</p> <p style="margin-left: 40px;">From 16L pin 5 to 5E pin 10</p>

Change schematic I20016 in the Logic Manual as follows:

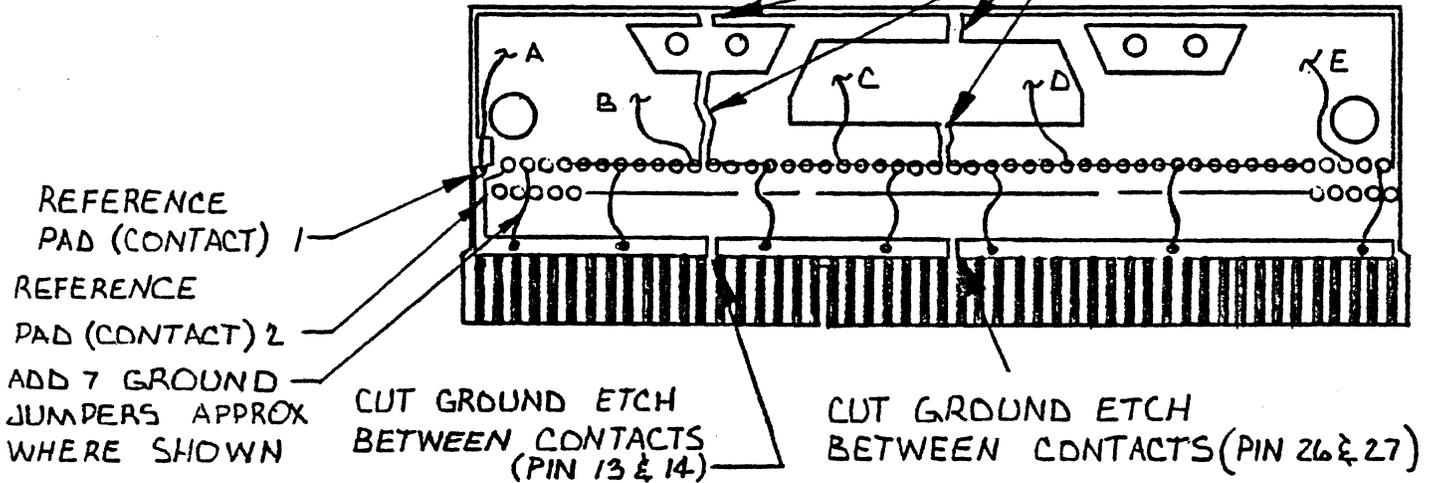
Reduce noise on ground by isolating grounds for read, write, and control signals.

REWORK THE CABLE ASSY BY MAKING INDICATED ETCH CUTS ON THE PWB (9) AND REWIRE THE GROUNDS AS SHOWN ON THE WIRING CHART.

CUT GROUND ETCH APPROX WHERE SHOWN 4 PLACES FRONT & 3 PLACES FAR SIDE.
