Internal Memo

Subject
ALTO BULLETIN SYSTEM (AL01)

Alto Bulletin (AL06)

This bulletin describes the correct way to change backplanes.

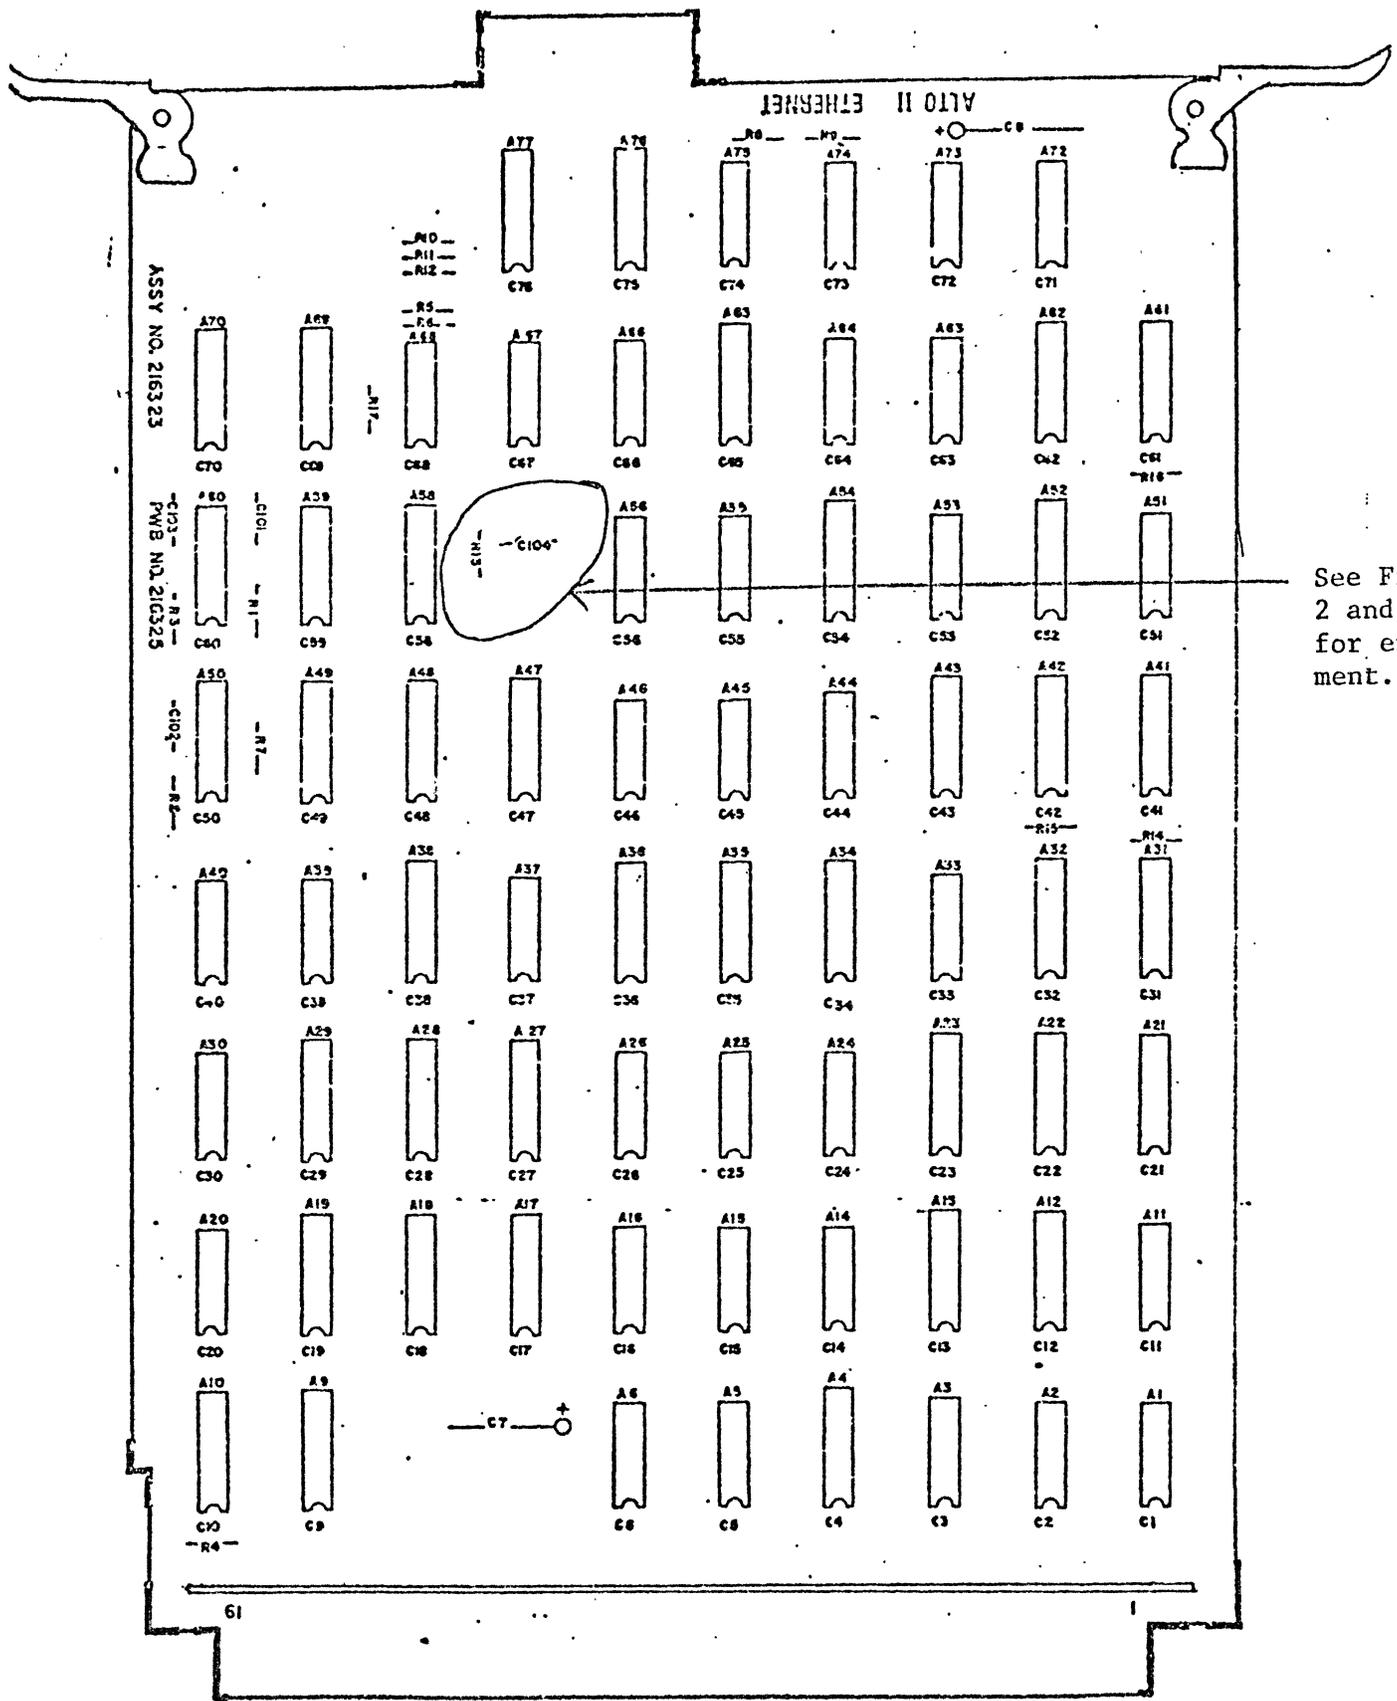
FIGURE 1

The Alto II Ethernet module, Assy. No. 216323, was found to have an Engineering Order (E/O) installed incorrectly. This only happened to approximately 16 Alto II's shipped around July 1978. However, all Alto II's that experience Ethernet type problems should be checked for this. The problems will show up as not booting from Ethernet (intermittent) or Transmission/Receive errors (using PUPTEST). Figure 1 shows where the E/O is located at on the module (attached).

See Figures 2 and/or 3 for enlargement.

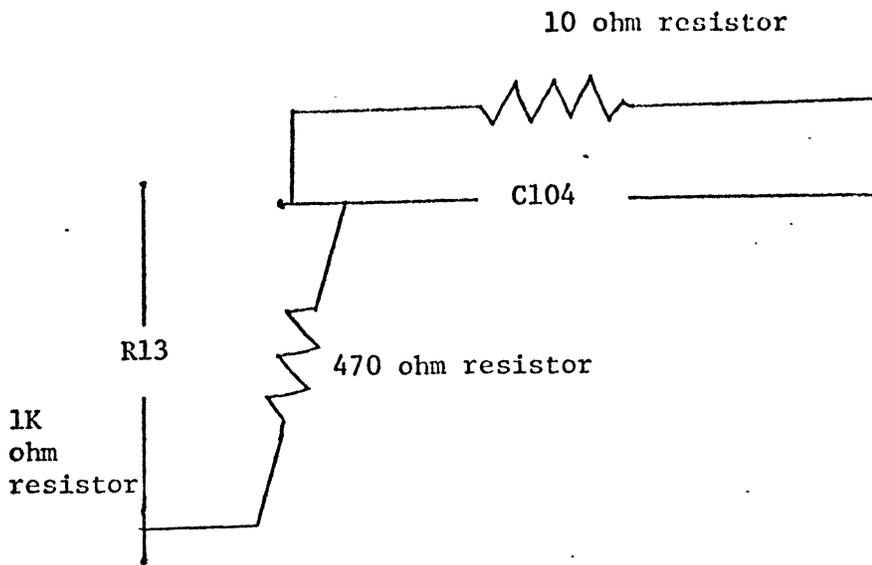
FIGURE 2
Engineering Order Done Correctly

The E/O is shown correctly in Figure 2 and shown incorrectly in Figure 3 (attached). If you have any problems with Ethernet modules, please verify that the E/O as shown in Figure 2 is the same as the module. If the module matches Figure 3, rework the resistor to match Figure 2.

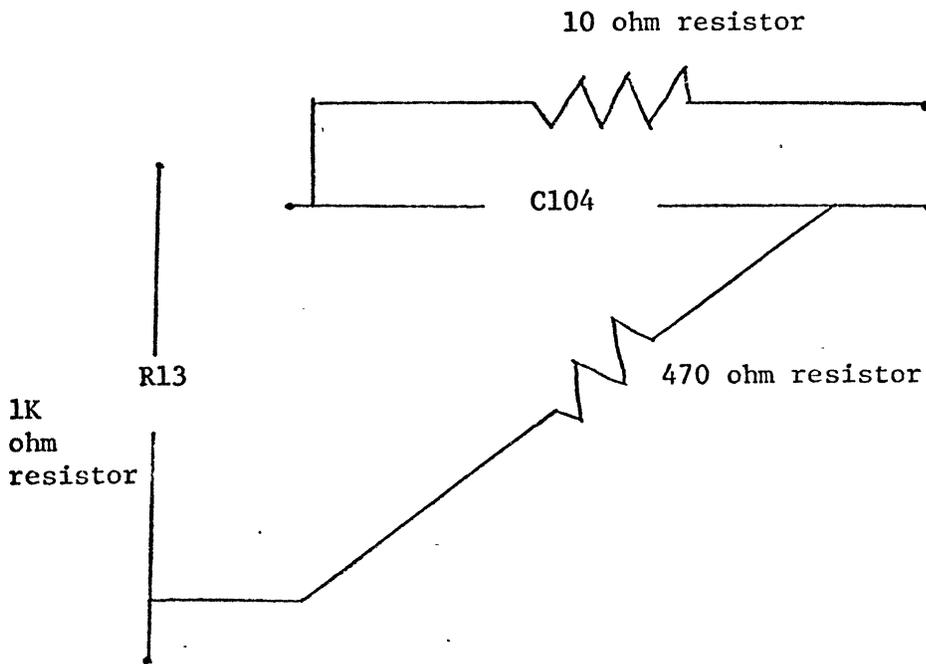
FIGURE 3
Engineering Order Done Incorrectly

NOTE: The 470 ohm resistor is on the wrong end of capacitor C104. It should be on the same end as the 10 ohm resistor is.

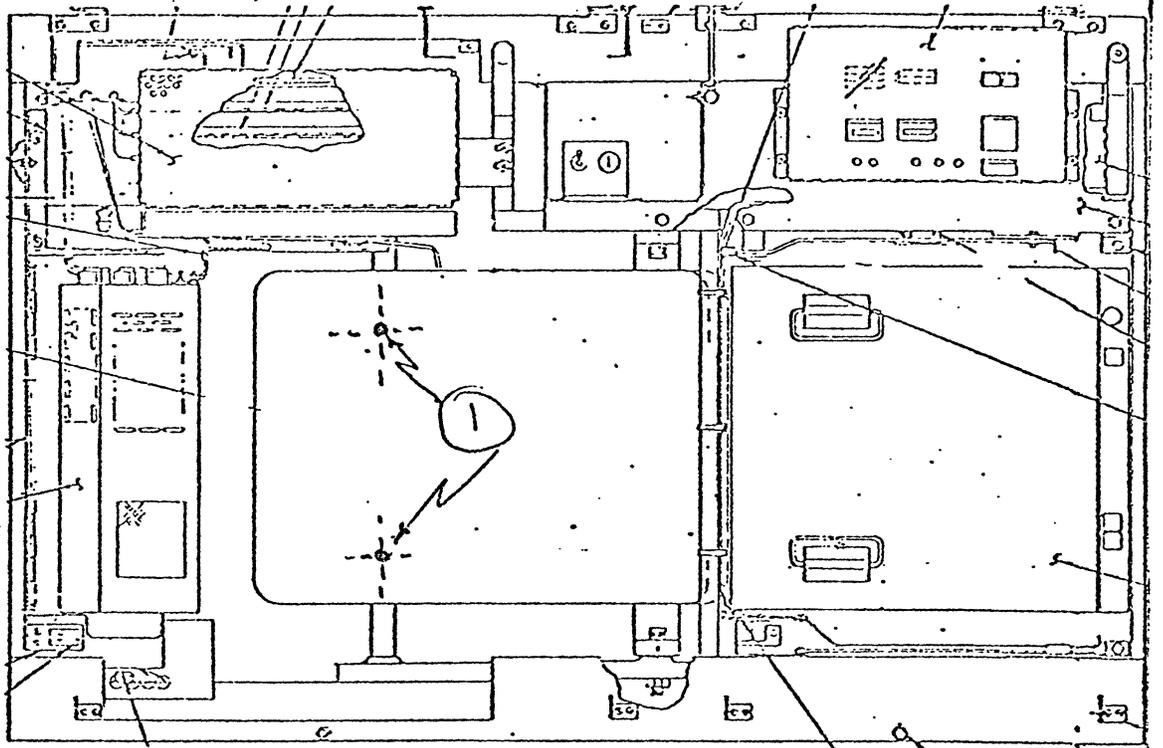
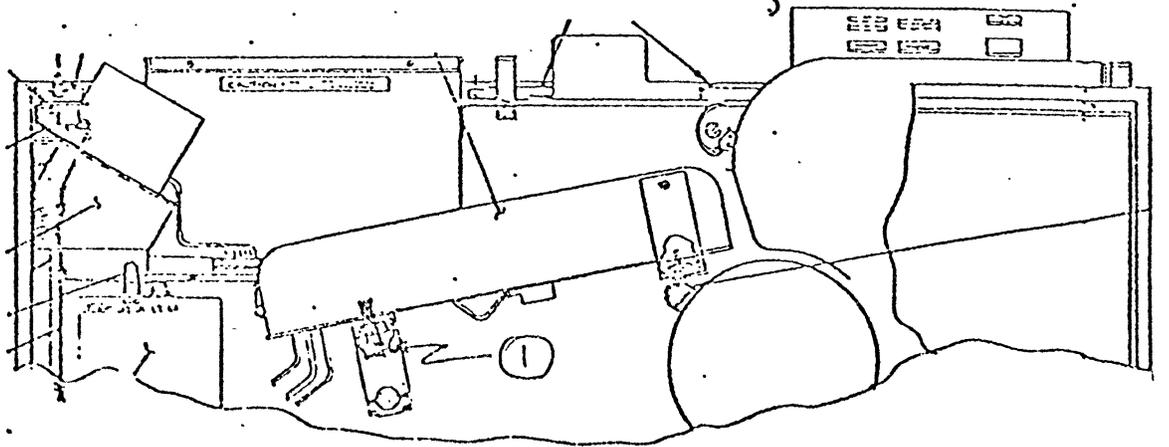
There is a possibility that when moving Dovers the Main Frame Flex is being transferred to the slot head base. This flexing may be disturbing the alignment of the slot head.

To prevent this problem, when a Dover is to be moved, the two allen bolts (item #1 on attached sheet) that attach the head to the lower mounting brace should be loosened before the Dover is moved. Then retighten the allen bolts once the Dover is in place.

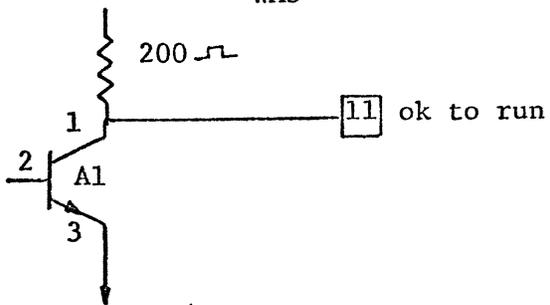
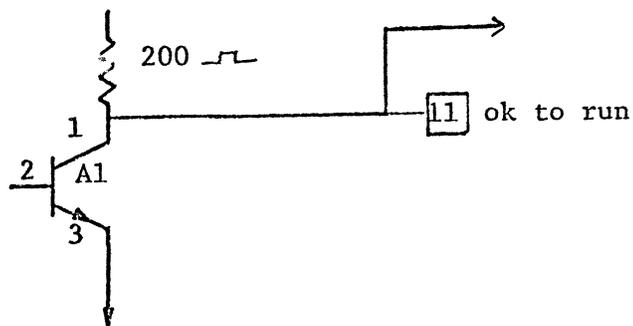
REVISE SHEET 7

This bulletin pertains to the Disc Control Module, Assembly #216389. A problem was found in the module in that when the processor was powered up, the Disc Control Module would not always be left in a bootable state. This problem was found to be intermittent and sometimes recycling the Alto and/or reseating the Disc Control Module would correct the problem.

Any drawing relating to Disc Control Module, Assembly #216389, should be changed as shown in Figure 2.

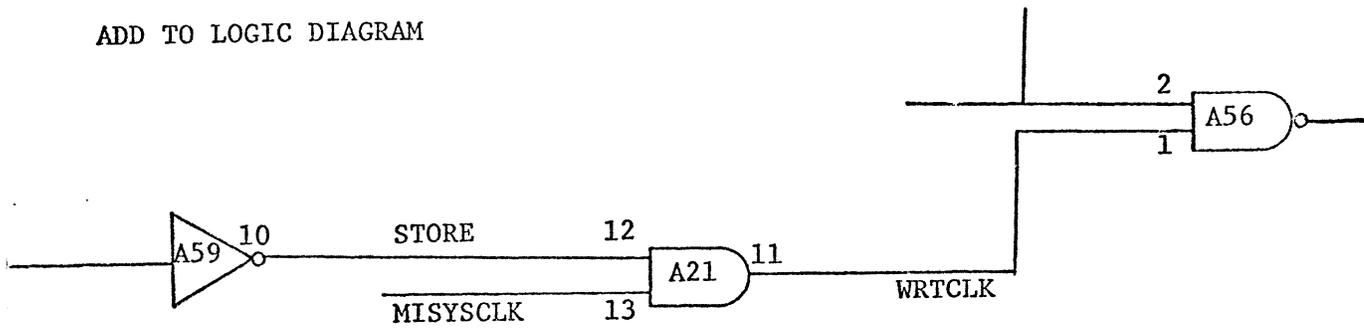
SHEET 7

A reliability error was found to occur at a certain time to cause the error status register to be erroneously cleared. This problem shows up as a failure in the AIM Module.

The drawing changes affected by this E/O are shown in Figure 2.

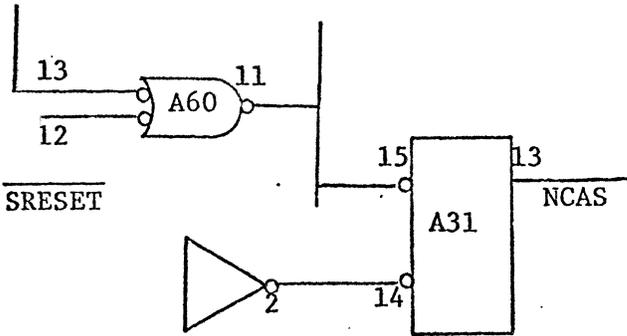
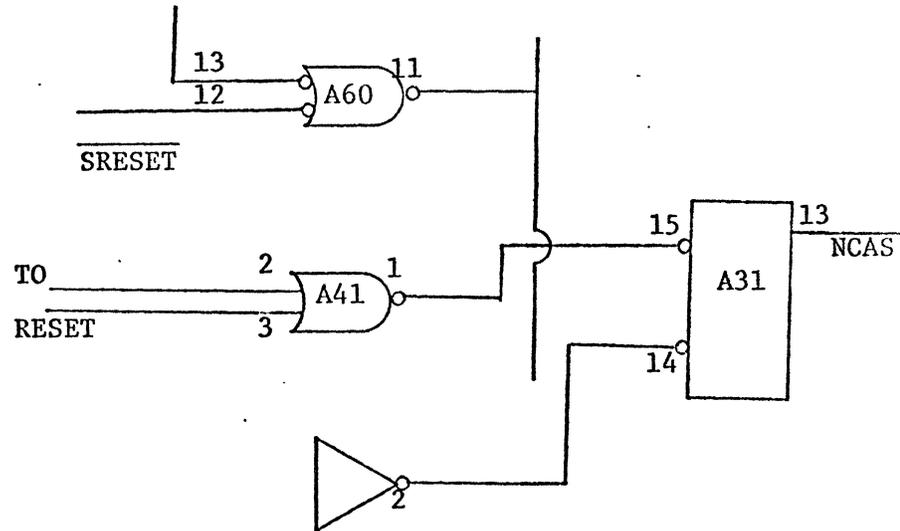
SHEET 12

A design error was found that when using an (XM) Alto II with an Orbit configuration, proper character widths are not produced on the Dover. This was found to be caused by a memory timing discrepancy.

The problem shows up when printing on a Dover as missing scan lines. The scan lines that are there are in no type of pattern.

The drawing changes are the same for both assembly #'s and are shown in Figure 2.

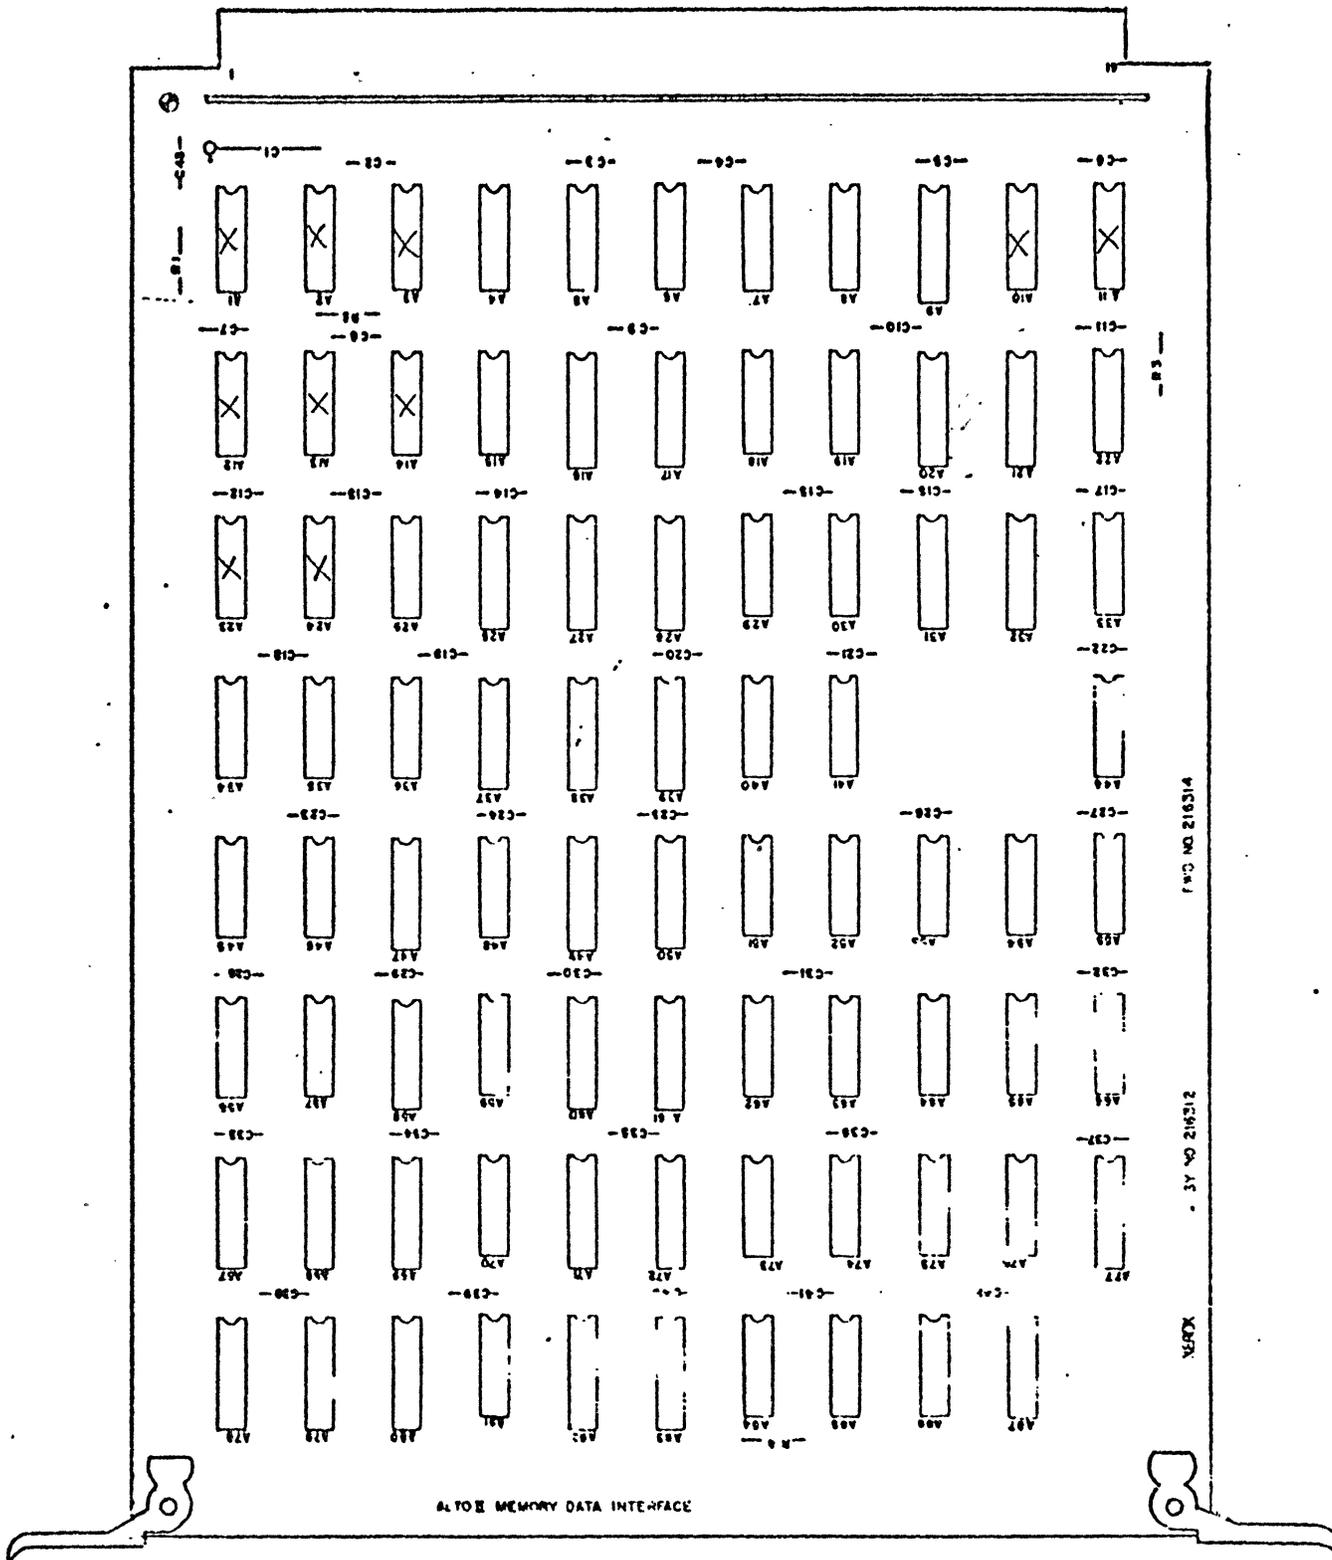
FIGURE 1

It was found that the DIM Module at certain times was experiencing noise related problems. These problems show up as intermittent failure with the DIM Module.

Chip locations marked with (X) are ones referred to in step 1 of E/O.

1. Remove the "74S132" microcircuits that are located in the following locations: A1, A2, A3, A10, A11, A12, A13, A14, A23, and A24. There should be a total of ten. See Figure 1.
2. Install new "74H00" microcircuits into the locations listed in step 1 making sure the microcircuits face the correct way in sockets.
3. Reinsert DIM Module into working Alto II and verify correct operation of all diagnostics.
4. After the E/O is completed, the DIM Module, Assembly #216312, should be Revision "D".
5. The chips removed in step 1 should be returned to me.
6. The chips required in step 2 are only being sent to the sites that have DIM Module, Assembly #216312, installed in non-extended memory Alto II's. These sites are: Boston, Rochester, and El Segundo.

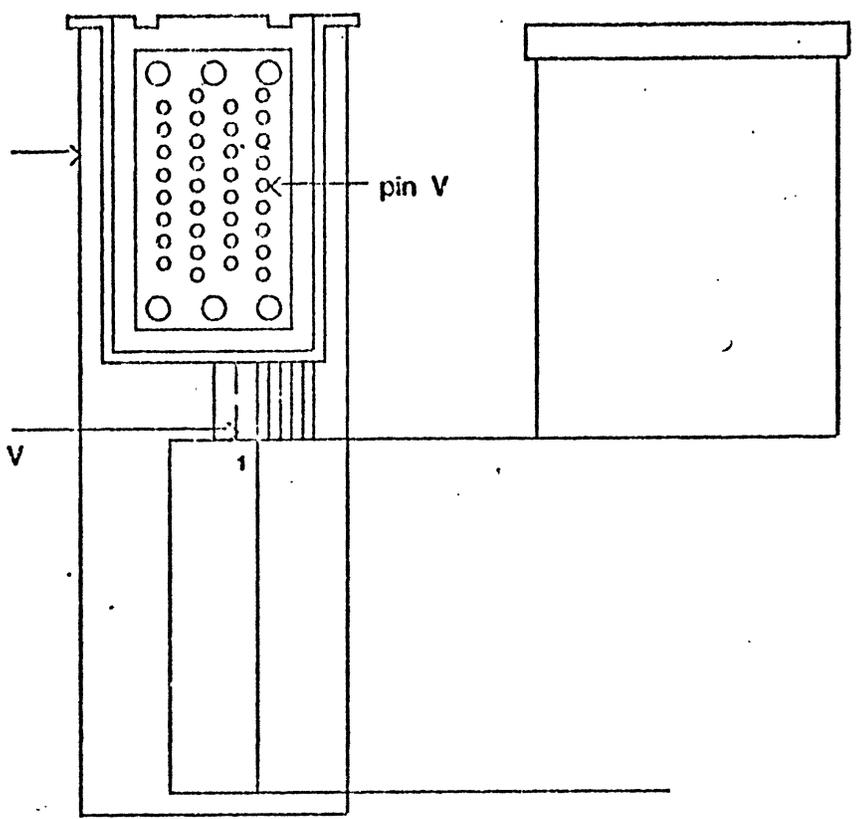
A problem has been found that when doing a Bravo hardcopy command to the Diablo Model 1355 WP printer, the printer does not handle proportional spacing correctly. This is the only time that the problem shows up.

Cut etch as shown
Winchester conn. pin V
to ribbon cable pin 1

Add insulated wire between
Winchester conn. pin V
and ribbon cable pin 10

1. Remove power from Diablo Model 1355 WP printer.
2. Remove Diablo Hytype printer adapter cable (Diablo P/N 40508-03) from printer.
3. On connector (top) side of adapter cable board, cut etch between pin V of Winchester connector and pin 1 of ribbon cable connector. See attachment 1.
4. On etch side of board, solder a jumper wire between pin V of Winchester connector and pin 10 of ribbon connector. See attachment 1.
5. Reinstall printer adapter cable into Diablo Model 1355 WP printer.
6. Re-apply power to printer.
7. Verify proper operation by running all diagnostics and using hardcopy command on Bravo.

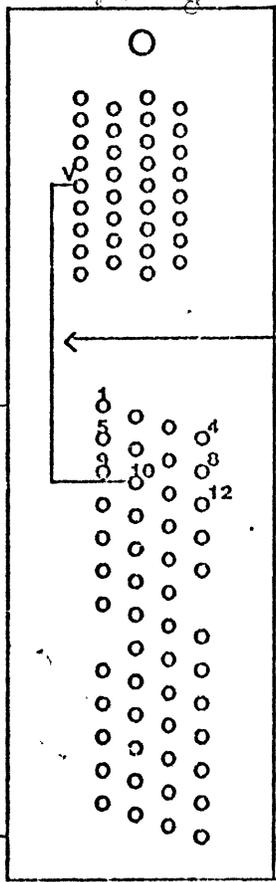
Note: Modification of the
standard Diablo Hytype
Printer Adapter Cable for
proportional spacing.
Diablo part no. 40508-03
