# **Desktop Board CC820 Specification Update**

Release Date: June 2000

Order Number: 749730-004

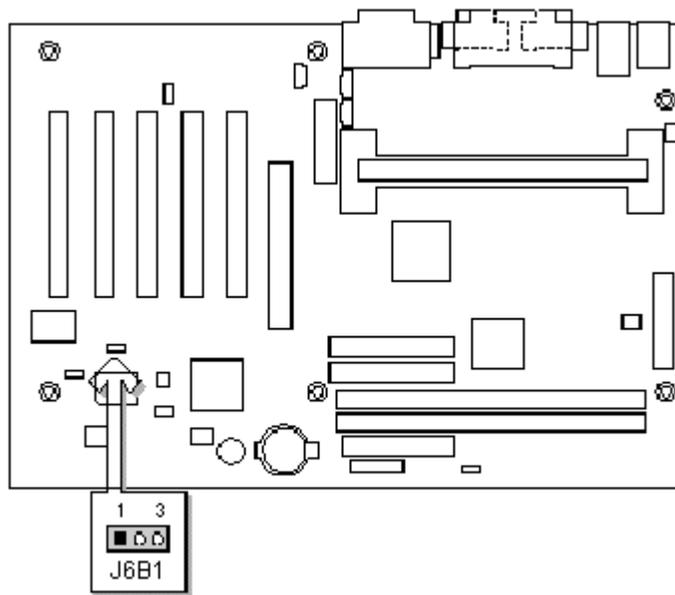
Figure 16. Location of the Jumper Block

The addition of jumper block J6B1 provides additional user control over system wake events. When the jumper is in its default location (shorting pins 1-2) the system will resume from S5 when a PME or WOL event is asserted. If the jumper is placed on pins 2-3 the system will no longer resume from S5 when PME or WOL events are asserted. This jumper does not in any way impact S3 resume events. *Please note that in order for the system to resume from S5 the operating system and drivers must also be configured to enable these wake events.*
