intel® Technical Advisory

TA-209-1

July 16, 1999

Inserting board stand-offs in incorrect holes or adding additional stand-offs may cause component failures on server boards installed in Astor 2 or Columbus III server chassis

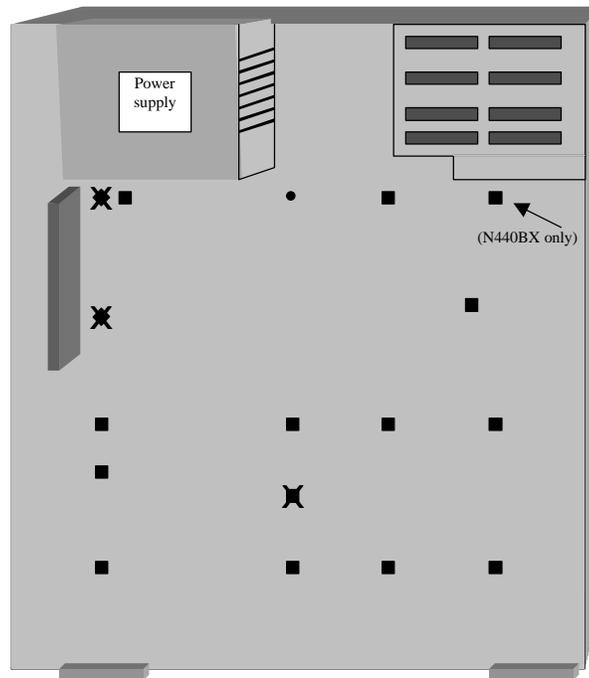
In order to support a wider variety of server boards in the Astor 2 and Columbus III server chassis, additional stand-off mounting holes were added. System Integrators assembling the chassis may insert some of the mounting stand-off pins incorrectly or may add additional stand-off pins not required to mount a board. When the server board is mounted onto the incorrect stand-offs, they may cause some component pins to short causing the component to malfunction.

The following diagram shows all stand-off mounting hole locations in both the Astor 2 and Columbus III server chassis. The "X" marks locations that should **not** be used when installing a T440BX, NL440BX, or L440GX+ server board into a Columbus III chassis and N440BX or L440GX+ into an Astor 2 chassis.

If a server is experiencing loss of keyboard, mouse, or SCSI functionality, verify that no stand-offs are inserted in locations marked with an "X" in the diagram above. If so, disassemble the server following the safety instructions located in the Chassis Integrators Guide, place stand-offs only in the appropriate locations and reassemble the server.
