intel® Technical Advisory

TA-550-1

April 25, 2002

Erroneous temperature readings from onboard thermal sensors on some SCB2 (SCSI) Server Boards

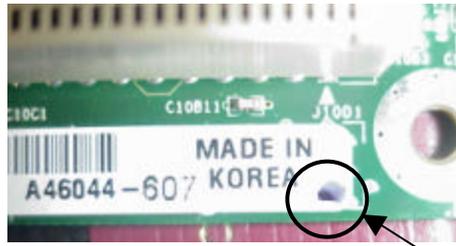
- All -607 SCB2 (SCSI) server boards shipped from Intel after April 15, 2002 will be screened to have the rev. 4 ADM1026 sensor chip. All screened product will show a black dot on the serial number label on the server board as well as on the outside of the packaging next to the serial number on the printed label.

Black dot showing a screened -607 board

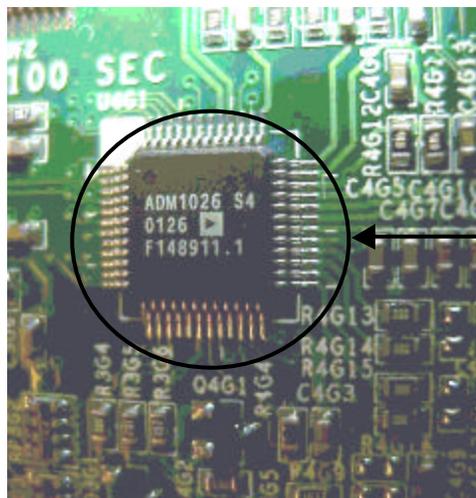
- A visual inspection of the server board. The ADM1026 chip is located next to the legacy floppy connector at designator U4G1. The rev. 4 ADM1026 chip will have a "ADM1026 S4" marking silk screened on the chip (See the photograph below). All SCB2 boards with this revision of the sensor chip are acceptable. Unacceptable -607 SCB2 boards will have a sensor chip with "ADM1026 JST" silk screened on it.

Correct Chip

A) Intel recommends screening all -607 SCB2 (SCSI) server boards for the rev. 4 ADM1026 thermal sensor chip. One of two methods can be used:
