# intel® Technical Advisory

TA-569-1

August 8, 2002

## Main Power connector latch on SE7500CW2 not long enough for all power supplies

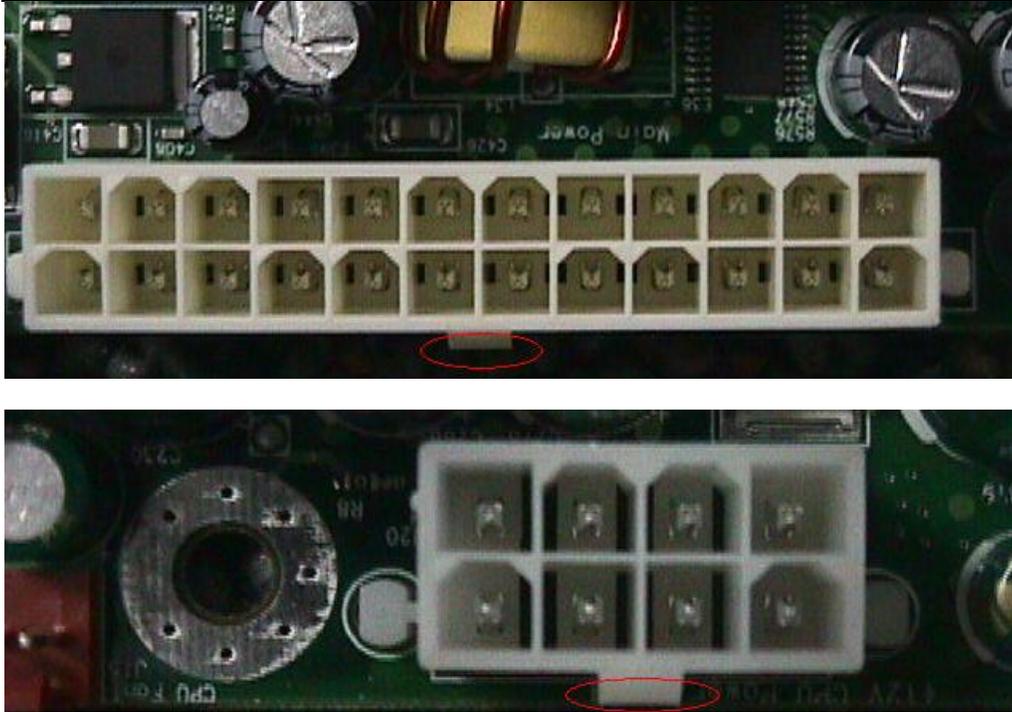
The SE7500CW2 server board is currently shipping with an incorrect version of main 24-pin SSI power supply connector and 8-pin +12V connector on the board. The version that is on these boards has a shorter retention latch and may not allow ATX style power supplies to lock securely into place when installed. Since ATX power supplies use only a 20-pin power connector, the latch for this connector is off center and may not engage when inserted into a 24-pin SSI power connector found on most Intel server boards. This could cause the power supply connector to become unseated when the system is shipped or when it is handled extensively.

The shortened latch is in the wrong location for a 20-pin ATX power plug. On a power supply connector, the power plug latch is usually centered on the connector. Intel uses a 24-pin main power connector with the latch centered between pins 12 and 13. If a customer were to plug a 20-pin ATX power supply into this connector, the latch on that connector is centered between pins 10 and 11. This is off center enough that it won't engage the latch on the 24-pin connector. To resolve this, Intel uses a 24-pin power connector with an extended latch that would accommodate either a 24-pin or 20-pin power plug. This connector is not on the current boards mentioned above.

**Figure 1:** Pictures of the current 24-pin and 8-pin connectors on the SE7500CW2 board.

Intel will be putting the correct power supply connector on boards starting on the -506 board PBA revision. This change will likely take place in October, 2002. Please refer to this Technical Advisory for any updates to this implementation date.

When using –502/503/504/505 boards and ATX power supplies, ensure the power plug is fully seated when the system arrives at its final destination.

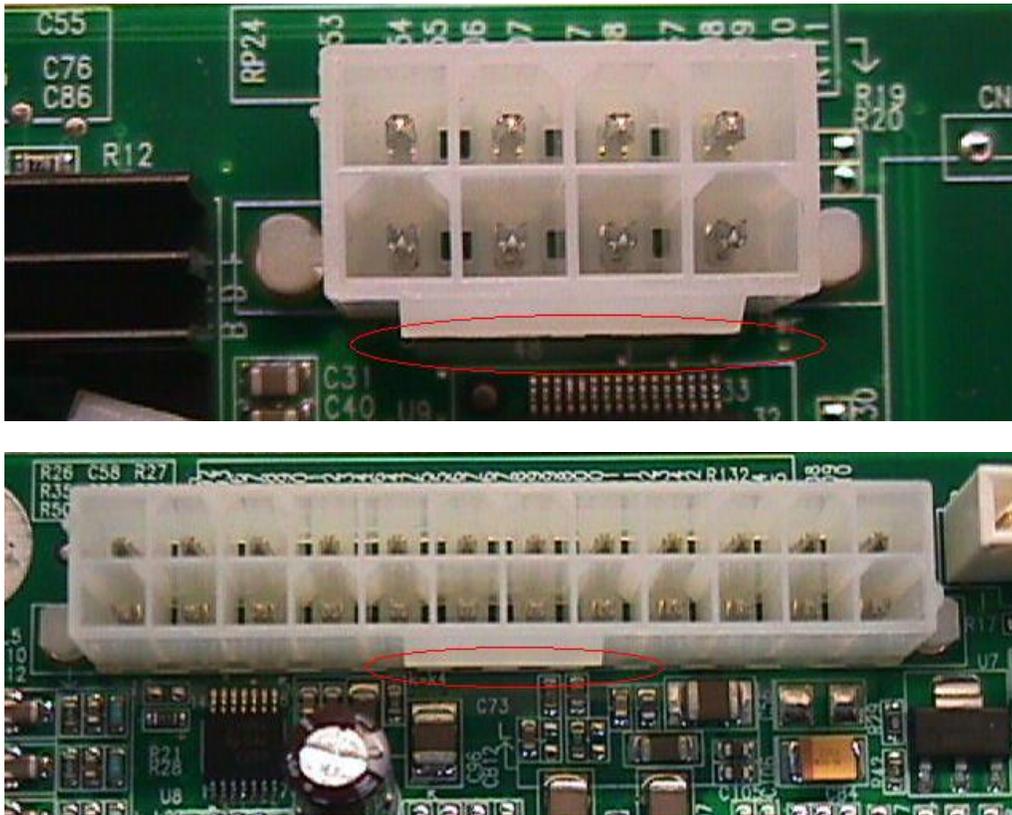
**Figure 2:** Sample of what the power-supply connectors will look like on the A87967-506 and above baseboards. Notice the latch is much wider than what is currently on the SE7500CW2 server board.
