# intel® Technical Advisory

TA-654-1

May 8, 2003

## Intel® Server Boards SE7500WV2/SE7501WV2 Hang at POST Code 12, 13, and 15 or During Operating System Boot

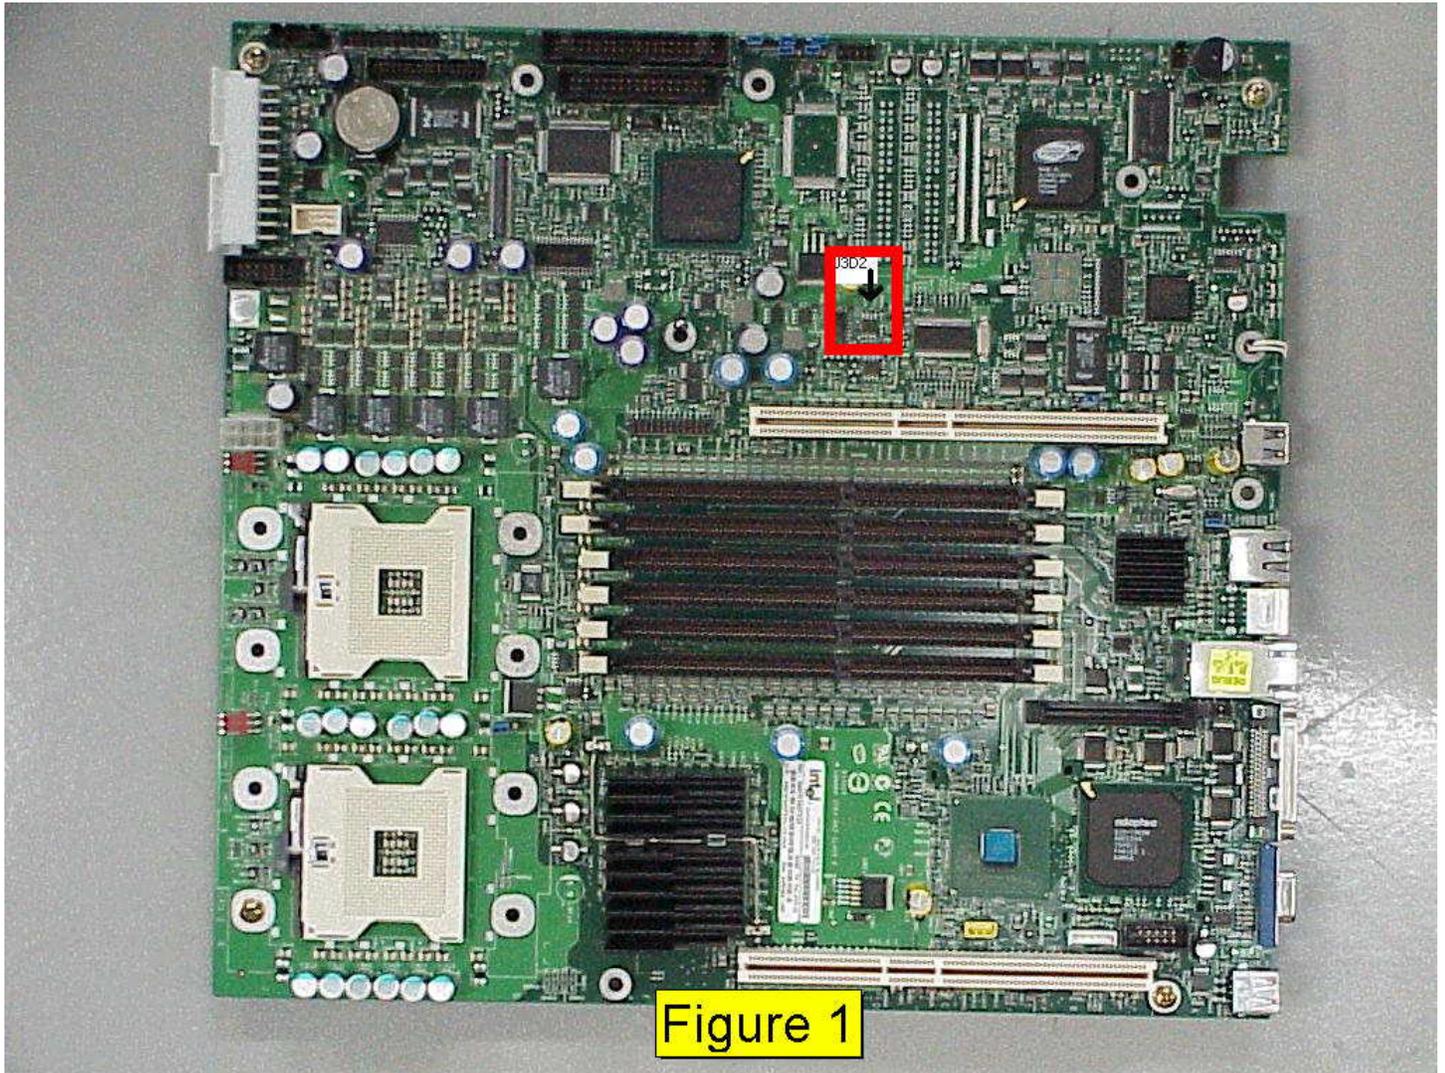
Intel has root caused the issue to a 1.25 Volt VRM controller chip at location (U3D2) on the server board. A specific date code of this chip (C9JL) was found to be operating outside the specification of the component. This failure is specific to a single date code (C9JL) only.

Intel recommends that customers screen their current inventory of Server board SE7500WV2 and Server board SE7501WV2 for the affected products. Boards found with the 1.25 Volt VRM controller chip (U3D2) affected date code (C9JL) should be returned to Intel using your normal warranty process. Please indicate that you are calling regarding TA# 654-1, along with the server board part number and serial number. Please see Figure #1 and Figure #2 for the location of the affected component and the location of the date code on the component.
