intel® Technical Advisory

TA-0645-4

April 28, 2003

Intel® Server Boards SE7501BR2 and SE7501HG2 FRUSDR version 5.5.B does not support default shipping configuration of the Intel Server Chassis SC5200 Hot-Swap Redundant Power.

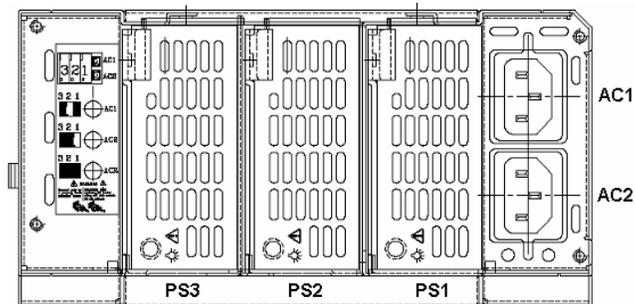
The Intel Server Chassis SC5200 (HSRP) Hot-Swap Redundant Power ships from factory with two 350W power supply modules installed in slots PS2 & PS3 (refer to figure below), a third power supply module can be purchased as an accessory to enable full power redundancy. The power supply cage enables two Alternating Current inlets to power all three modules: AC1 powers modules PS1 and PS3, and AC2 powers modules PS2 and PS3. With two power supply modules installed in PS2 and PS3, the system requires AC presence only on the AC2 inlet.

When updating the Intel Server Boards SE7501BR2 and SE7501HG2 with their FRUSDR utilities (version 5.5.B), the update utilities incorrectly request movement of these two power supply modules to positions PS1 and PS2. In this condition, only the PS2 power supply is powered when only AC2 is present; exposing the potential for exceeding power rails which could result on a system reboot. This issue is not exhibited in a fully power redundant configuration (i.e. 3 power modules and 2 AC cords present).

Figure 1. SC5200 HSRP Power Supply Module & AC Inlets

The development of FRUSDR utilities (version 5.5.B) for both Intel Server boards did not take into account that when integrated into an Intel server chassis SC5200 HSRP, the system should allow to be powered with only one AC receptacle present (e.g. AC2).

Intel is developing new BMC Firmware and new FRUSDR utility for the Intel Server boards SE7501BR2 and SE7501HG2 which will correct this situation, the following table details the version where fixed and estimated release date:

Intel recommends customers to update their Intel Server boards SE7501BR2 or SE7501HG2 installed in an Intel Server Chassis SC5200 HSRP to this new BMC Firmware and FRUSDR releases when available. The utilities can be downloaded from <http://support.intel.com> once available.
