Intel® Server Board SHG2

Specification Update

Intel Order Number: C20107-002

January 2003

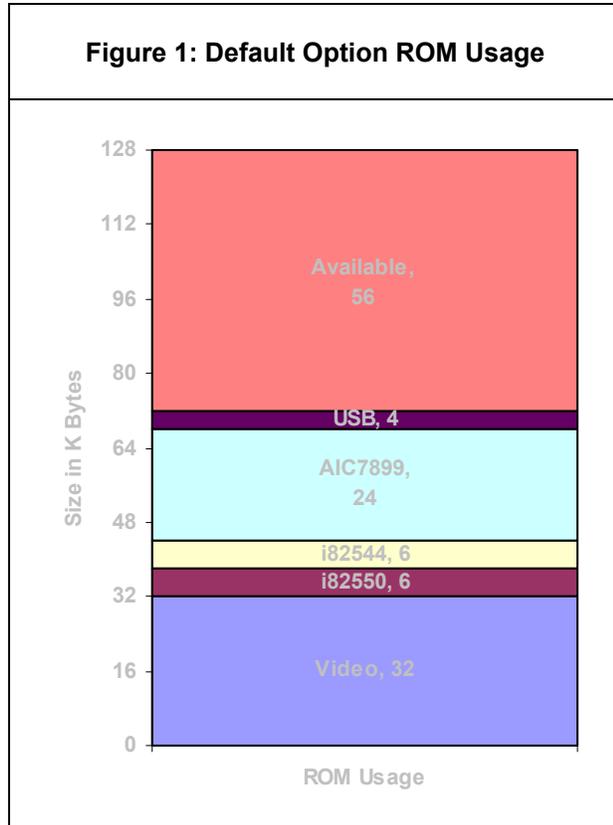
When all of the on-board option ROMs are loaded at boot time, there is a reduced amount of reserved space left for add-in adapter card option ROMs to expand and load (see *Figure 1*). If enough space does not exist for a particular adapter, that adapter's option ROM will fail to expand and will post an error message during system boot.

For example, assume *Adapter A's* (a SCSI adapter) option ROM requests 64K of initial memory and then reduces the final amount of memory used to 32K. In the example in *Figure 1*, the *Adapter A's* option ROM expansion would fail because the initial request for memory was 64K while 56K is available.

In order to enable Adapter A's option ROM to load, adjustments need to be made to the option ROM usage area. Since Adapter A is a SCSI adapter, in this example it is determined that the on-board 7899 SCSI controller option ROM can be disabled because it is not going to be utilized as a boot device. By disabling the on-board 7899 option ROM, 24KB of space is release giving a total of 80KB. In this configuration Adapter A will pass the initial request of 64KB space, reduce to 32KB, and will successfully load leaving a memory usage map similar to that shown in Figure 2.
