intel® Technical Advisory

TA-0588-2

Mar 5, 2003

SSH4, SPSH4, SRS4 Failure to Expand Adapter Option ROM

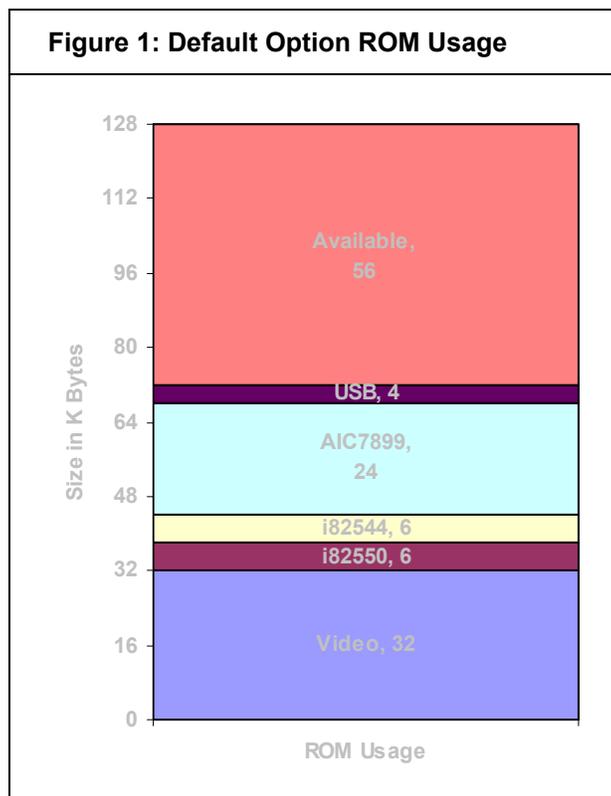
Figure 1: Default Option ROM Usage

When all of the on-board option ROMs are loaded at boot time, there is a reduced amount of reserved space left for add-in adapter card option ROMs to expand and load (see *Figure 1*). If enough space does not exist for a particular adapter, that adapter's option ROM will fail to expand and will post an error message during system boot.

For example, assume *Adapter A's* (a SCSI adapter) option ROM requests 64K of initial memory and then reduces the final amount

of memory used to 32K. In the example in *Figure 1*, the *Adapter A's* option ROM expansion would fail because the initial request for memory was 64K while 56K is available.

Intel recommends that option ROM scanning be disabled for any device or PCI slot that does not require the option ROM for a boot device, or other functionality such as RAID management.

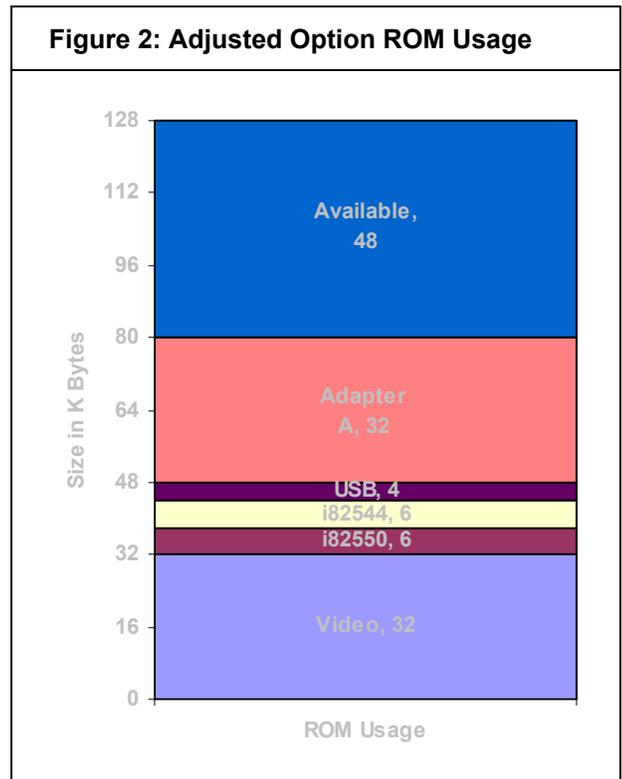
In order to enable *Adapter A's* option ROM to load, adjustments need to be made to the option ROM usage area. Since *Adapter A* is a SCSI adapter, in this example it is determined that the on-board 7899 SCSI controller option ROM can be disabled because it is not going to be utilized as a boot device. By disabling the on-board 7899 option ROM, 24KB of space is release giving a total of 80KB. In this configuration *Adapter A* will pass the initial request of 64KB space, reduce to 32KB, and will successfully load leaving a memory usage map similar to that shown in *Figure 2*.

SSH4 BIOS P06 fixes this issue by moving legacy USB into the EBDA area of the BIOS this returns the 16k assigned to Legacy USB to the available space as illustrated above. In addition by optimizing the BIOS code another 59k has been added to the space available for the expansion of adapter option roms. This is an increase of 59 k bringing the total space for add-in adapter option roms to 107 k

A modification was also made to BIOS P06 to query the adapter for the amount of space needed for its option rom to expand during post. BIO now reports the amount of option rom space requested by the adapter and the amount available to the adapter. It is still prudent to disable the option rom scan for devices not needed in the boot process. There are some adapters that need 48 K or more to expand their option rom
