# intel® Technical Advisory

TA-667-1

September 15, 2003

## Intel® Server Chassis SPSH4 and SRS4 SAF-TE Controller Crystal Operating Outside Design Specifications

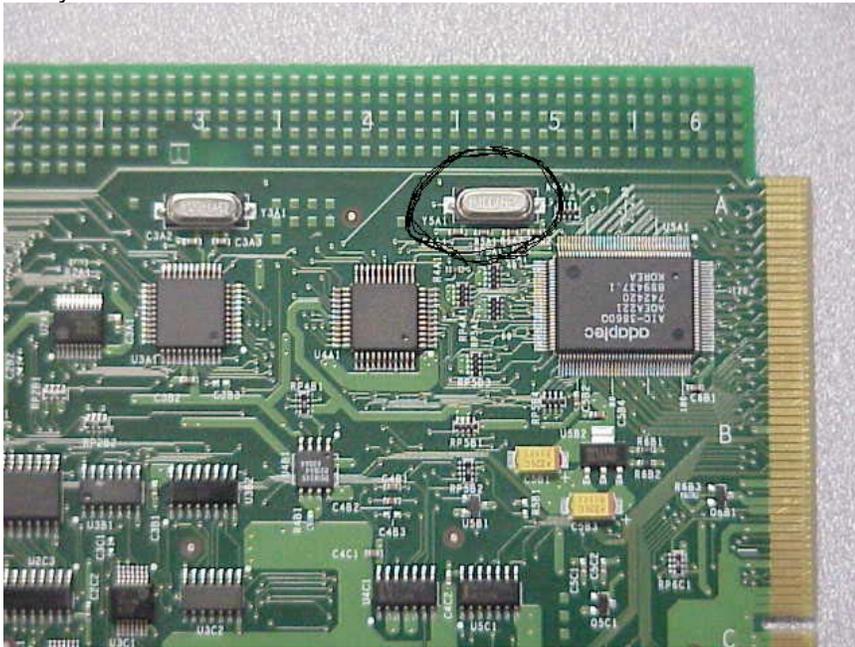
- Product built between June 30, 2003 (WW<sup>27</sup>) and September 5, 2003 (WW<sup>36</sup>)
- Product bearing the Serial Numbers: IMJR3<sup>27</sup>XXXXXX through IMJR3<sup>36</sup>XXXXXX
  - Decode Mechanism is: First Digit=Year=2003, Second and Third digits=Work-Week, X=Don't Care (DC)
- Crystal in location Y5A1 on the SAF-TE card is marked with "40.0[N] XXXX"

- Product built **before** June 30, 2003 (Serial #: IMJR326XXXXXX) **OR after** September 5, 2003 (Serial #: IMJR337XXXXXX)
- System configuration is SCSI only (i.e., use SCSI drives in “non-RAID” configurations only)
- System configuration is a non-SAF-TE RAID
- Crystal in location Y5A1 on the SAF-TE card is marked with “R400 XXXX”

The SAF-TE card design specifications require the use of a crystal with fundamental frequency (f0) of 40.0 MHz. However, the failing SAF-TE cards (supplied by a single-vendor) were determined to have been built with 3<sup>rd</sup> overtone (3f0=3\*13.3MHz) crystals.

1. Remove hot swap drive bay from the Intel Server Chassis SPSH4 and SRSH4 chassis (for chassis products).
2. Remove the white plastic piece (part number 743492-004) attached to the hot swap backplane bay with four screws.
3. Remove the hot swap backplane board and the attached SAFTE card from the hot swap backplane bay.
4. Find the crystal (silver colored) at location Y5A1 on the SAFTE card (PBA A42862-110). The crystal location is shown in the photograph below.
5. Crystals marked with "R400 XXXX" are NOT affected by this issue. Crystals marked with "40.0 [N] XXXX" are affected by this issue. The XXXX markings are date-code related and should be considered as don't cares for the "crystal" issue

Customers who have material affected by this issue should obtain replacement product through normal warranty procedures. To get parts contact Intel using your normal warranty process. Please indicate that you are calling regarding TA number 667-1, and have the following information when you call; the part number requested, and the serial number(s) for the system(s) or board(s) needing the replacement part.
