intel® Technical Advisory

TA-0306-3

December 21, 2000

STL2 Server Board Front Panel Connector Fault LED Implementation

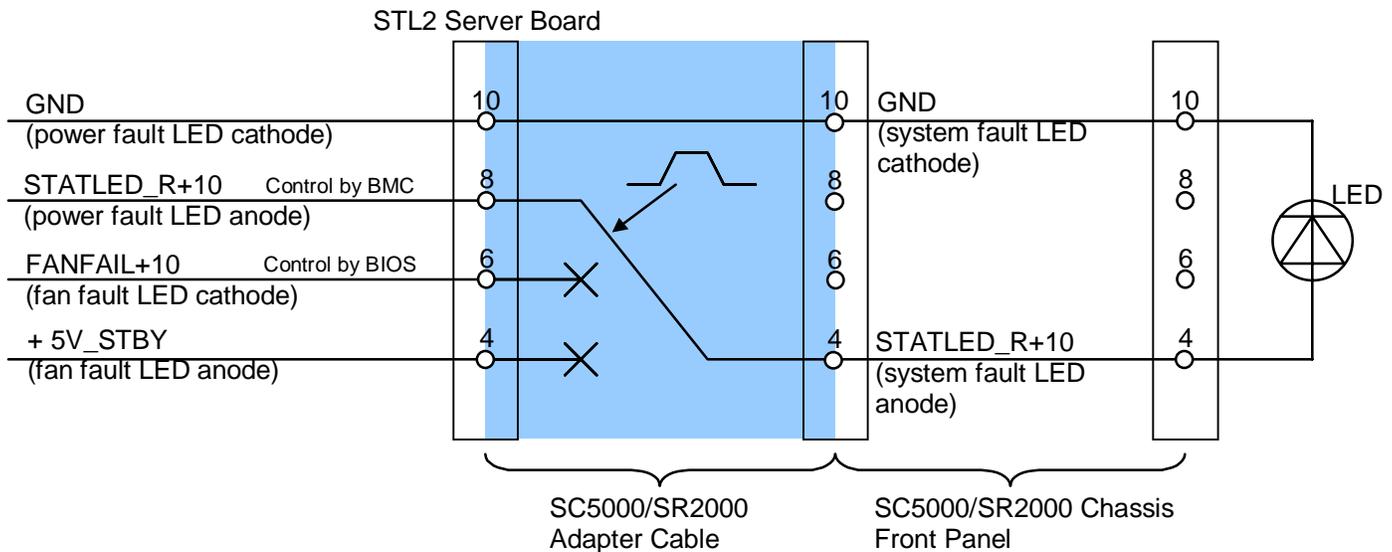
The following circuit diagram shows the SC5000/SR2050 alternate front panel cable solution. The signals indicated at the SC5000/SR2050 chassis front panel result when the alternate front panel cable is used in combination with the modified STL2 BMC firmware version 11.16:

If the alternate cable is installed but the modified STL2 BMC firmware version 11.16 is not used, the SC5000/SR2050 chassis system fault LED will include only the power fault LED signal, instead of combined power and fan fault LED signals.

The alternate front panel cable effectively removes the physical fan fault LED signal from the system fault LED circuit by disconnecting front panel pins 4 and 6, and also re-routes the power fault LED signal from pin 8 to pin 4. The alternate cable should be used in combination with a modified STL2 BMC firmware, version 11.16, that routes both the power and fan fault LED signals to pin 8 on the STL2 server board, thus forming a single system fault LED. STL2 BMC firmware version 11.16 will be included on the STL2 server system CD-ROM and is available on the FDBL website. STL2 BMC firmware version 11.16 will be available at <http://support.intel.com> in October 2000.
