Intel[®] Pentium[®] III Processor

Specification Update

August 2008

Revision 060

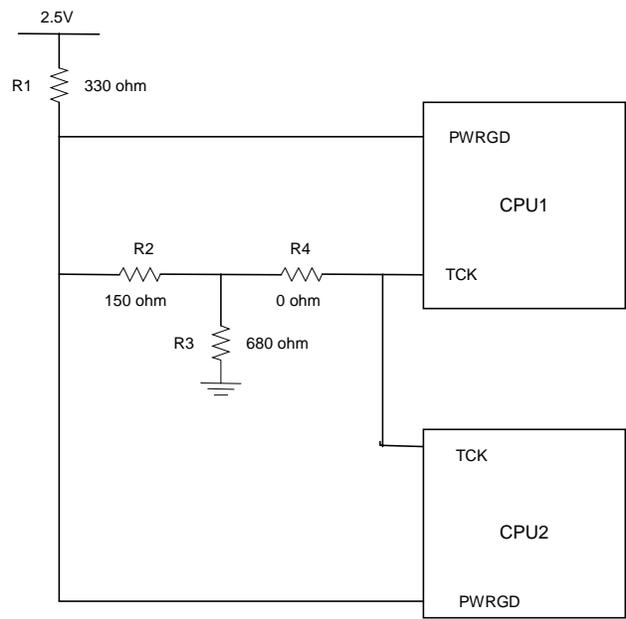
Pentium® III Processor with 512KB L2 Cache Platforms Workaround

Assumes the inputs to the CPU_PWRGD are open collector signals that are Wire-ANDed together

In addition, the example workaround circuits shown do not support production baseboard test methodologies that require the use of the processor JTAG/TAP port. Alternative workaround solutions must be found if such test capability is required.
