Manual Update

Document Title: TMS380 Adapter Chipset User's Guide
TMS380 Adapter Chipset User's Guide Supplement

Document Number: SPWU001D, SPWU003

Revision: F

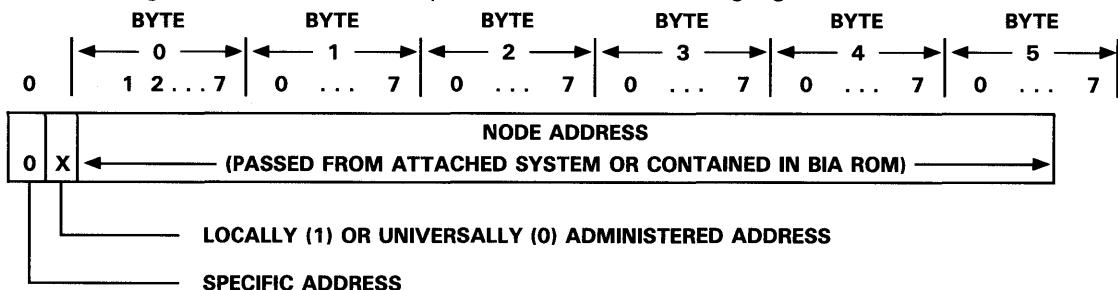
3-14	The last paragraph on this page should be changed to read as follows: A ring station address assigned by the attached system or contained in the BIA ROM must conform to the format shown in Figure 3-14. Note that bit 0 of byte 0 must be set to zero. Bit 1 of byte 0 may be set to either 0 or 1 when the TMS38021 Protocol Handler is used but must be set to 1 when the TMS38020 Protocol Handler is used. Violating these conditions causes the Adapter to reject the address assignment with a node address error.
------	---

Figure 3-14 should be replaced with the following figure:

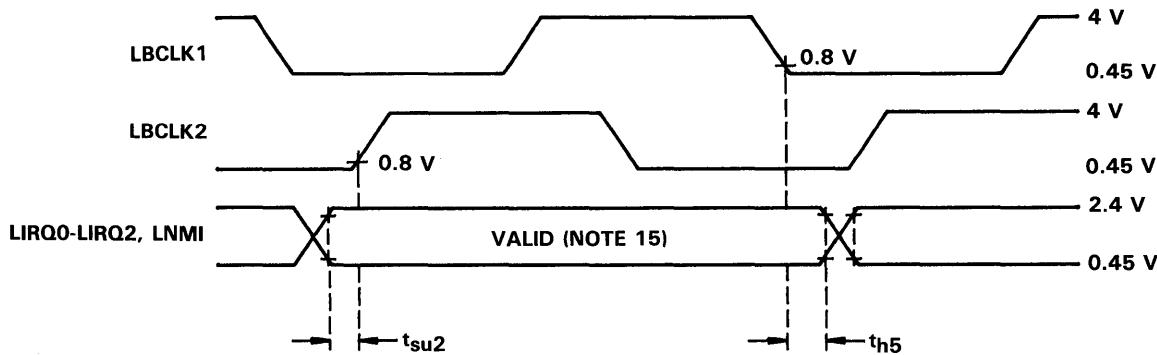
A-20

The figure under "interrupt timing" should be replaced with the following new diagram:

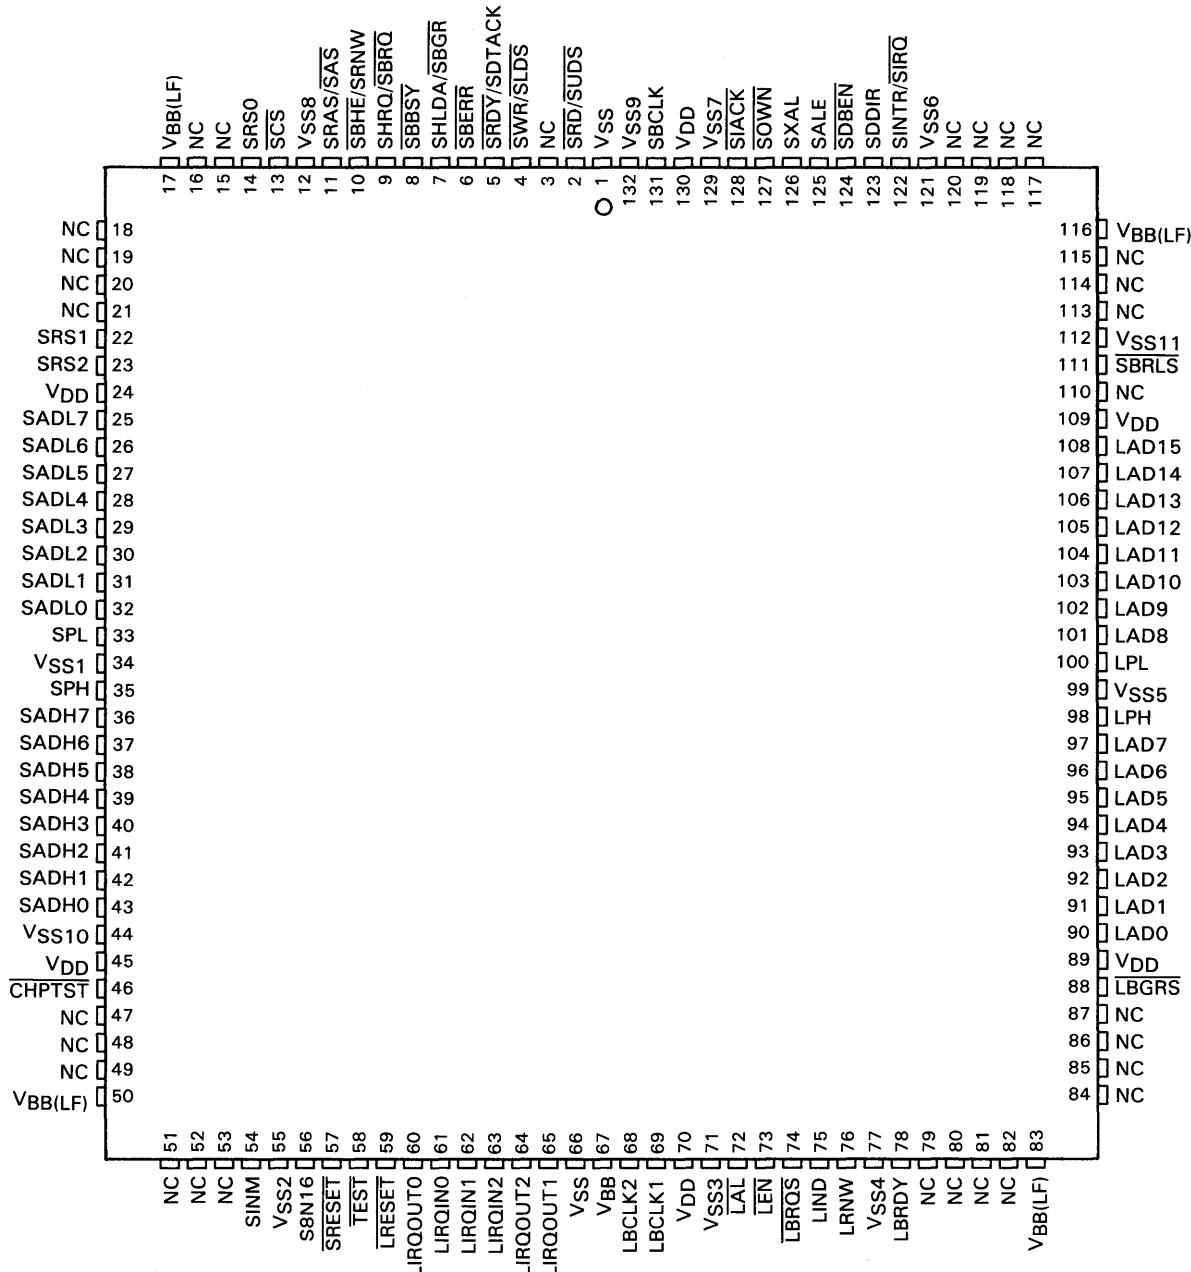
Add the following pinout drawing:

Special Note: The user PC board design should include a connection from the VBB pin (67) to one of the VBB(LF) pins (17, 50, 83, 116). This connection should be as short as possible. The VBB(LF) pins should be unconnected.

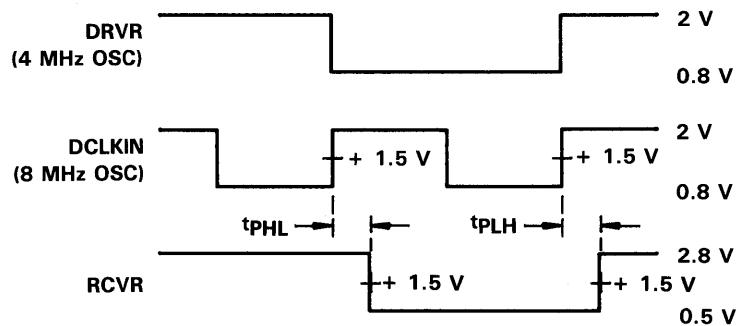
FIGURE 15. PROPAGATION DELAYS FROM DCLKIN TO RCVR WITH INTERNAL WRAP MODE

Figure 15 should be replaced with the following:

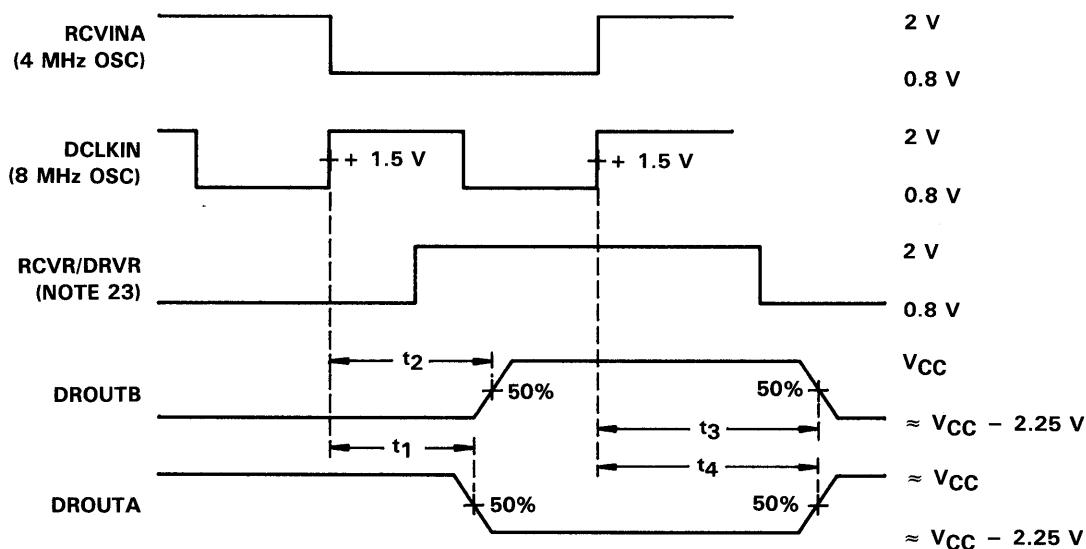
FIGURE 16. SKEW AND ASYMMETRY FROM DCLKIN TO DROUTA AND DROUTB

Figure 16 should be replaced with the following:

Note 23: For this test the RCVR output is tied directly to the DRVRR input to test the asymmetry of the transmitter in a repeater configuration.

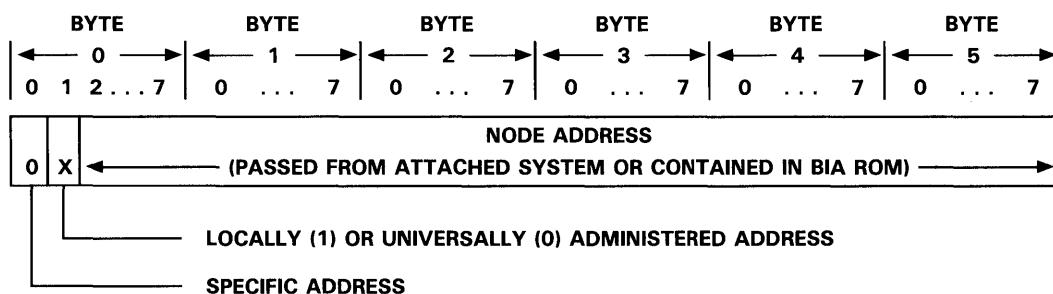
**FIGURE B-1. BURNED-IN ADDRESS FORMAT**

The burned-in address must conform to that shown in the figure below. Note that bit 0 must be set to zero. If the TMS38020 Protocol Handler is used, bit 1 must also be set to zero.

B-8 Replace Figure B-1 with the following:

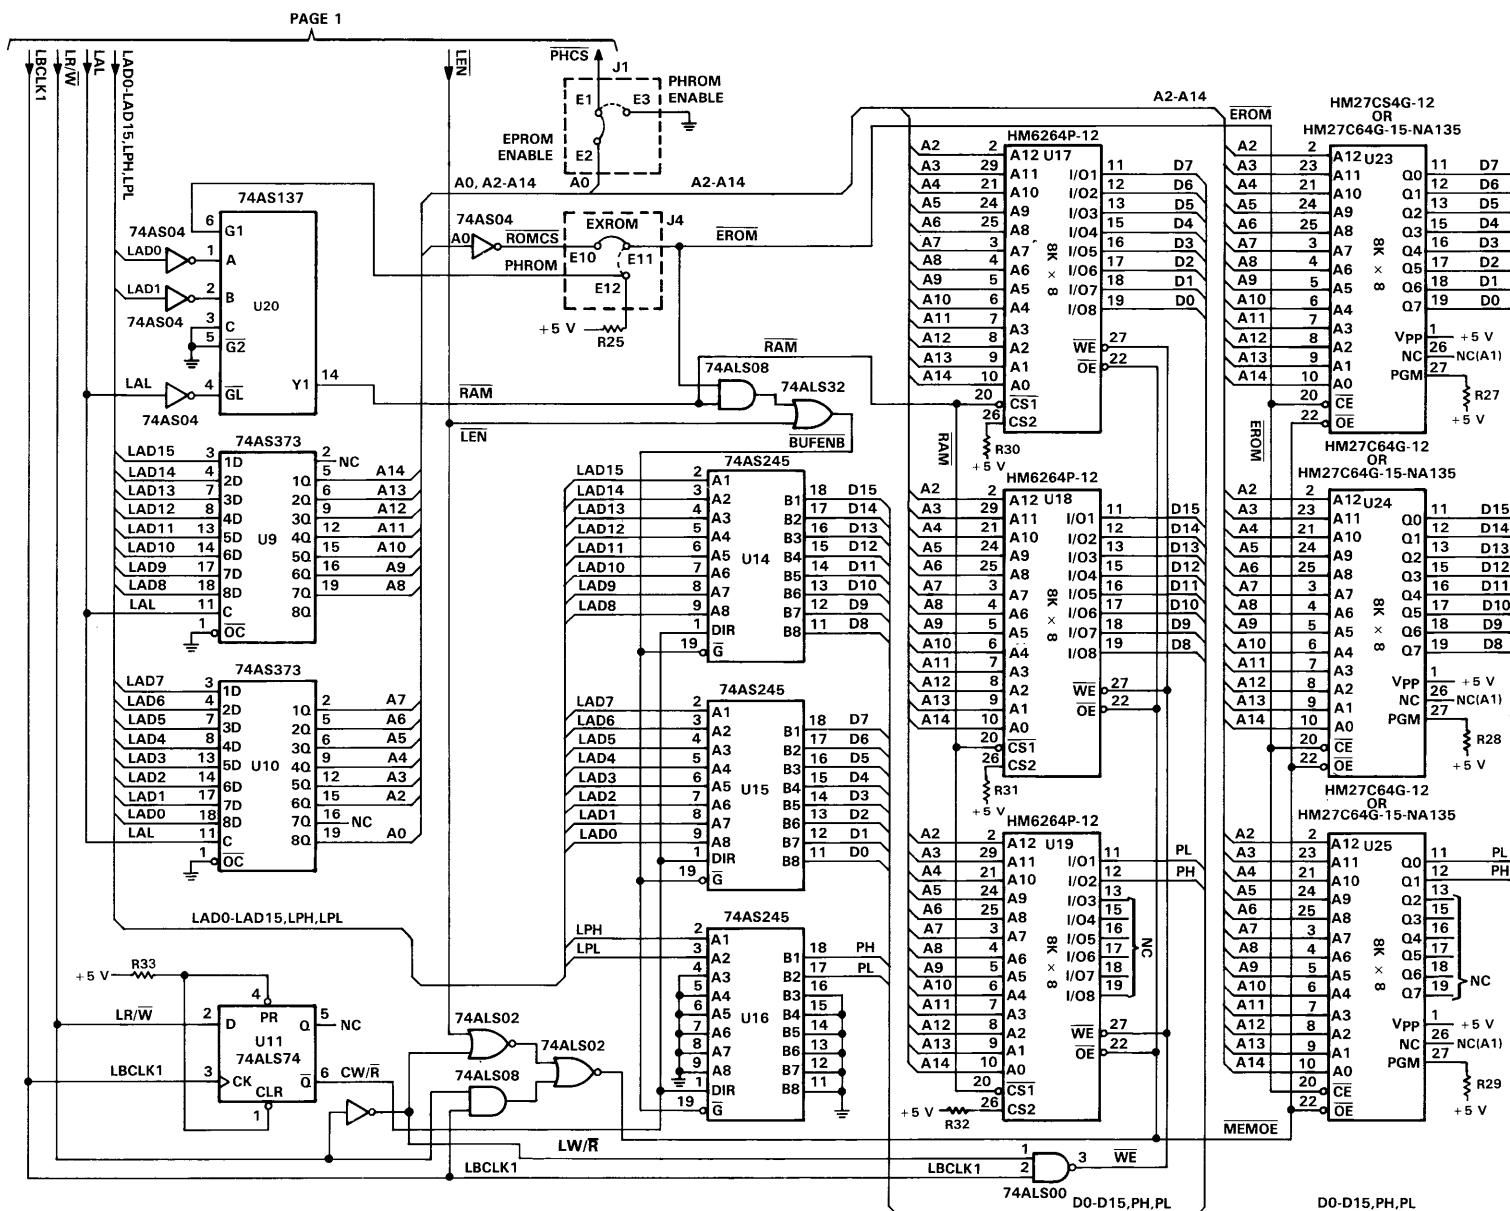
FIGURE 4-5. ADAPTER CHIPSET INTERCONNECT DIAGRAM (3 of 4)

Figure 4-5, sheet 3 of the Adapter Chipset Interconnect Schematic should be replaced with the new sheet 3 on page 13 of this update.

Figure 4-5 sheet 4. The value for capacitor C3 should be changed to 22,000 pF ± 10%, and a Note 4 reference added. The following should be added to the bottom of the page as Note 4:

NOTE 4. For additional noise immunity, the value for C3 has been increased to 22,000 pF. For existing designs, the original 6,800 pF value may be used.

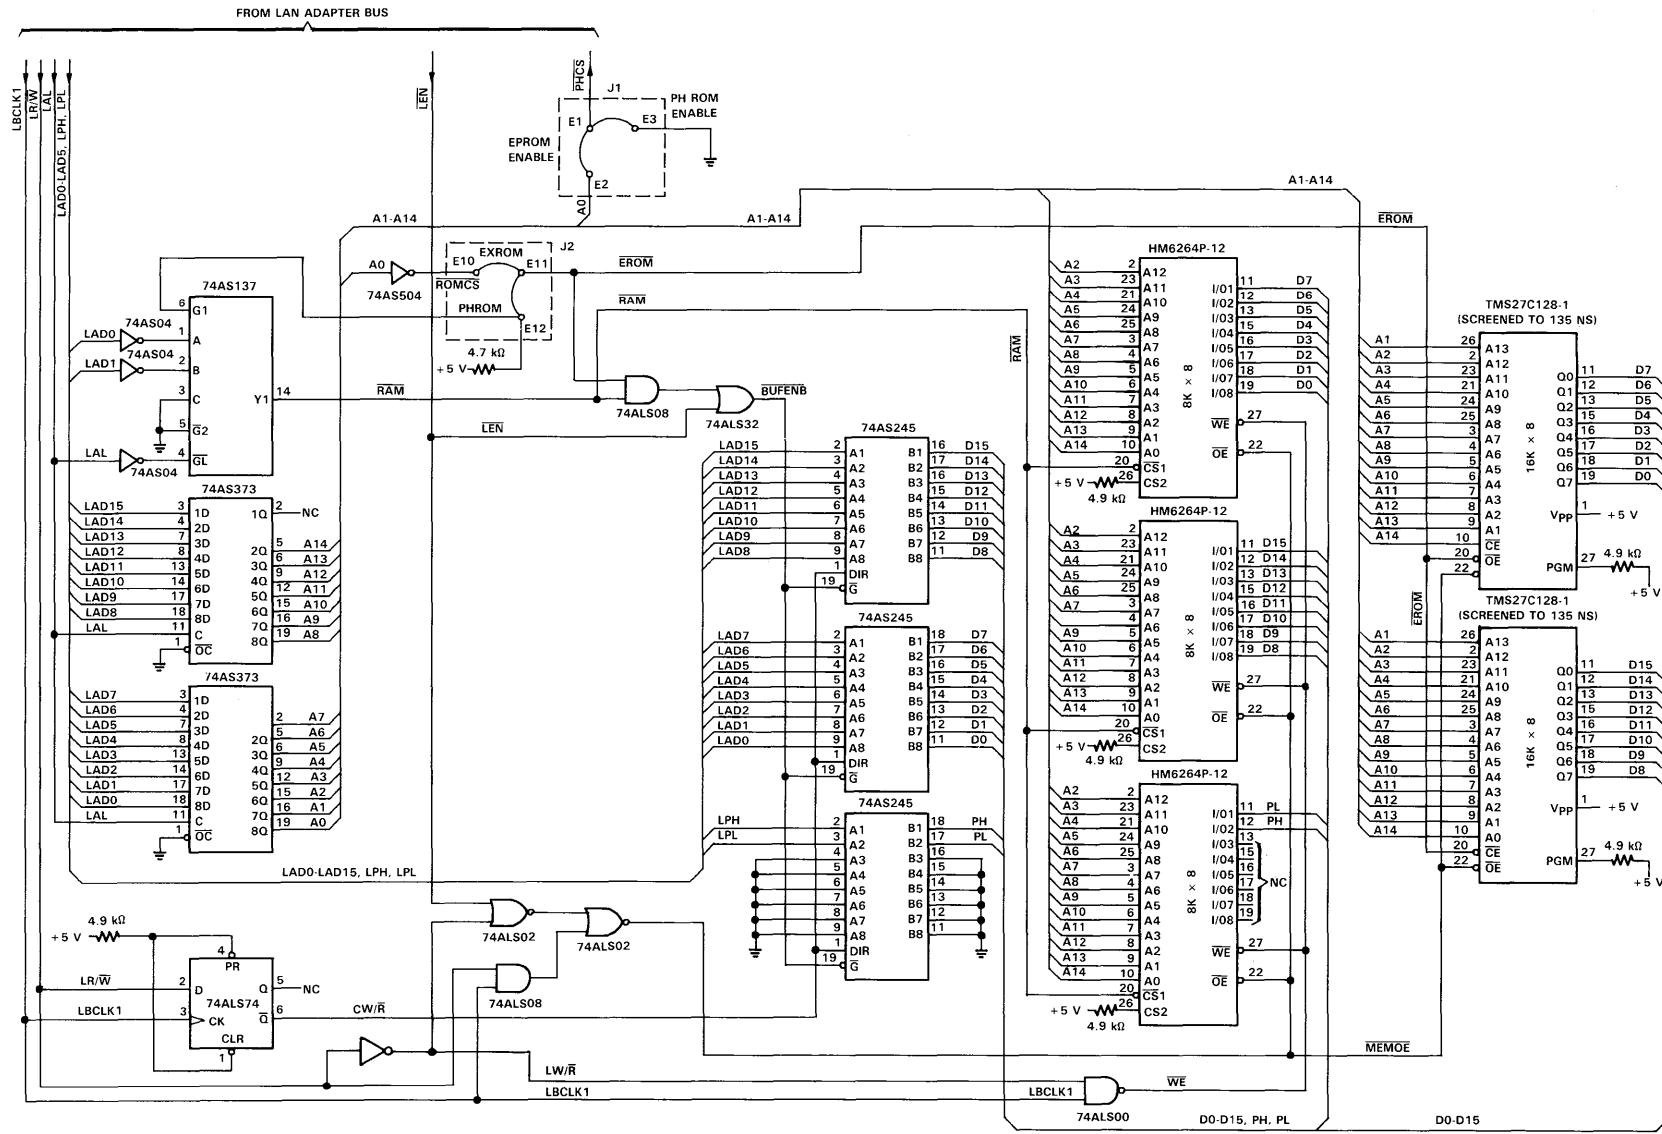
FIGURE 3-2. EPROM-Based Adapter Bus Schematic

3-2 Figure 3-2 should be replaced with the new Figure 3-2 included on page 18 of this update.

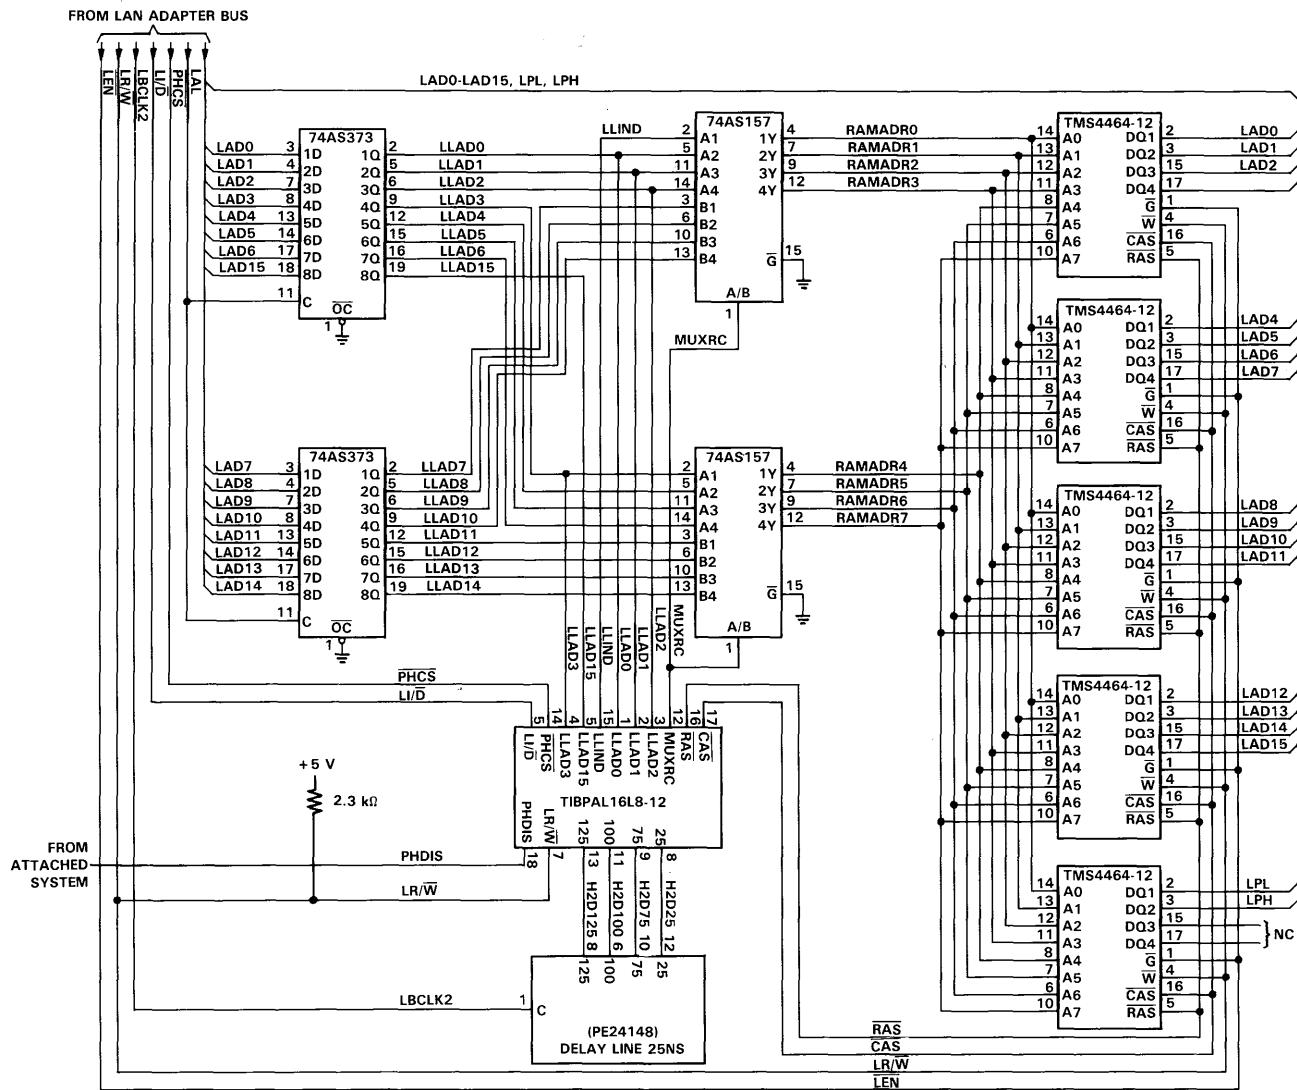
FIGURE 4-4. DRAM Schematic

4-4 Figure 4-4 should be replaced with the new Figure 4-4 included on page 19 of this update.

NOTE: PHDIS signal is controlled by host software to disable PHROM and enable DRAM from >C000 to >FFFE.

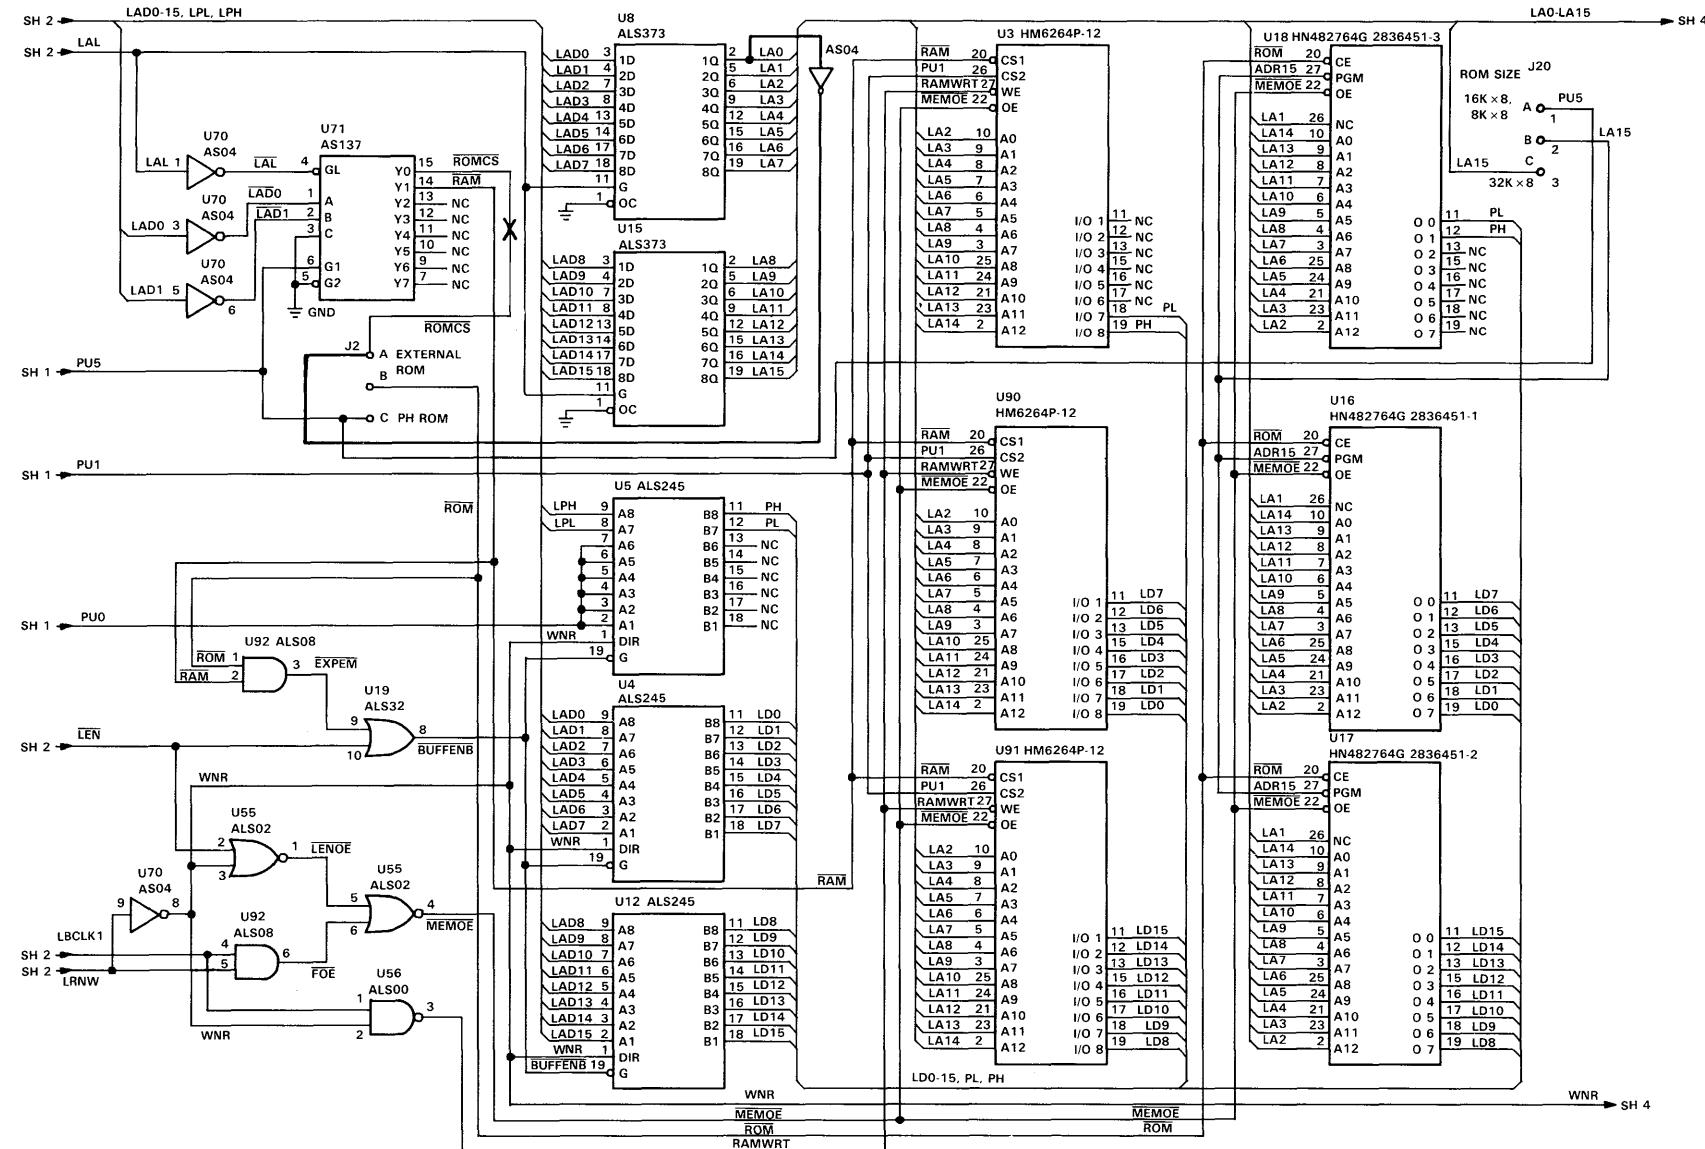
FIGURE B-2. PC Family Card Logic with Modifications

- A-37 The manual updates listed in the appendix are also included in this update.
- B-3 Replace Figure B-2 with the new Figure B-2 on page 20 of this update.
