## CONTENTS

### SERVICE ADVICES

Service Advice Index  
Service Advices

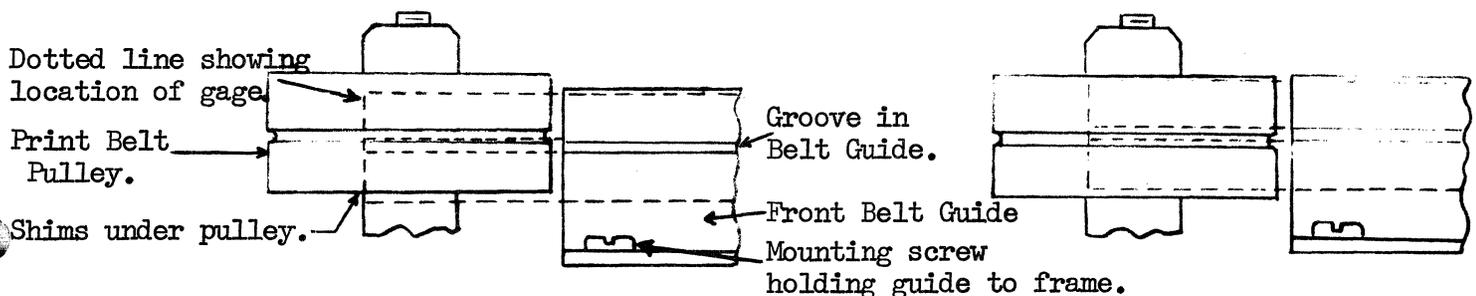
Figure 2 - Pulley Alignment

PULLEY TOO HIGH - REMOVE SHIMS TO CORRECT PROBLEM

PULLEY TOO LOW - ADD SHIMS TO CORRECT PROBLEM

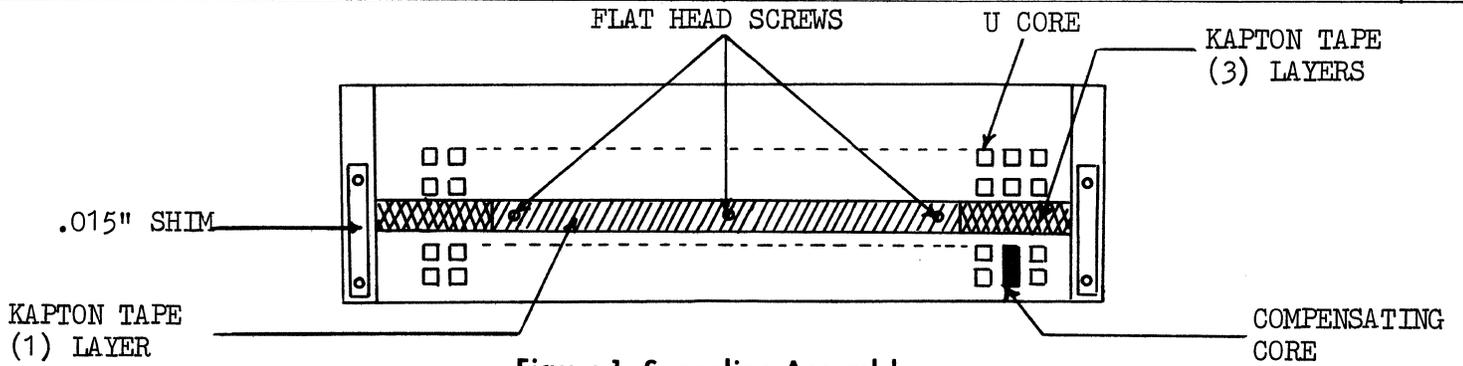
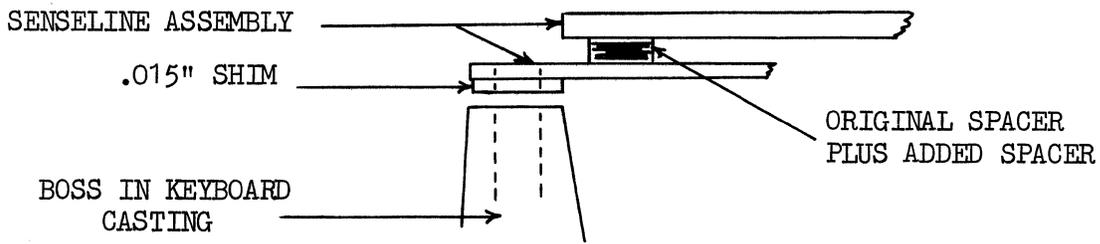
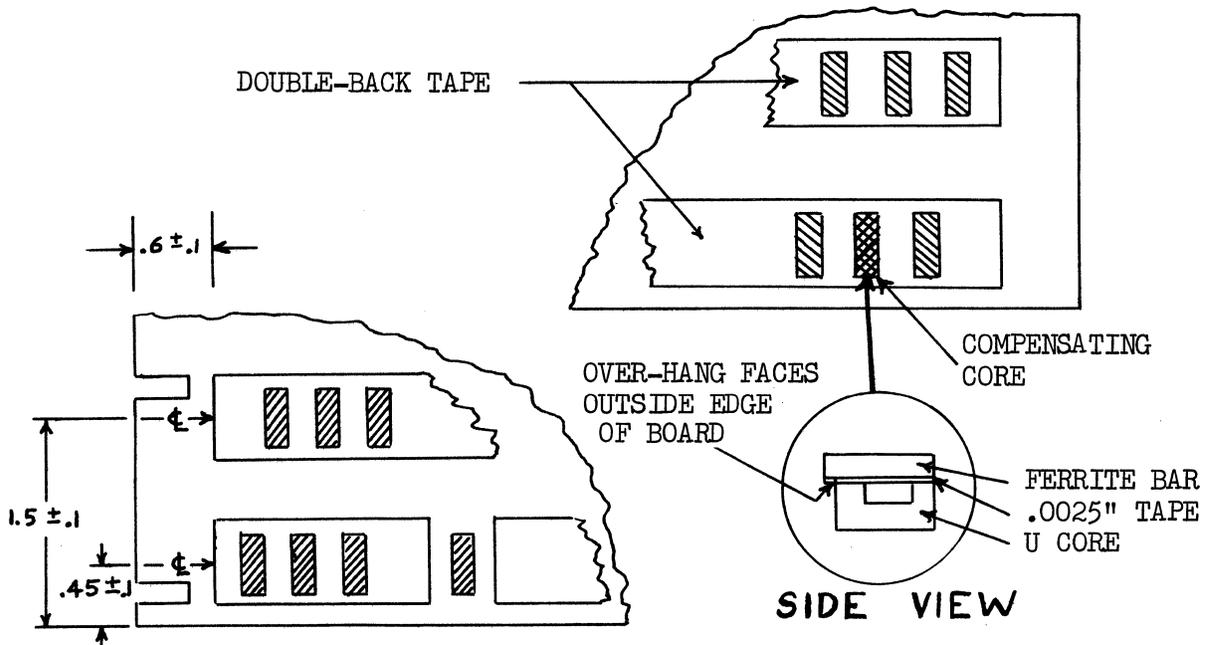
TO:  GENERAL DISTRIBUTION	TAB	SUBJECT PROCEDURE FOR CORRECTING DOUBLE PRINT AND U CORE BREAKAGE PROBLEMS	NO. 41A
		CATEGORY Field Modification

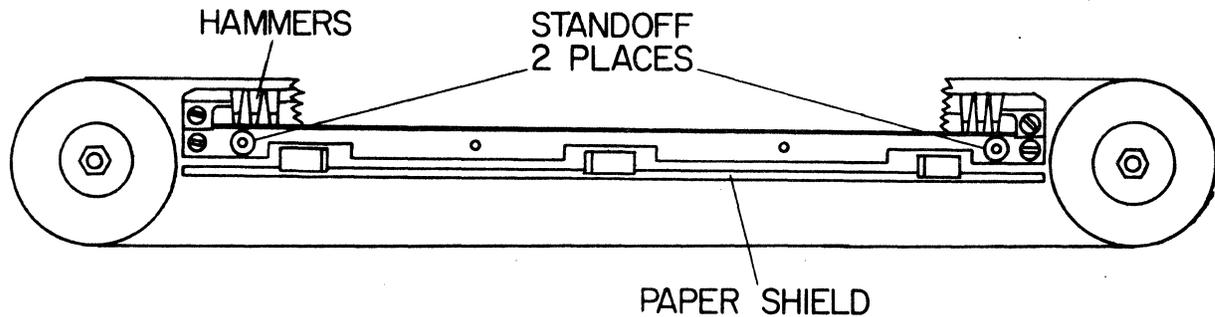
The drawing below shows the standoff locations. Their part number is 44A410778-001 and they are mounted with 2-56 x .25" Allen head screws (N170P5004C).

If you encounter Printers in the field without these standoffs, they should be added. The longer screws, listed above, must be used when mounting the standoffs. The screws now used are too short.

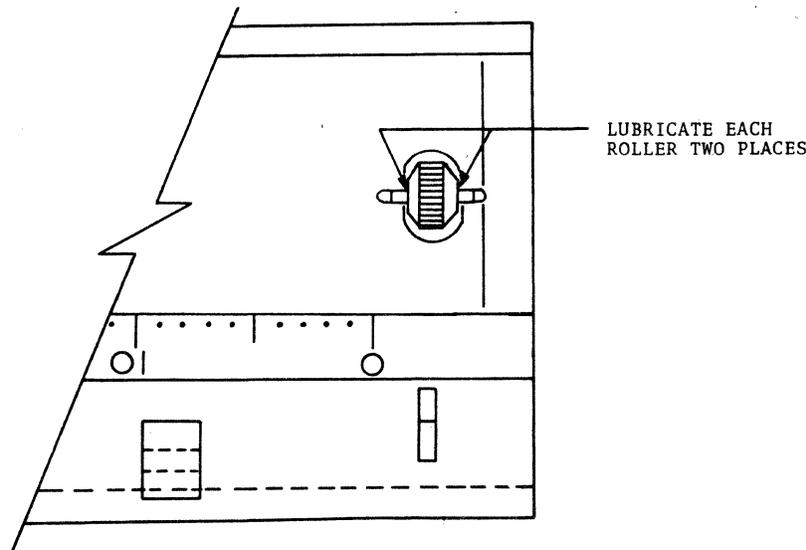
If lubrication does not free the rollers, the plastic paper shield will have to be replaced.

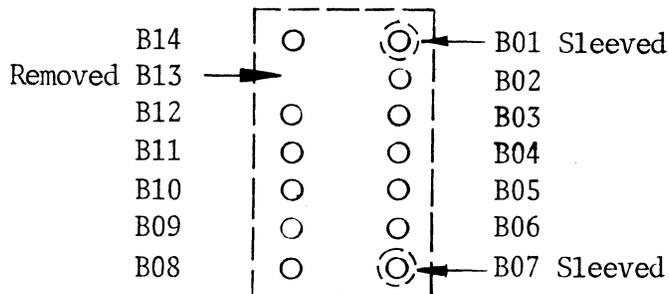
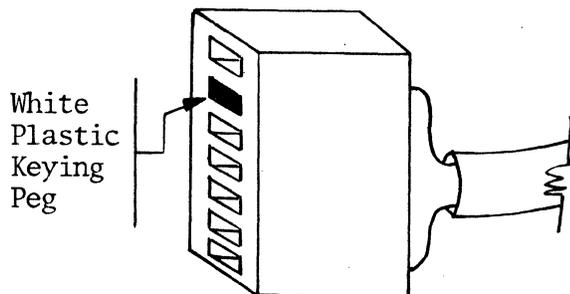
This change insures that the plug and the connector will only be mated properly and only with each other.

Should you have to replace the transformer in a Printer, the replacement part will have this new keyed plug. You will have to modify your Mother Board POWC connector to accept this keyed plug. Do this by removing pin B13 from J10. Do not remove the keying peg from the XFMR plug slot, however, for this would defeat the keying effect.

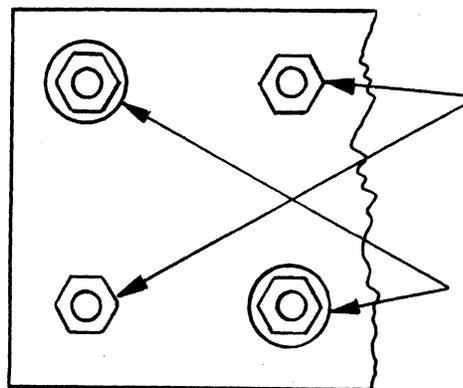
There should not be insulating washers here.

There should be insulating washers here.

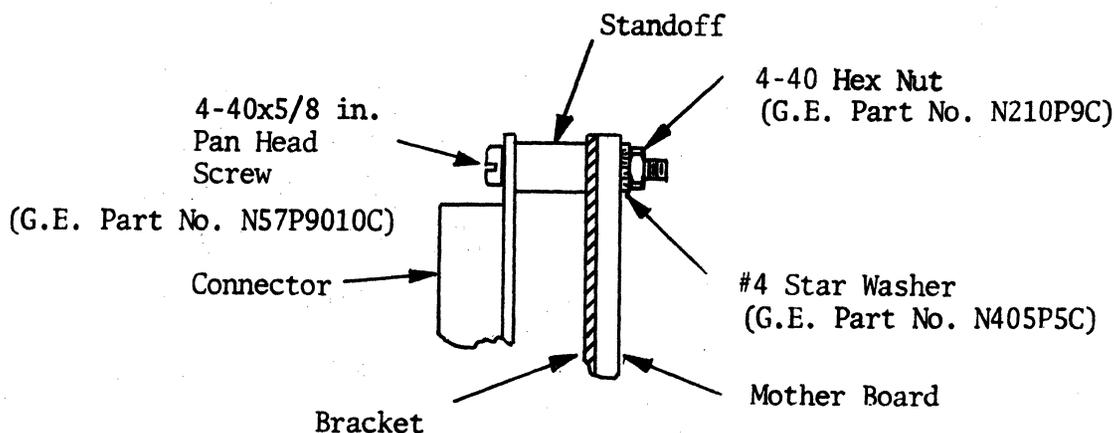
TO:  GENERAL DISTRIBUTION	FILE Terminet 300 Printer Service Book Terminet 1200 Printer Service Book	NO.  74-13.0
	SUBJECT MOTHER BOARD GROUND CONNECTIONS

Cover the nut and screw end with solder and allow solder to flow on to the printed circuit pad under the washer. Make sure the solder does not come in contact with any other printed circuit.
