**PDP-11/45, 11/50 MOS MEMORY
TROUBLESHOOTING GUIDE**

1st Edition, August 1974
2nd Printing, January 1975

This troubleshooting guide is intended to assist the service person in the repair of PDP-11/45, 11/50 MOS Memory Systems. This document is for Field Service use only and is to be treated as a Tech Tip.

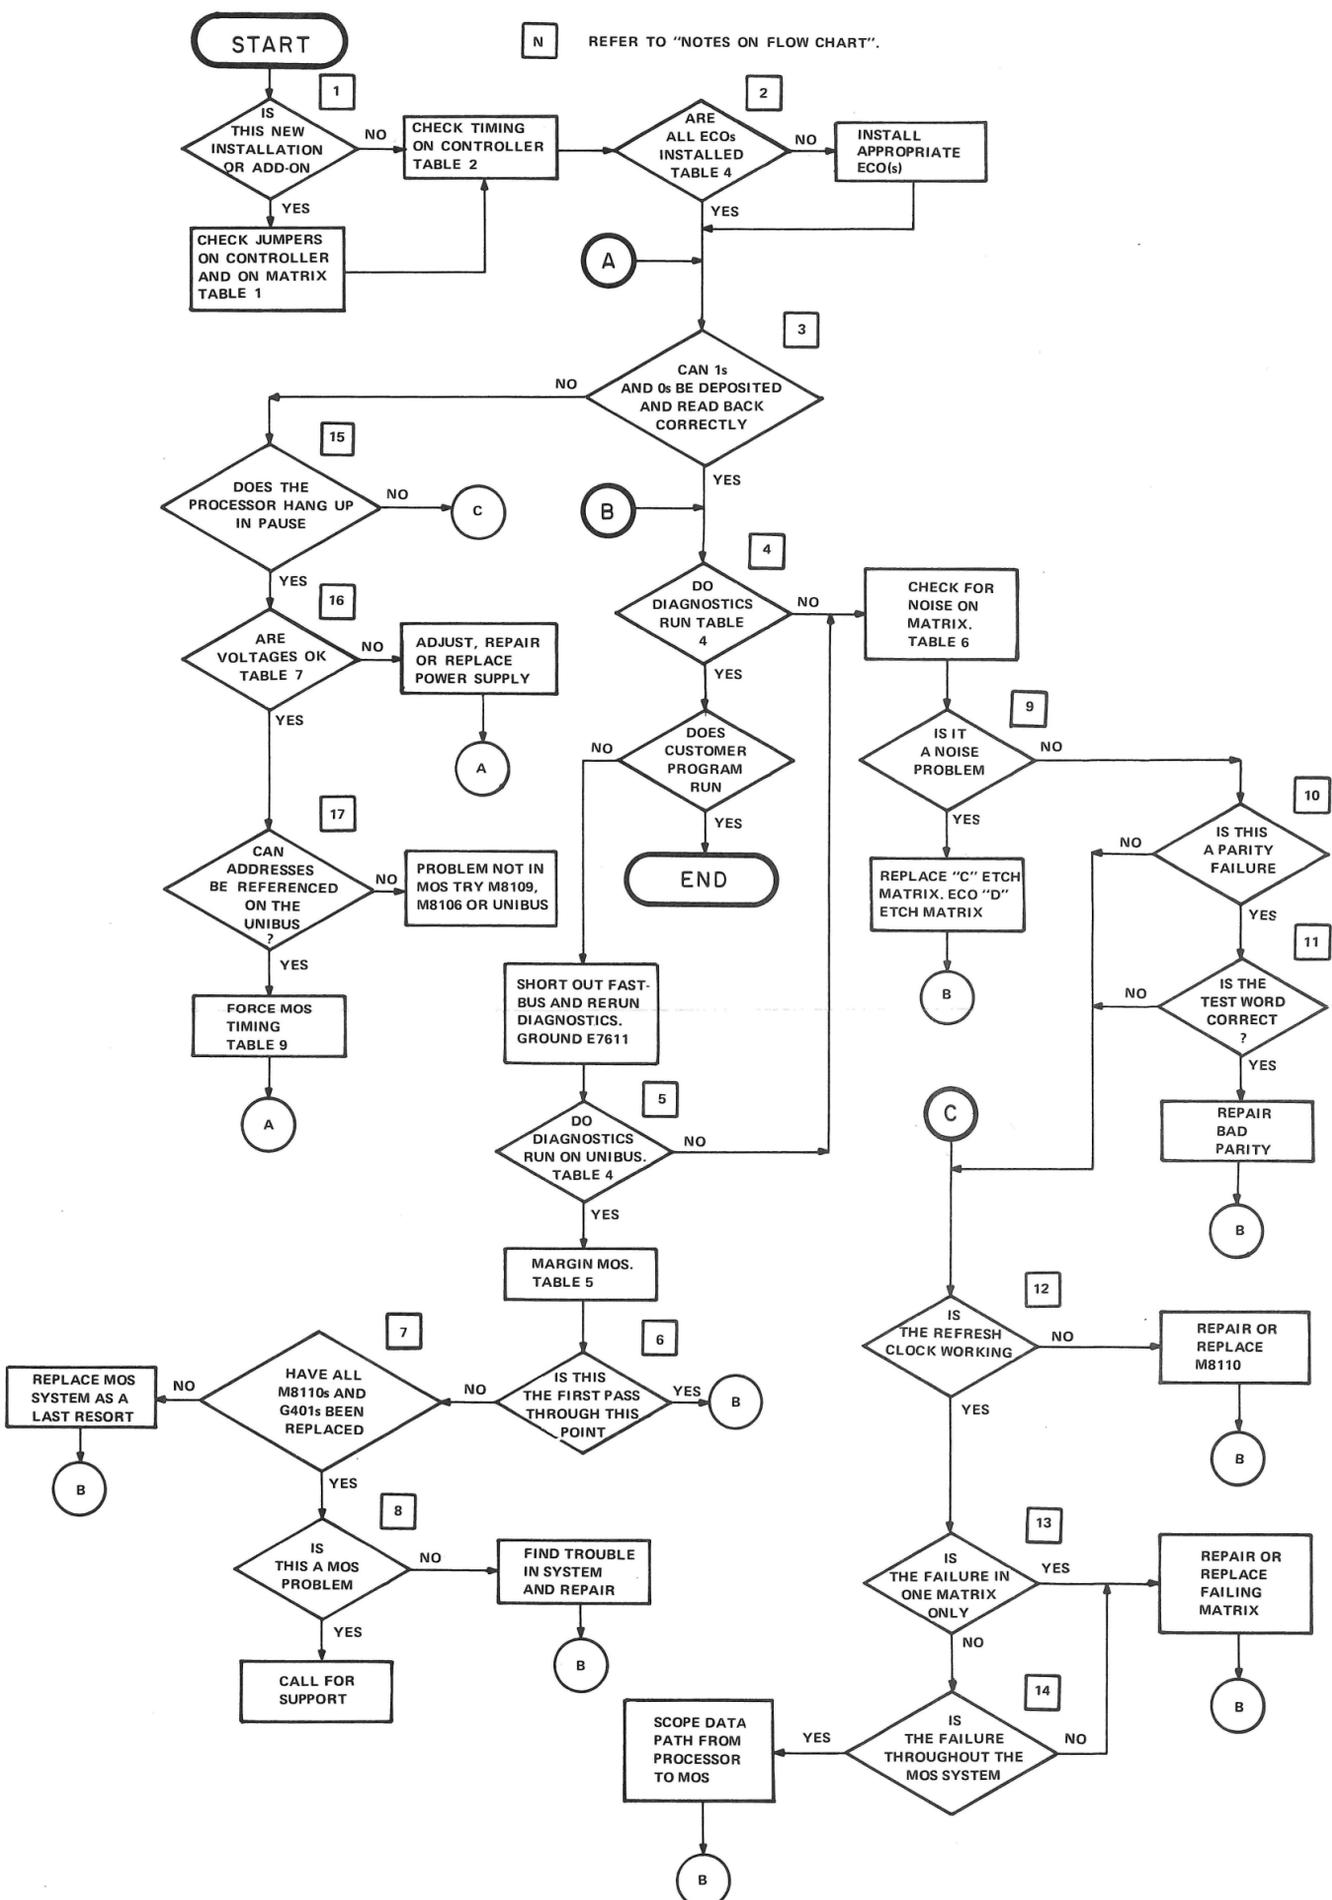
PDP-11/45, 11/50 MOS Troubleshooting Chart

1 If this is an add-on or if the controller or the matrix have been reassigned to new addresses, the jumpers may be wrong. An indication of this is a deposit of 0s that read back as 1s.

2 Various ECOs fix related MOS problems. Processor ECOs should also be checked: they may help fix some problems which are not documented.

4 If software like RSTS-E or some customer software fails, it might take a long time for diagnostics to fail or they might not fail at all.

9 A C etch G401 cannot be ECOed to fix noise problems. A D etch G401 can be ECOed to fix noise problems.

A C etch G401 should not cause noise problems if less than half of the 37 level shifters are 3207A-1s.

11 Data storage problems in a matrix are generally caused either by a missing voltage or by an inoperative refresh clock.

7 If no problem can be found, this is the only thing left to try. Jumpers and timing must be checked after installing new modules.
