6.1.31 AM-1000 Hard Disk Cleaning Procedure

Winchester 60MB Motor Control Circuit Board Enhancement

AM-610 Enhancements

AM-1000 Winchester Drive Assembly Modification

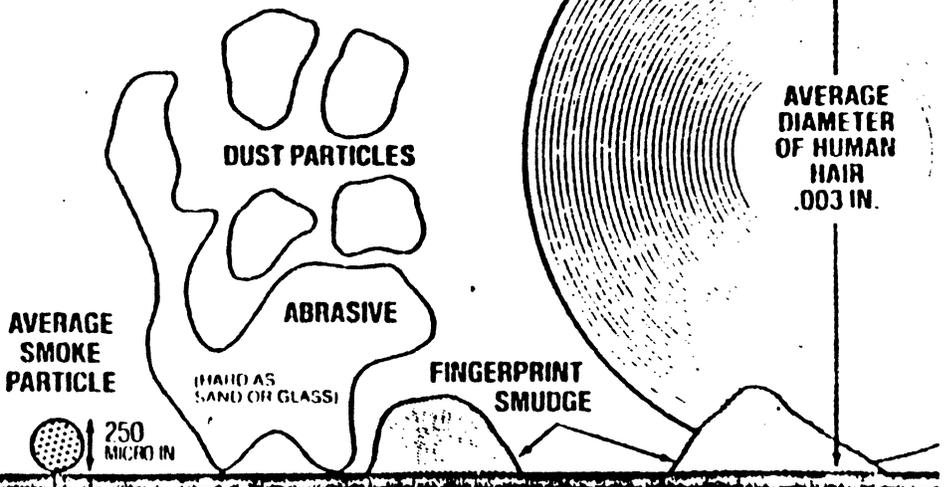
HEAD/DISK RELATIONSHIP

FLYING DISTANCE AND CONTAMINATION

Data heads fly on a very thin layer of air that is squeezed between the heads and the disk. Due to the extremely small distance between the heads and the disk, care must be taken when handling the disk pack.

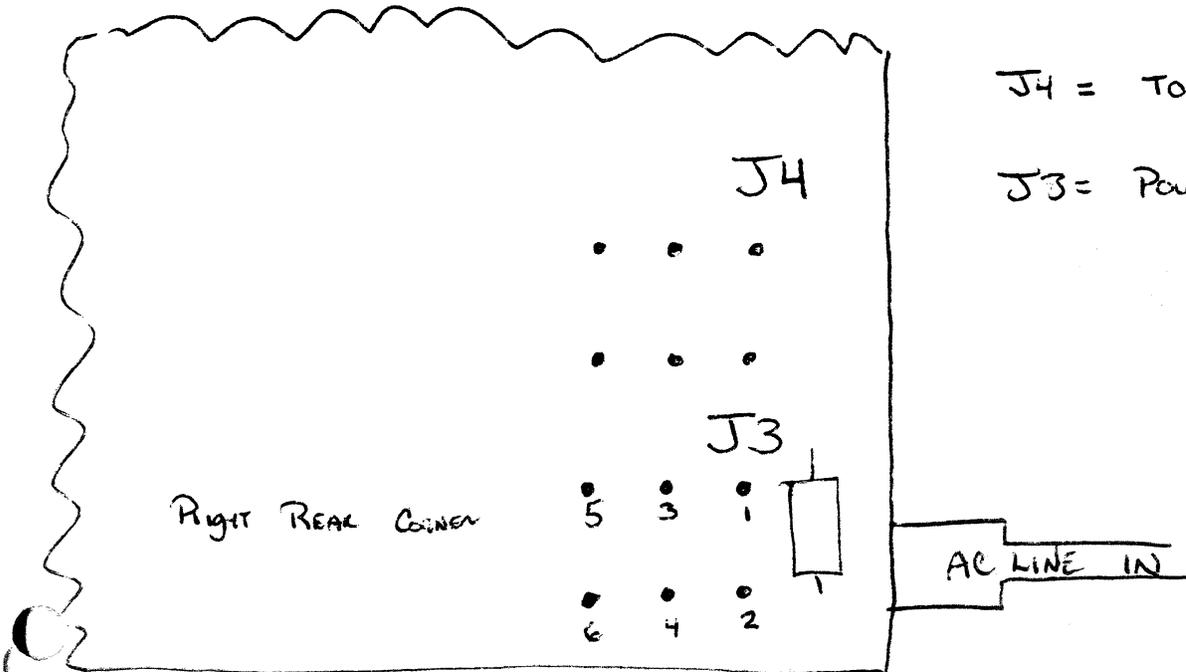
POWER SUPPLY VOLATAGES

J4 = TO MOTOR CONTROL CIRCUIT
 J3 = POWER SUPPLY IN

PIN	(COLOR)	DESC
1	(BLACK)	LOW RETURN
2	(YELLOW)	+24V
3	(BROWN)	-5V
4	(ORANGE)	-12V
5	(RED)	+5V
6	(WHITE)	+24V RETURN

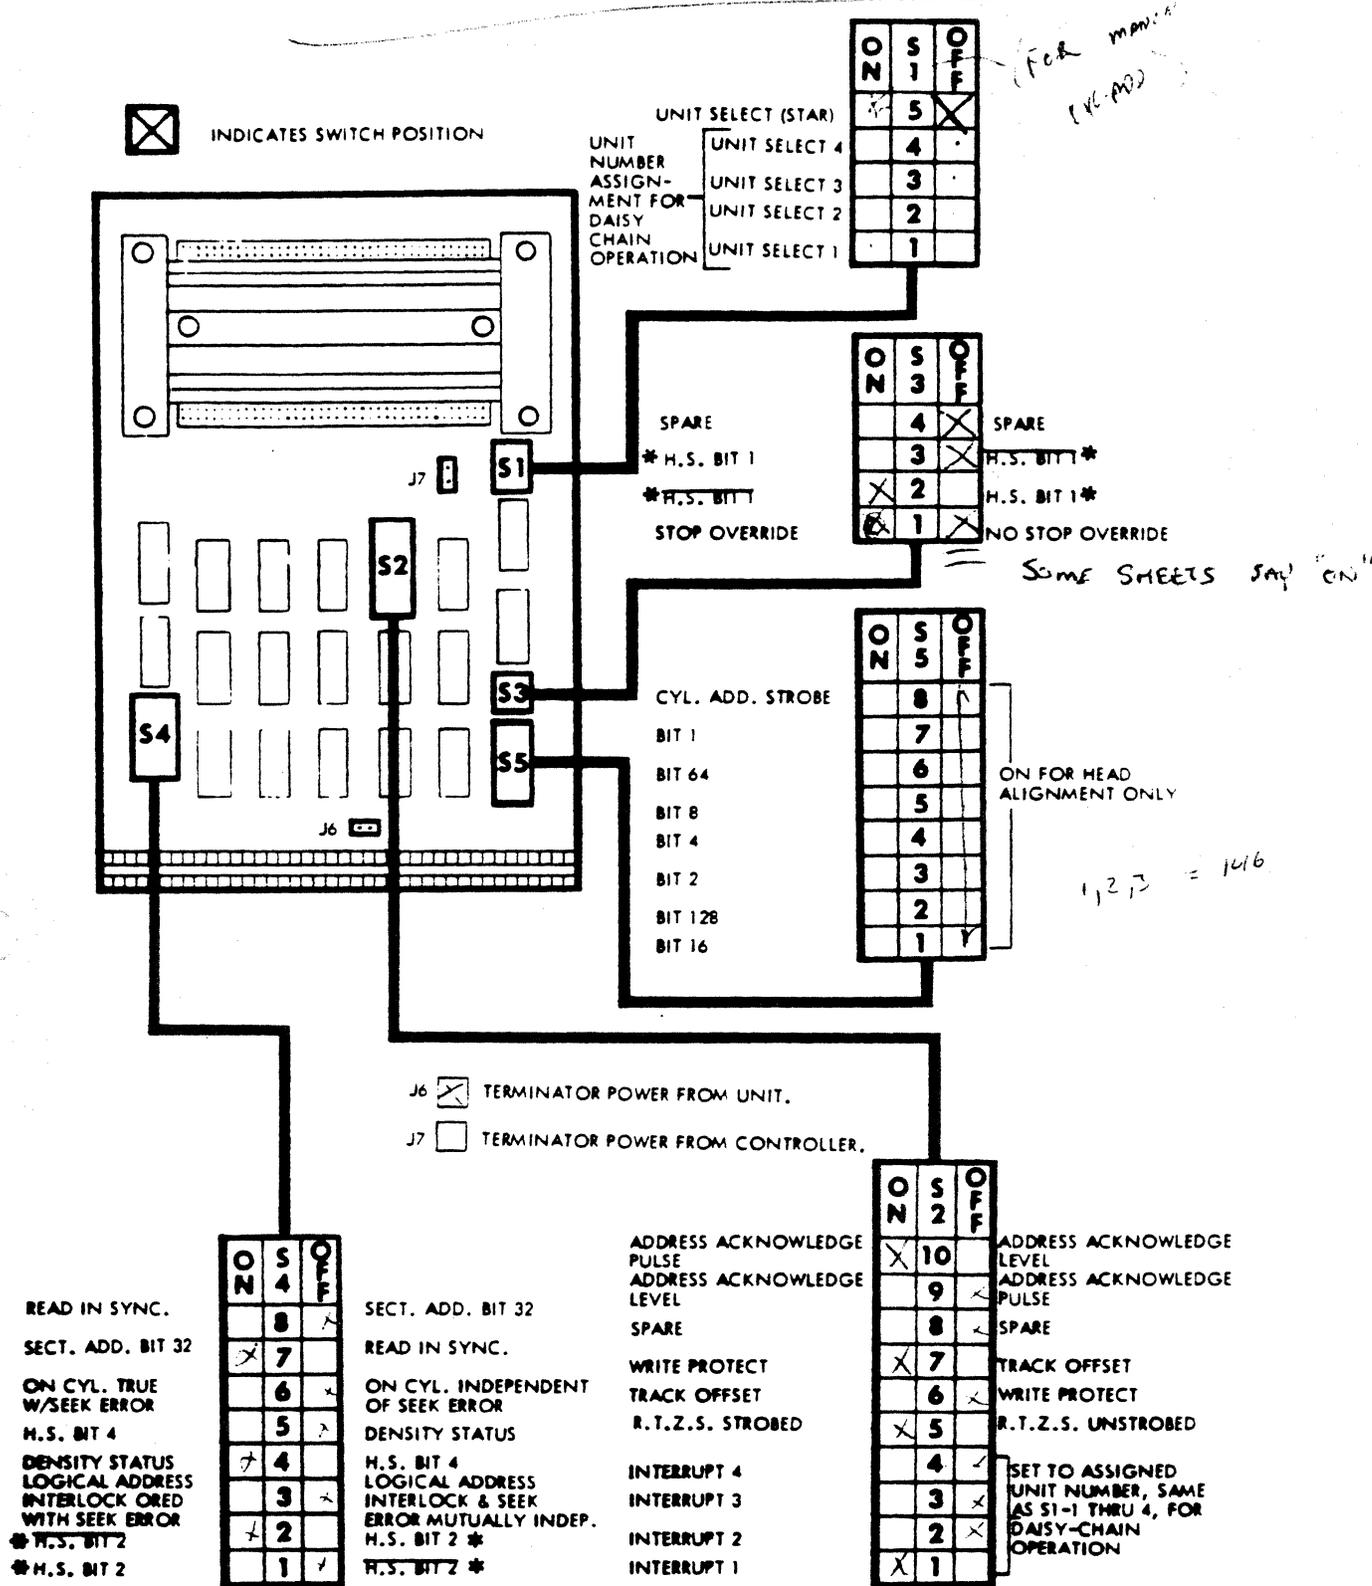
FIGURE 5-2. TERMINATOR CHIPS

- connecting a special terminator plug (Refer to Figure 5-2), or
- installing terminator chips on the I/O board. (Refer to Figure 5-2).

* WITH HEAD SELECT SWITCHES SET TO UNINVERTED POSITIONS, HEADS ARE NUMBERED 0, 1, 2, 3 FROM TOP TO BOTTOM. WITH HEAD SELECT SWITCHES SET TO INVERTED POSITIONS, HEADS ARE NUMBERED 0, 1, 2, 3 FROM BOTTOM TO TOP. H.S. BIT 2 IS EQUIVALENT TO DISK SELECT. H.S. BIT 1 SELECTS THE TOP OR BOTTOM SURFACE OF THE SELECTED DISK.

* S3-2 MUST BE OFF IF S1-5 IS ON.
