FORTUNE SYSTEMS CORP.
SERVICE NOTICE INDEX

SERVICE NOTICE

NUMBER 0001

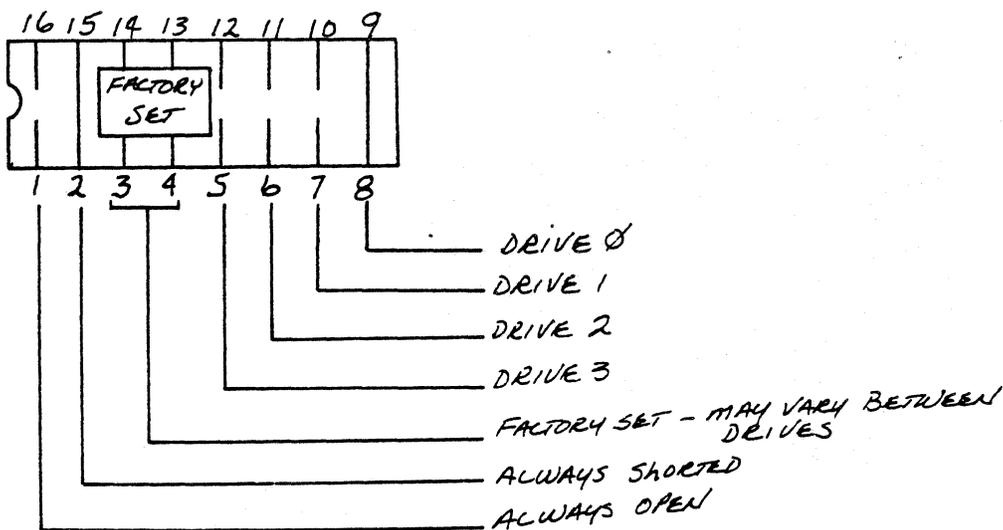
PROBLEM: NEW HARD DISK DRIVE FOR THE FORTUNE CPU. FORTUNE IS NOW SHIPPING THE "MINI-SCIBE" HARD DISK IN THE SYSTEM AND FOR SPARES.

SOLUTION: SEE BELOW FOR THE PROPER PLUGGING OF THE "MINI-SCIBE" DISK.

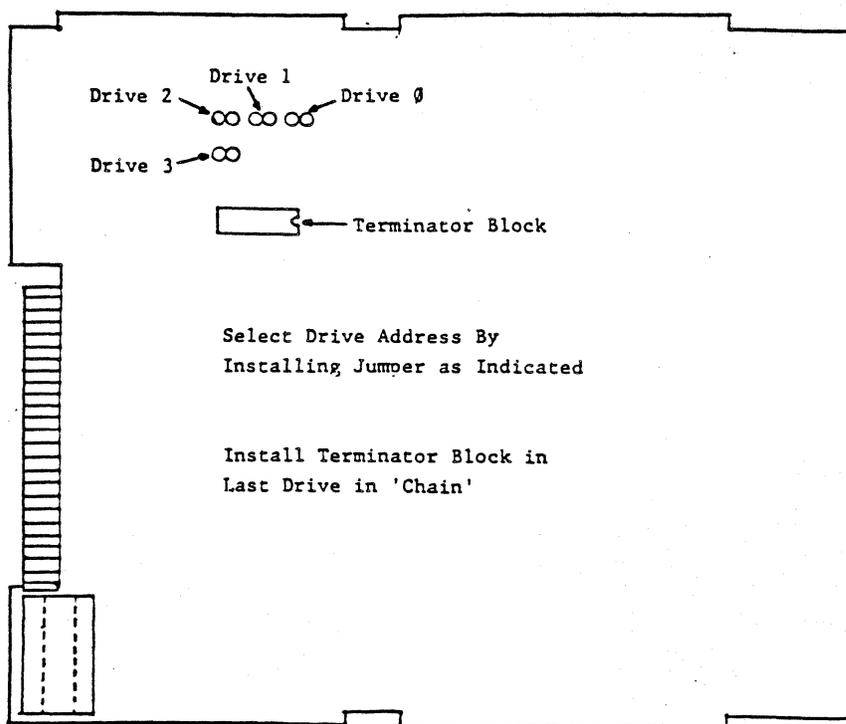
PROBLEM: FORTUNE IS NOW SHIPPING "SHUGART" FLOPPY DISK DRIVES IN THE SYSTEM AND AS SPARES.

Select Drive Address By
Installing Jumper as Indicated

Install Terminator Block in
Last Drive in 'Chain'

SOLUTION: BELOW IS THE PLUGGING FOR THE "SHUGART" FLOPPY DISK DRIVE:

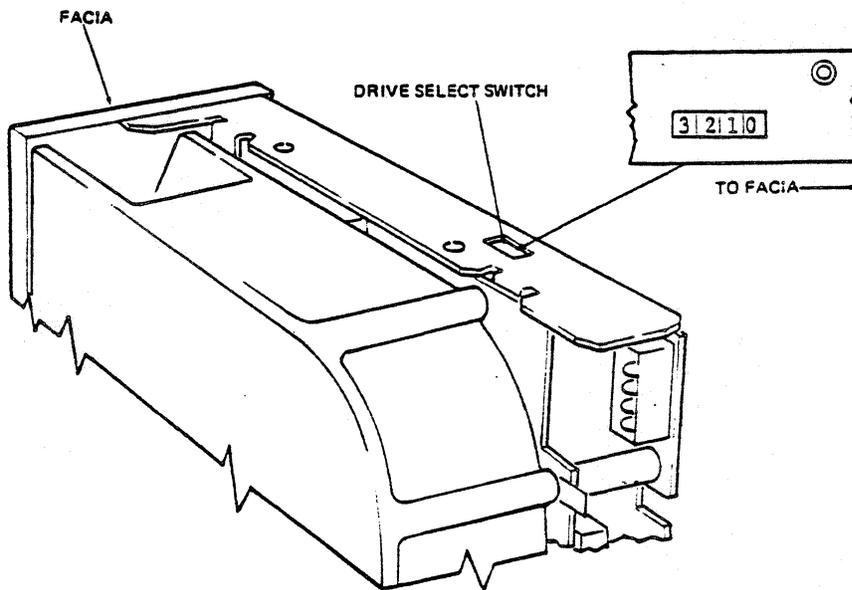
PROBLEM: Fortune is now shipping AMPEX PYXIS Model 27 (20 Meg) hard disk.

To identify a drive, the pole corresponding to the address of the drive is closed. Only one pole in each drive can be in the closed position.

SOLUTION: Below is the addressing information.

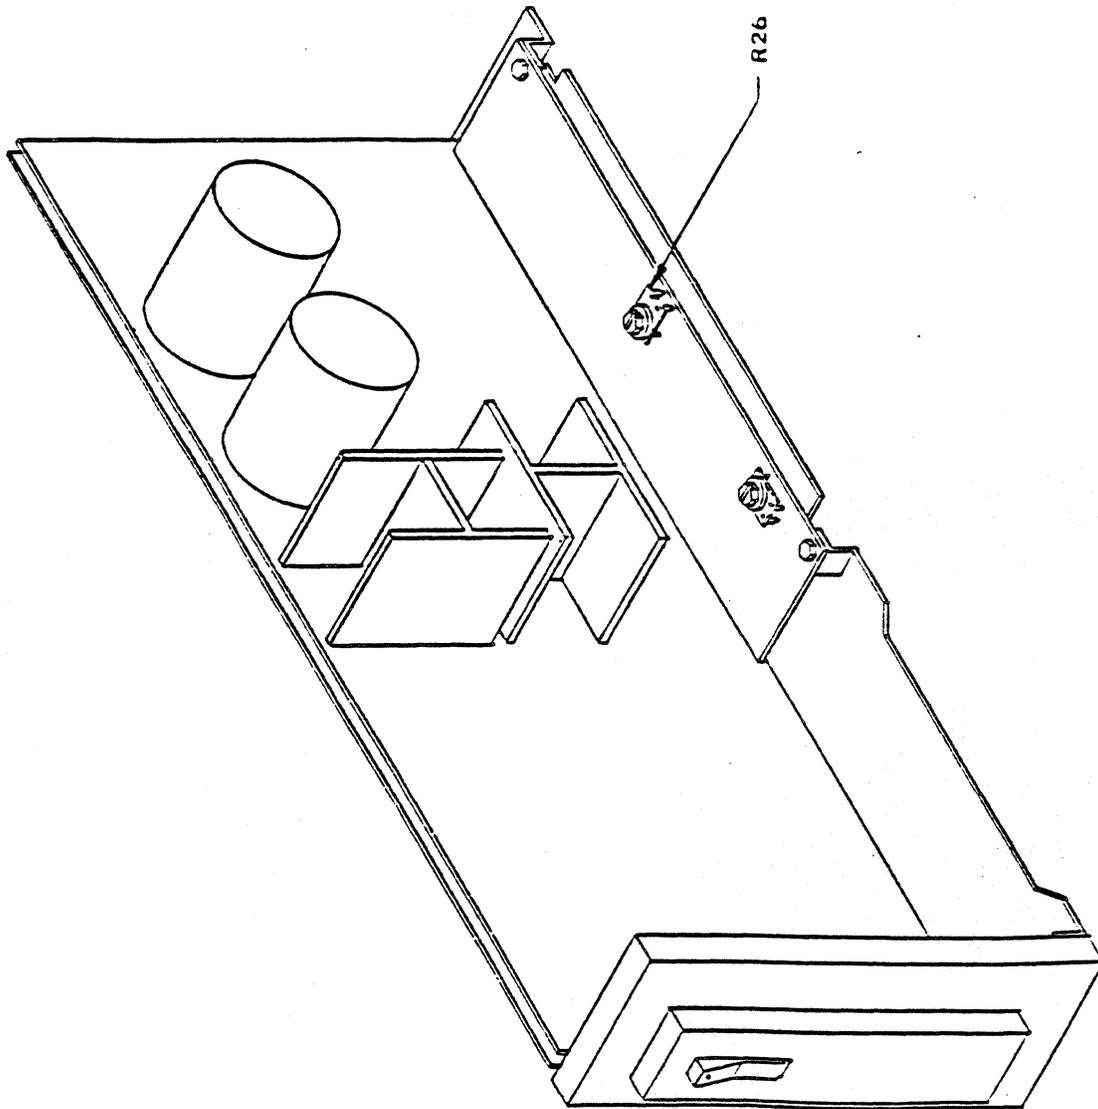
FIGURE 1.0

Check the +12 volt output, it should be less than 12.60 volts. If it is above, adjust potentiometer R26 (see Figure 1.0) until voltage is 12.60 volts.

Check the -12 volt output, it should be between -11.40 volts and -12.60 volts. This supply is used only for RS232 type communications options at this time. If the system includes only RS232 type options (Comm A or Comm B), the supply will be acceptable if the -12 volt output is as low as -13.00 volts.

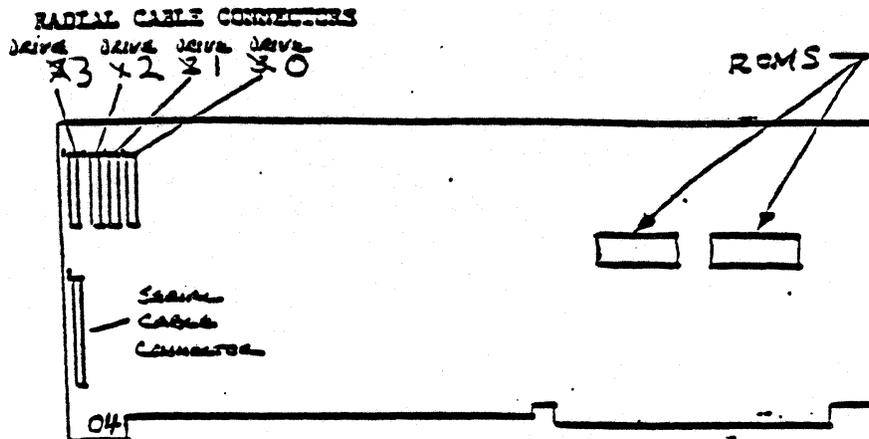
PROBLEM: All expansion cabinets have to be connected to a 1000079-04 hard disk controller. The hard disk controller shipped with the expansion cabinet is a 1000079-04. Notice that the drive radial cable connectors have been changed. Drive 0 is now the right radial connector and drive 3 is the left radial connector. The new hard disk controller can be identified by an '04' stamped as shown. Also, there is a daughter board located in the lower left corner.

SOLUTION:

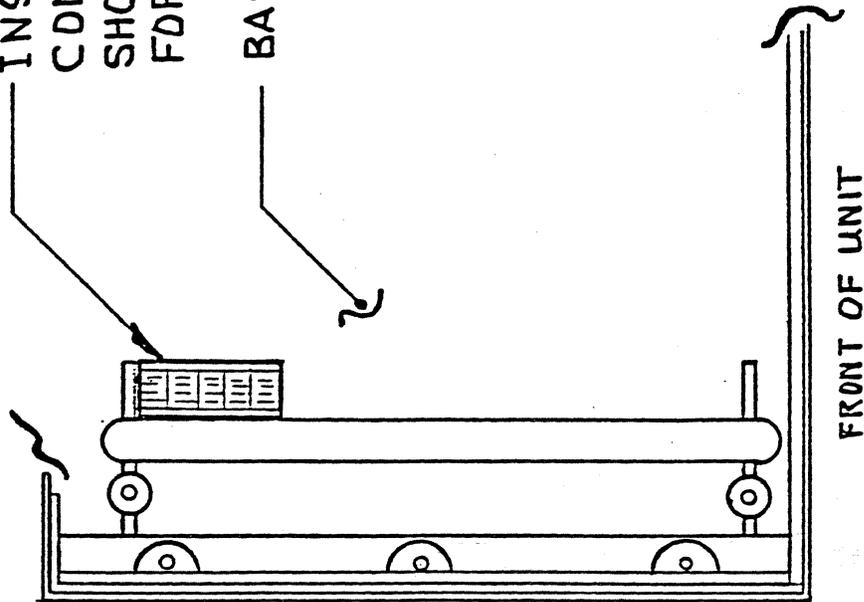
FIGURE 1

INSTALL COPPER
CONTACTS APPROX AS
SHOWN, 5 EA AS REQUIRED
FORTUNE P/N 1001794-02

1. Remove old power supply.
2. Remove 1001612-01 or 02 capacitor from disk drive assembly as this parts is not needed with the Western Electric supply.
3. If 230 V operation is required, configure supply as shown in figure 3 and attach the required label as shown in figure 2. Make sure that the plug (Figure 3 ref 1) is pressed down firmly in place as the power supply is selected for 230 V operation if the plug is not plugged in all the way.
4. If not already installed, attach copper contacts as shown in figure 1.
5. Install new power supply, reconnect cables.
6. Invert the CPU top cover, and install insulator as shown in figure 4.
7. Reassemble CPU and run diagnostics as required.

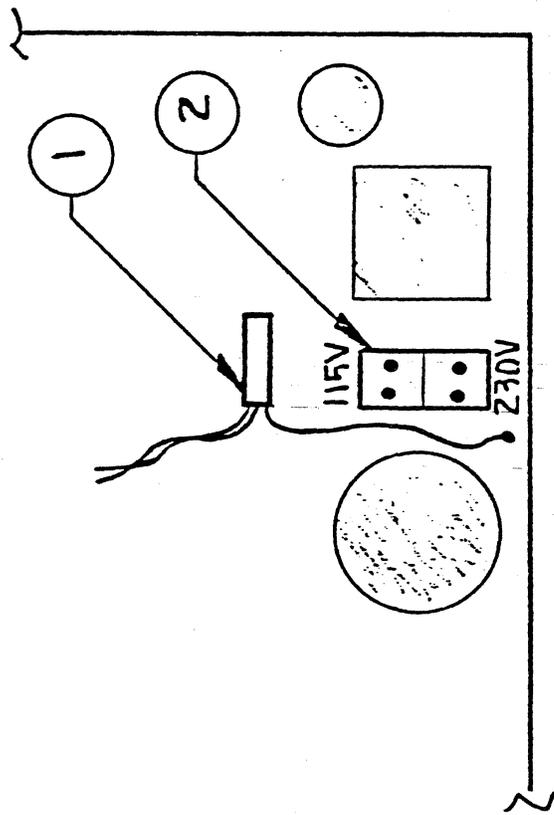
FIGURE 3

- ① VOLTAGE SELECT PLUG .
- ② 115 / 230 VOLTAGE SELECT POSITION, INSERT PLUG IN TO LOWER POSITION TO CONNECT TO 230V .

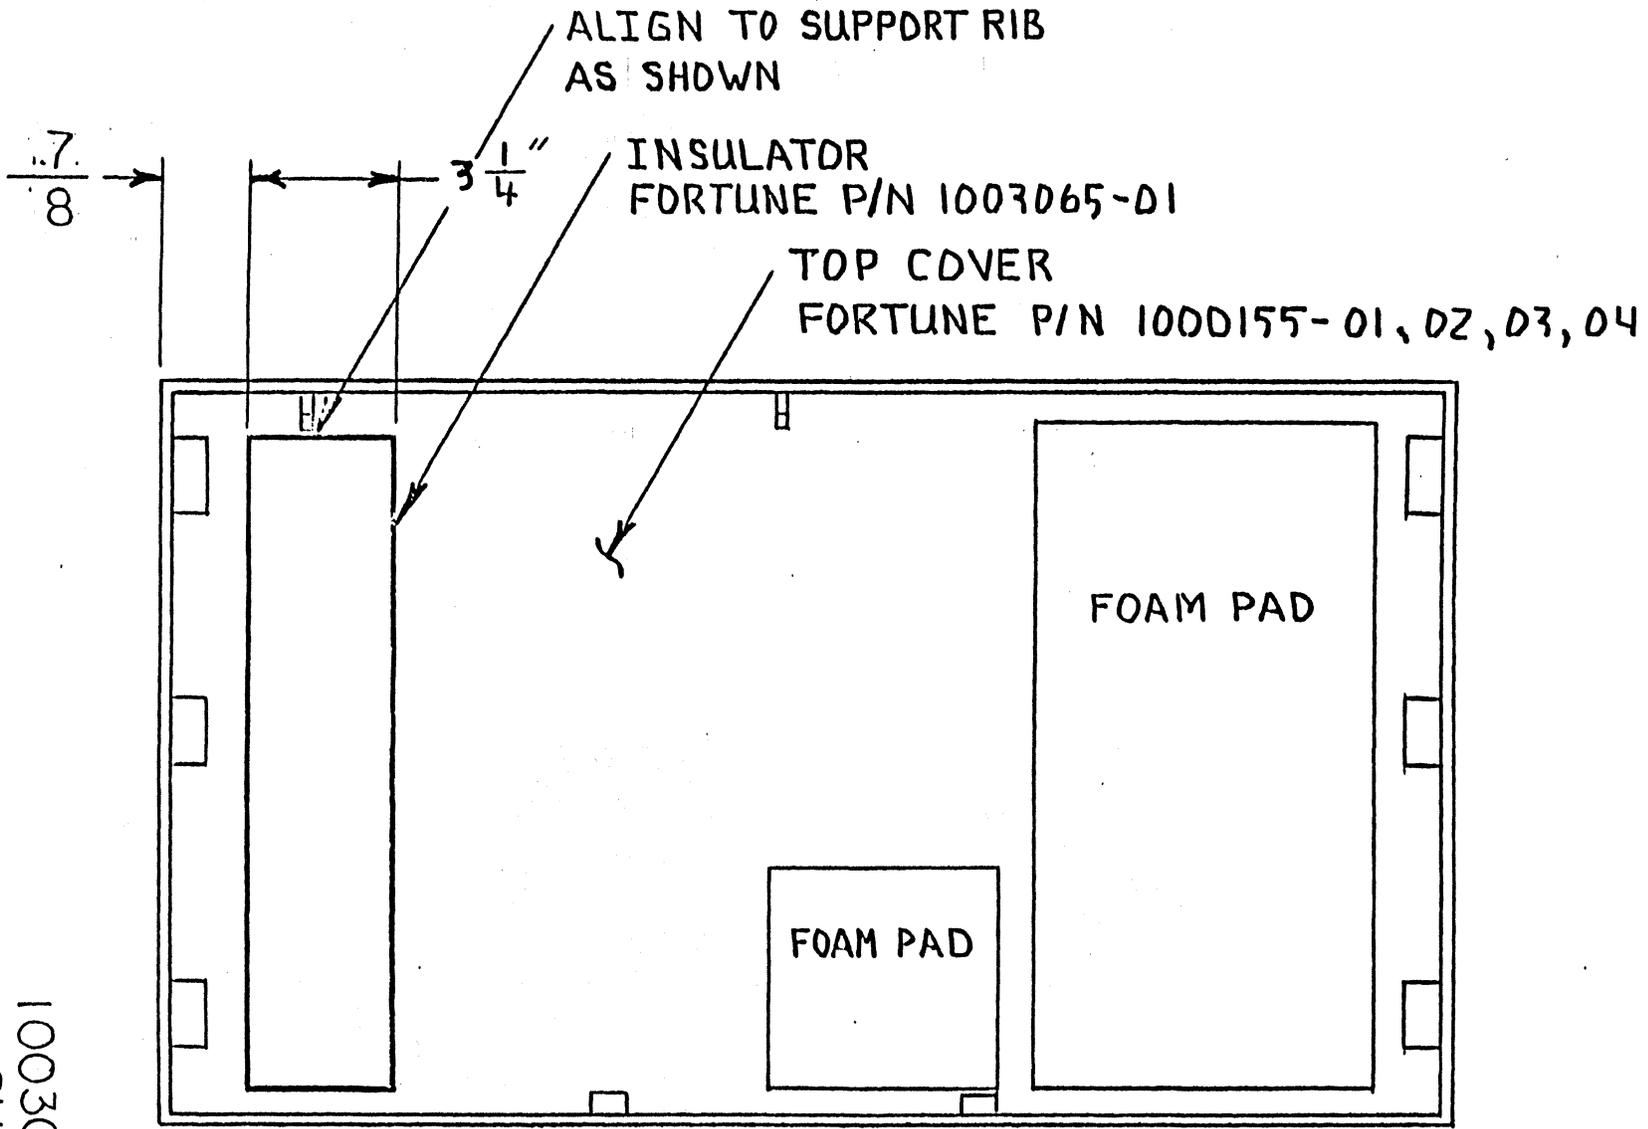
FIGURE 4
TOP COVER INSULATOR ASSY

WIRE HARNESS MUST BE SPREAD OUT
THIN IN AREA ① SO AS NOT TO
INTERFERE WITH FAN MOUNTS .

WIRE MUST REMAIN BELOW TAB ②
SO THAT WIRES DO NOT BECOME
PINCHED BY COVER .

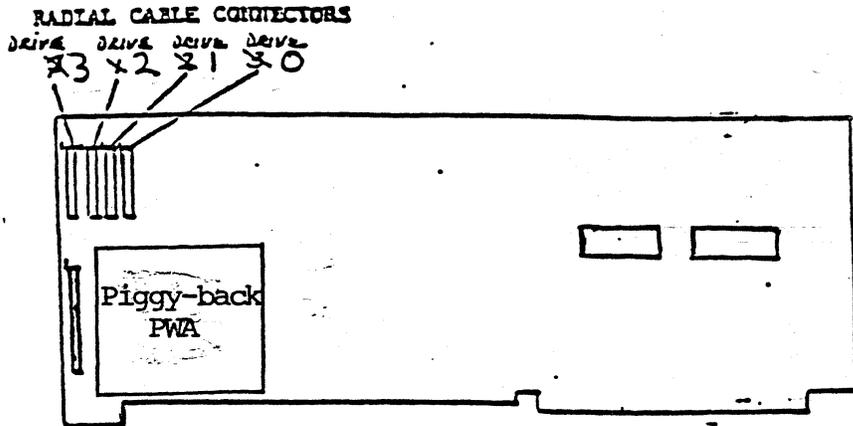
PROBLEM: Effective 4/16/84 all computers being built by Fortune Systems Corporation will have a 1000079-04 hard disk controller installed. All repair and return 1000079-01 hard disk controllers will be replaced by/or upgraded to 1000079-04 hard disk controllers. The 1000079-04 hard disk controller has the radial (data) cables connectors reversed and a piggy-back PWA has been installed. The piggy-back PWA enables the hard disk controller to be used with multiple drive systems.

SOLUTION:

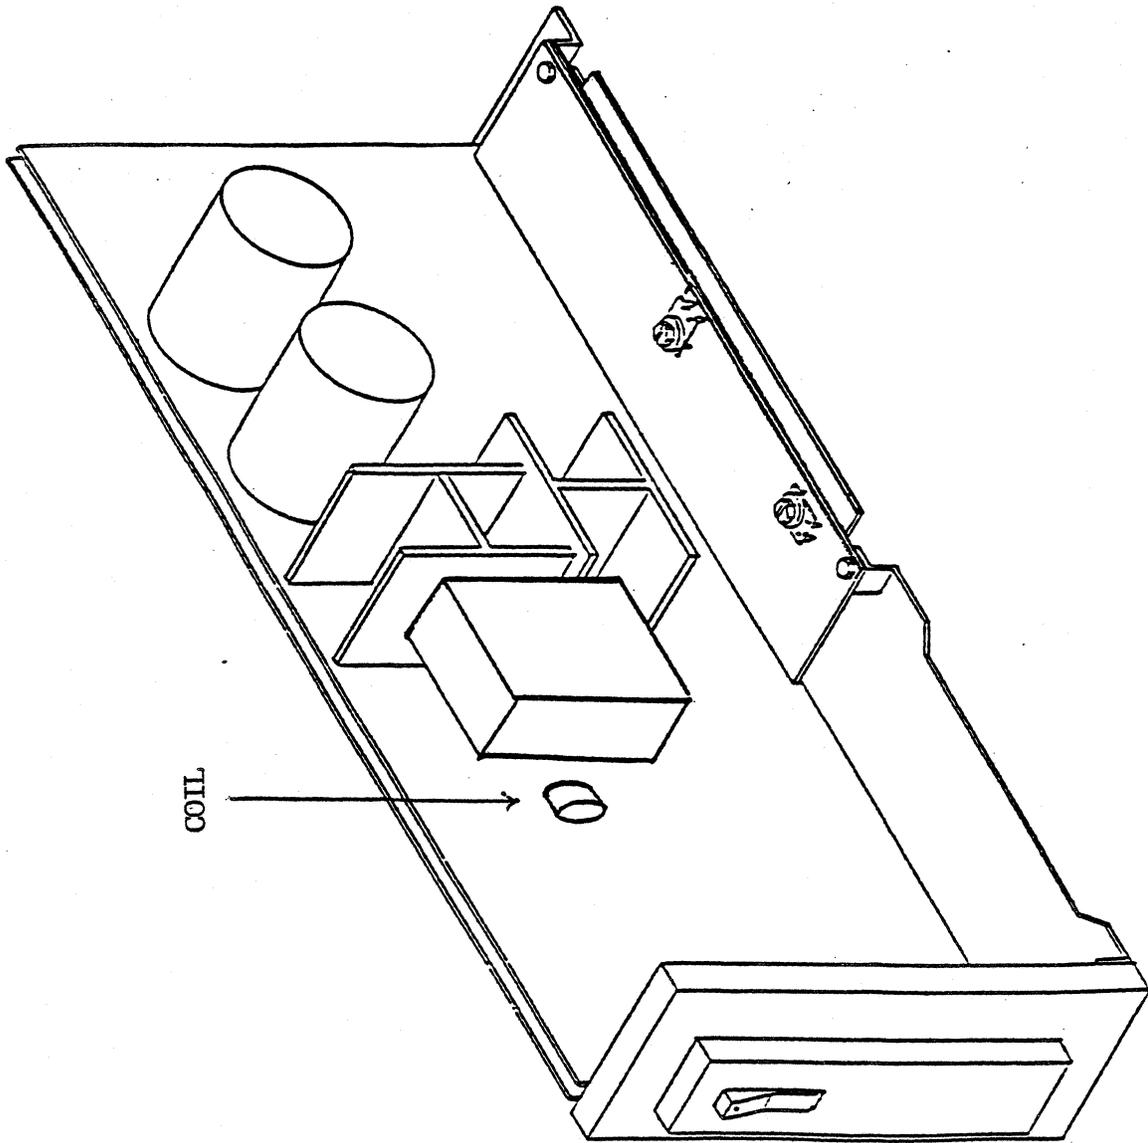
FIGURE 1.0

The first was a 22 amp supply (1000050-01 or 02). The Zenith part number (OE-A-00012 is located on the back of the supply. It can be further identified by the absence of a small coil on the power supply electronics board. See figure 1.0 for details.

The second was a 28 amp supply (1000050-03 or 04) also manufactured for Fortune by Zenith. The Zenith part number (OE-A-00012-01) is located on the back of the supply. It can be further identified by the presence of a small coil on the power supply electronics board. See figure 1.0 for detail.

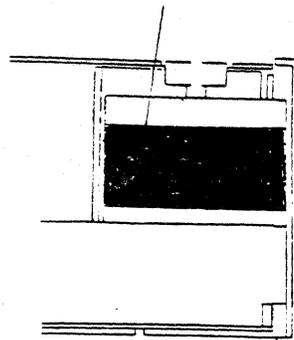
Wide
Band
Stepper
Motor

Check the microprocessor IC22 (40 pin chip on component side of logic board) to see if proper chip is installed. If the drive has a narrow band stepper motor (see figure 3) the correct numbers should be 6109-2. If the drive has a wide band stepper motor (see figure 4) the correct numbers should be 6052-13B. If the microprocessor is the wrong revision, call Customer Support (415) 594-2949 for a replacement, be sure to also ask for a capacitor (part# 1000376-08). After replacing the microprocessor, install the capacitor.

If the microprocessor is the wrong revision, call the Customer Support Hot Line 800-FOR-3216 for a replacement. After replacing the microprocessor, reassemble the drive and put an update label on the top left front of the drive. Run diagnostics and return to the customer's system.

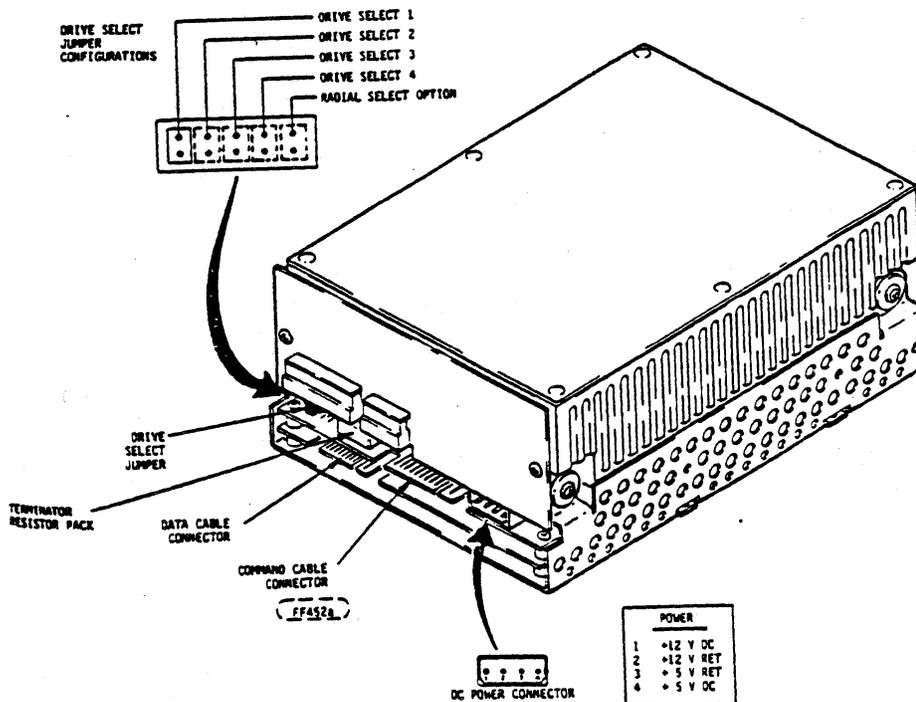
PROBLEM: Fortune Systems Corporation has qualified a new 45 megabyte hard disk drive. It is made by CDC and has a C45 designation.

SOLUTION: Since you will be receiving this new drive in systems and as a spare, please note this drive type when cold booting and running diagnostics. Drive jumpering and termination is the same as the J30 drive.
