## CONTENTS

### SERVICE ADVICES

Service Advice Index  
Service Advices

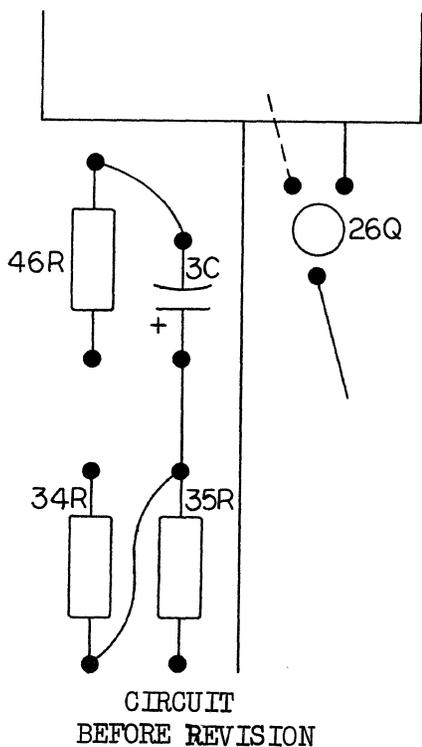
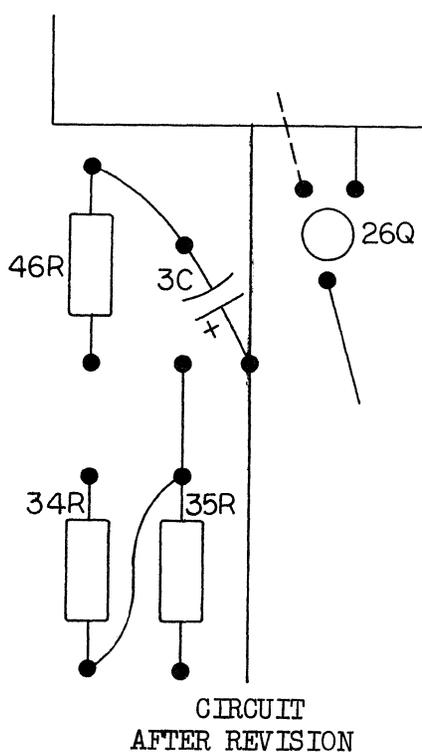
A modification to the Reader Board (RDRB) 44B412360-G01 used in "B" Model Terminet 300 ASR units can easily be made to improve the reliability of the reader. Without this modification, it is possible for the reader to occasionally stop reading and shut off for no apparent reason. The modification consists of performing the following steps:

1. Turn off power and remove the RDRB from the reader drawer.
2. Locate capacitor 3C (2.2 uf).
3. Remove the capacitor lead from the P.C. board which connects to resistor 35R and 34R.
4. Reconnect this capacitor lead to the collector of 26Q and 31Q.
5. Re-install modified board, and turn power on.
6. Adjust potentiometer 1P on RDRB board for a 2.3 to 2.4V reading across resistor 18R.

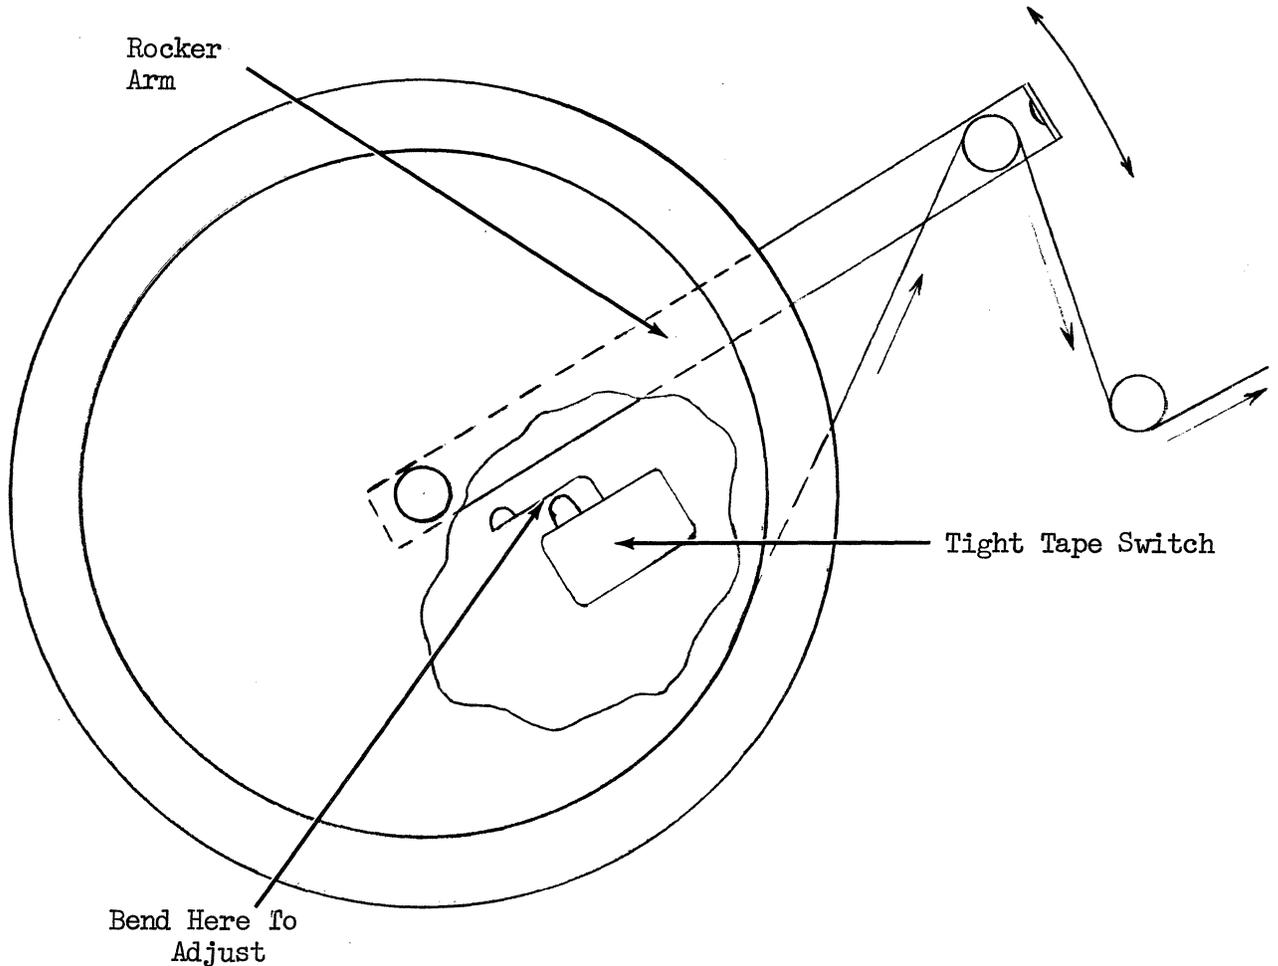
The Tape Punch Drawer Assembly in the TermiNet 300 Desk Console has been improved. Starting approximately fiscal week 45, some Punch Drawers manufactured in Waynesboro include a tight tape control which shuts the Punch off and causes an "alarm" condition whenever tension on the tape becomes excessive.

The correct adjustment on the tight tape switch is made at the factory and no further adjustment should be required. If, however, adjustment should become absolutely necessary, the switch arm can be bent up or down as required to obtain the desired setting. (See sketch below).
