INFORMATION BULLETIN LOG
CUSTOMER SERVICE

PRODUCT PERQBULLETIN NO. 001SUB-ASSEMBLY MOTHER BOARD/IO BOARD

PART NO. MOM-001/IOB-001MODIFICATIONS FOR LASER PRINTER
OPERATIONSERIAL NO. ALL

MODIFICATION
FOR LASER PRINTER OPERATION

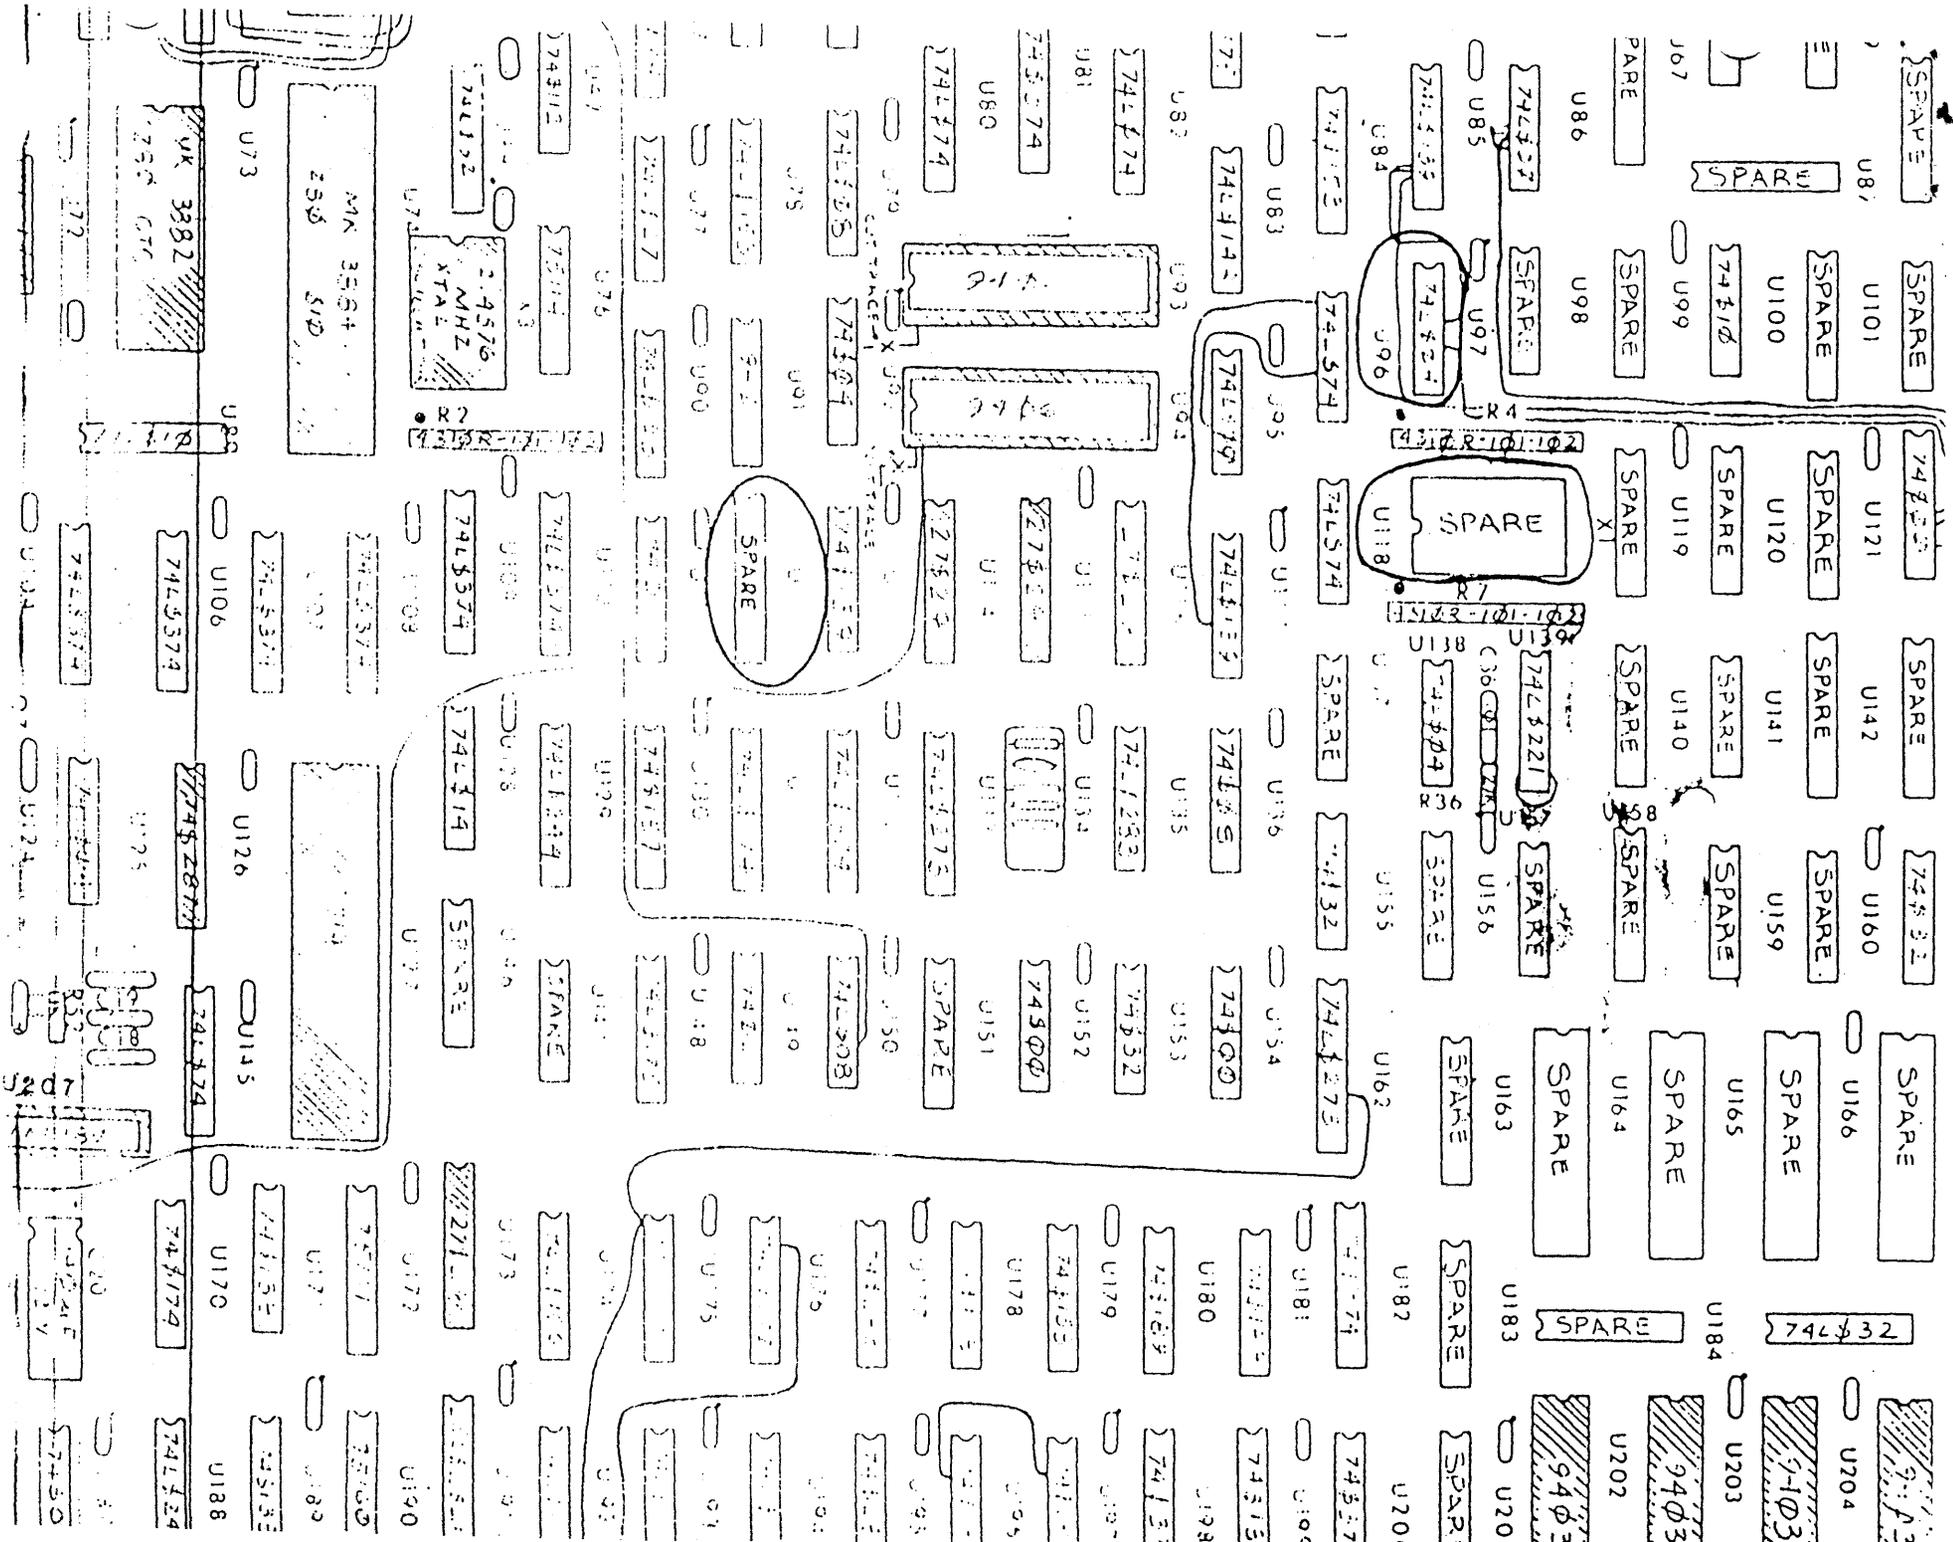
LASER MODS

This bulletin is to verify that the PERQ System has the necessary changes to ensure proper operation of the LDP-10 Laser Printer.

1. Verify that there is continuity between the backplane pins as reflected on the attached drawings.
If the wiring is missing, add the wire utilizing 30 gauge wire-wrap wire.
2. Remove IC U112 from the IOB-001 Board by cutting the chip out with a pair of miniature cutters. (See attached drawing).
(NOTE: On later revision IOB-001 Boards this IC will already be removed).
3. Add 470 ohm, $\frac{1}{4}$ watt resistors as follows:
 - a. From pin 2 to pin 7 of U118.
 - b. From pin 12 to pin 7 of U118.
 - c. From pin 2 to pin 7 of U96.
 - d. Ensure that pin 2 and pin 12 of U118 and pin 2 of U96 are not connected to ground.

Ensure that pin 2 and pin 12 of U118 and pin 2 of U96 are not connected to ground.

NOTE: If there is a resistor pack holder at position U134 the above resistors are not required.
