Internal Memo

Subject
ALTO BULLETIN SYSTEM (AL01)

Alto Bulletin (AL06)

This bulletin describes the correct way to change backplanes.

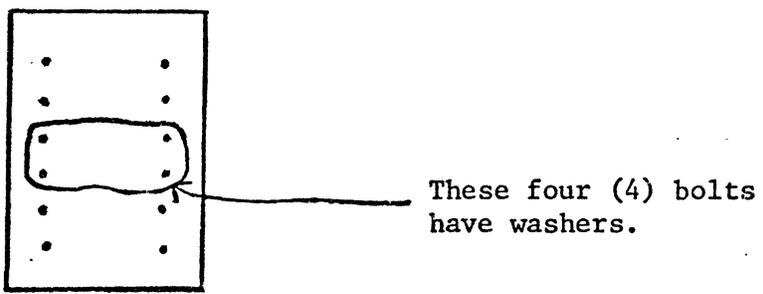
- F) Remove the 12 bolts holding the backplane onto the frame, taking note which bolts have the washers.

- G) Carefully remove backplane.
- H) Inspect the new backplane for bent pins or other abnormalities.

I) Install new backplane in reverse order.
