Intel[®] StrongARM^{*} SA-1110 Microprocessor

Specification Update

April 2001

Notice: The SA-1110 may contain design defects or errors known as errata. Characterized errata that may cause the SA-1110's behavior to deviate from published specifications are documented in this specification update.

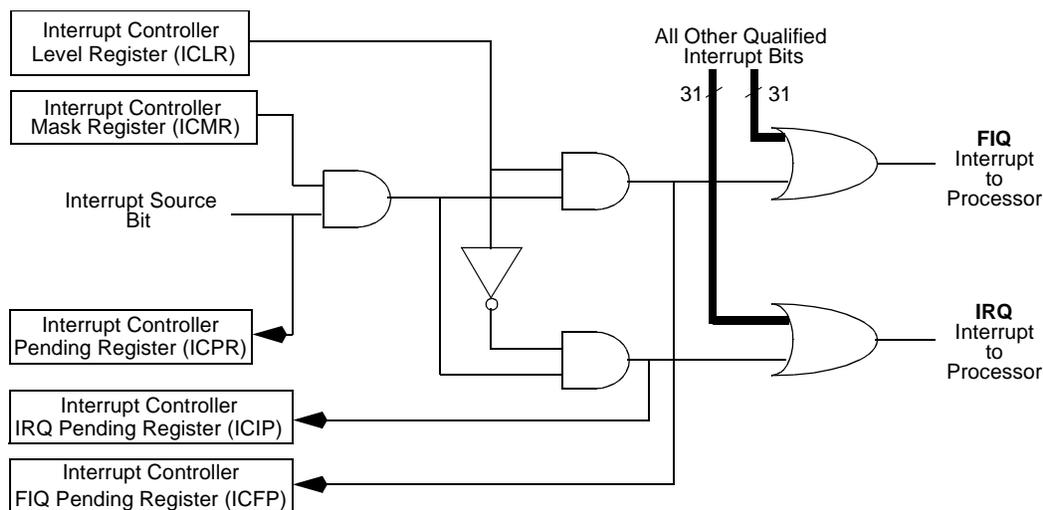
Figure 9-2. Interrupt Controller Block Diagram

Made the following changes to Figure 9-2.

Figure 9-2 now appears as:

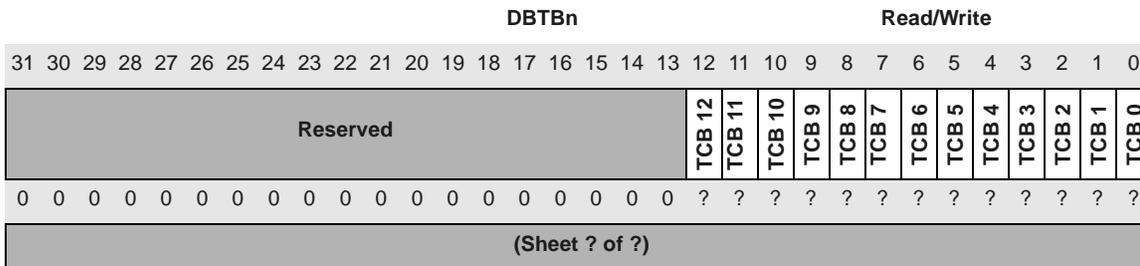
58. DMA Buffer B Transfer Count Register (DBTBn): Section 11.6.1.6

Changed DMA Buffer B Transfer Count register reset values for the Reserved bits to 0.

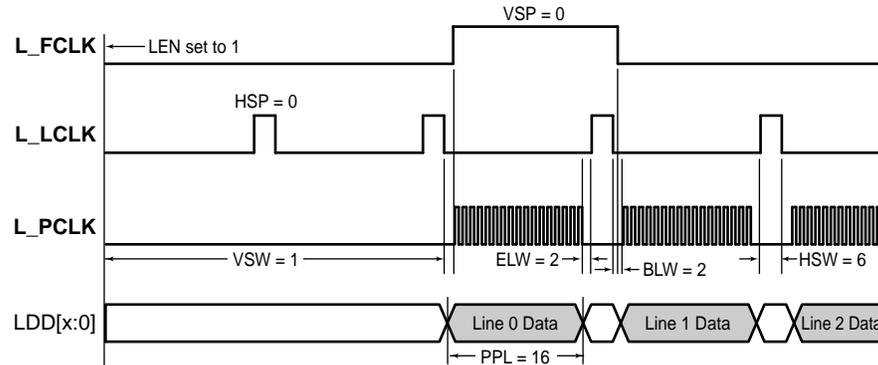
Figure 11-10. Passive Mode Beginning-of-Frame Timing

Changed the Notes: in Figure 11-10 to show the range of HSW as 1 to 64, not 0 to 64. The corrected figure is shown below:

**Notes:**

LEN - LCD enable:

Figures 11-10 to Figure 11-14 describe the LCD controller timing parameters.

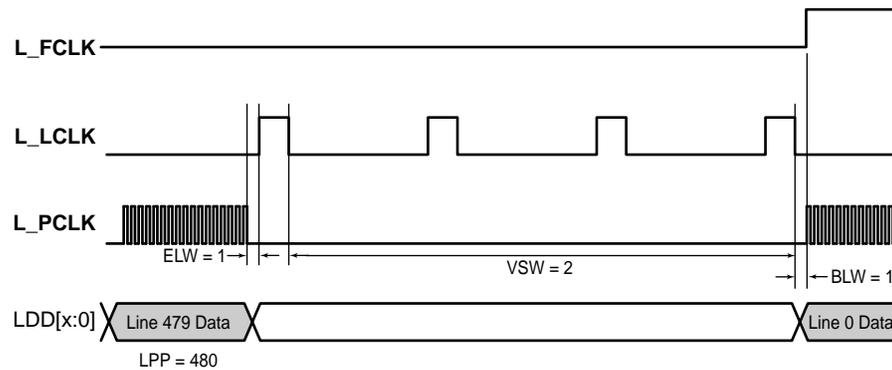
Figure 11-11. Passive Mode End of Frame Timing

In Figure 11-11 at the location where L_LCLK is deasserted just prior to Line 0 Data, there are two vertical bars depicting BLW = 1. Extended the right vertical bar upward to near L_LFCLK. At this point, changed L_FCLK to show a transition from deasserted to asserted (shown below.)

Also, changed the Notes: in Figure 11-11 to show the range of BLW as 1 to 256, not 0 to 256. The corrected figure is shown below:

Notes:

- BLW - Beginning-of-line pixel clock wait count:
1 to 256 "dummy" pixel clock periods to wait after line clock is negated before asserting pixel clocks (pixel clock does not transition).
- VSW - Vertical sync pulse width:
In passive mode, 1 to 64 line clock periods to wait between the end of one frame and the beginning of the next frame (line clock transitions).
- ELW - End-of-line pixel clock wait count:
1 to 256 "dummy" pixel clock periods to wait after last pixel in line before asserting line clock (pixel clock does not transition).
- LPP - Lines per panel:
1 to 1024 lines per panel.

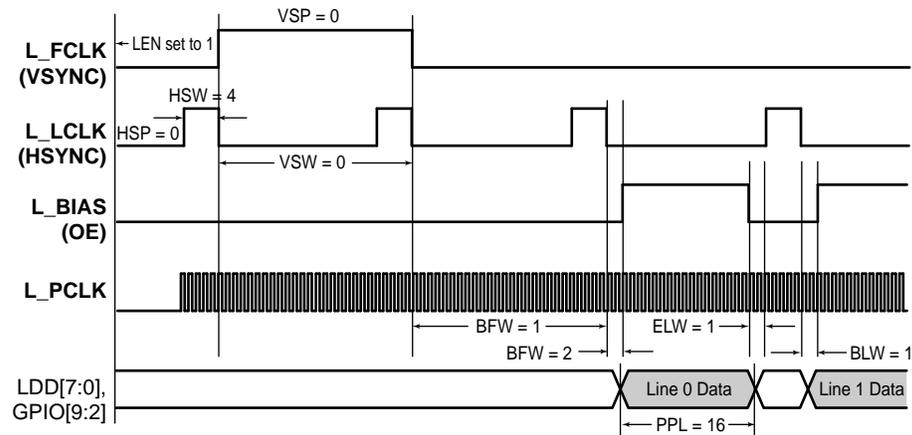
Figure 11-13. Active Mode Timing

Corrected Notes: in Figure 11-13 to show the range of PPL as 16 to 1024 (not 1 to 1024.) The corrected figure is shown below:

**Notes:**

LEN - LCD enable:
