60- and 66-MHz Pentium® Processor Specification Update

Release Date: February 1997

Order Number 243326-001

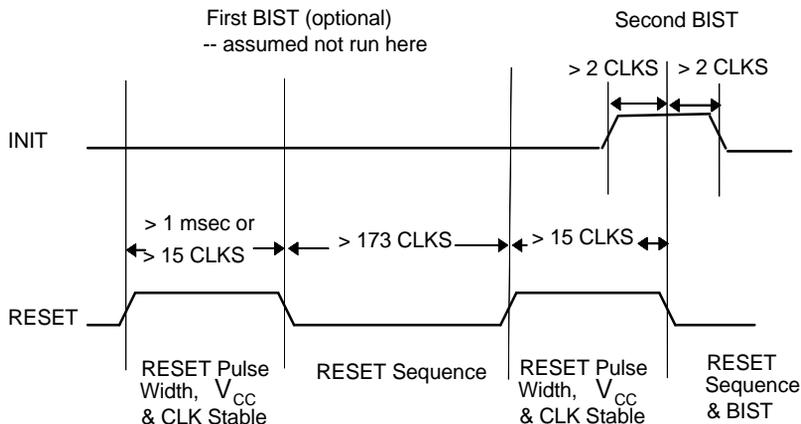
1. Invoke a double RESET — All false BIST failures have occurred during cold RESET. In order to accurately execute BIST, a double RESET sequence may be performed as shown in the figure below:

The first RESET pulse is used to ensure that all logic used in the BIST test is correctly initialized; optionally, INIT may be driven high to enter BIST at the falling edge of the first RESET. In this case the results of the first BIST should be ignored.

After deassertion of the first RESET pulse, a minimum of 173 clocks must elapse before assertion of the second RESET. (Note that if BIST was entered at the end of the first RESET, this 173-clock requirement is satisfied by the time required to complete the first BIST.) During the second RESET, INIT is toggled high in order to run the 'real' BIST. This BIST correctly returns results in EAX.
