**Maintenance
Handbook**

**IBM 3270 Information
Display System**

**IBM 3271 Control Unit
IBM 3272 Control Unit
IBM 3275 Display Station
IBM 3277 Display Station
IBM 3284 Printer
IBM 3286 Printer
IBM 3288 Line Printer**

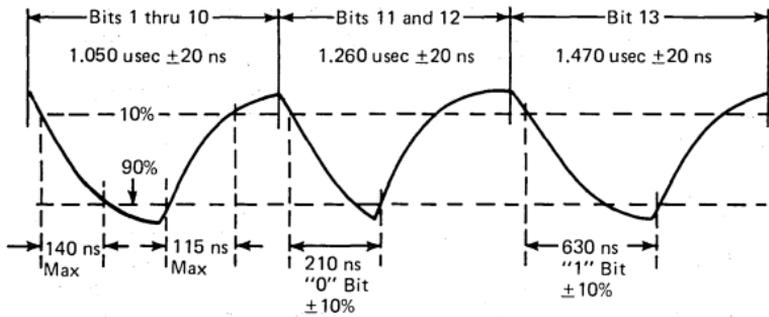
Bits on the coaxial cable center conductor appear as negative-going pulses. The center conductor of the coaxial cable, when measured at the control unit with reference to the outer conductor (shield), will be 0 volts with no signal present and power on at each unit. The minimum cable length is 2000 feet (610 m). The maximum coaxial cable length is 5000 feet (1 524 m). The signal from the control unit on the coaxial cable center conductor will appear as follows at the device:

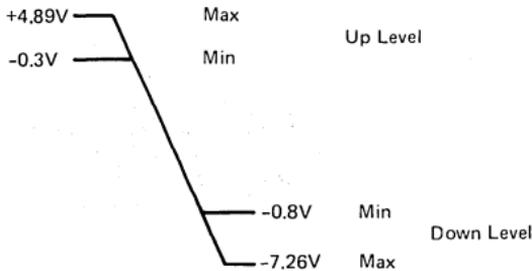
The pulse amplitude, as referenced to dc return (outer conductor of coaxial cable), will be as follows for a control unit or device:

The minimum pulse amplitude at the receiving end is therefore 0.5V.

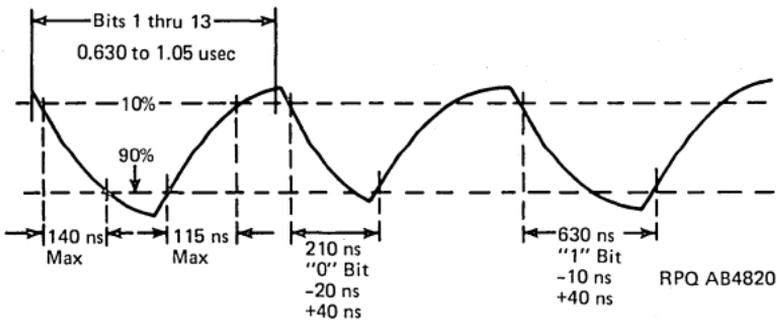
Bit timings from the device to the control unit will meet the same requirements as from control unit to device except for the bit rate. The bit rate from the device will be 630 ns minimum to 1.050 usec maximum per bit. The minimum duration of the "Up" level after crossing the 10% point going in the positive direction for a 1 or 0 bit until the start of the next consecutive bit will be 100 ns.

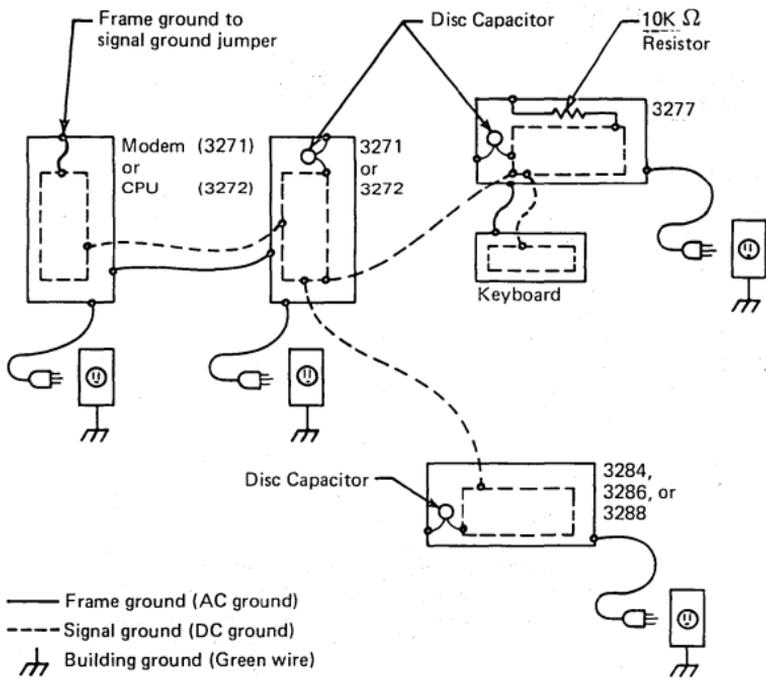
Figure 1-2. 3270 System Grounding

Signal ground and frame should be tied together only in the channel, external modem or modem cable. If these grounds are tied together at any other place, a ground loop condition can occur. The most common areas to find ground loops are in the keyboard (3277 ECA number 035 corrects this problem) and coaxial cable connections. Check for all ground loops while at the control unit by doing the following:

2. For devices, disconnect one coaxial cable at a time from the Control Unit and measure between the outer shield of the coaxial cable and frame ground of the control unit.

Device	Resistance
3277	7K to 10K ohms (min)
3284	Infinity (open circuit)
3286	Infinity (open circuit)
3288	Infinity (open circuit)

MISSING GROUNDS (Fig. 1-2)

GROUND LOOPS (Fig. 1-2)

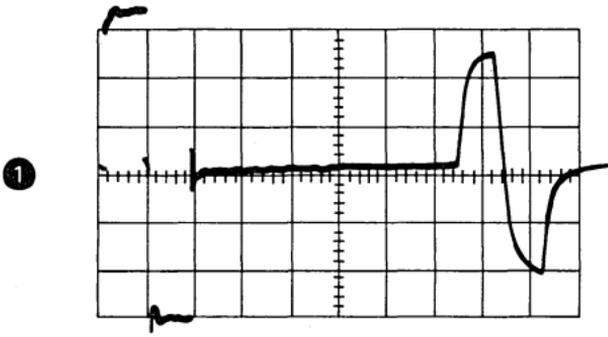
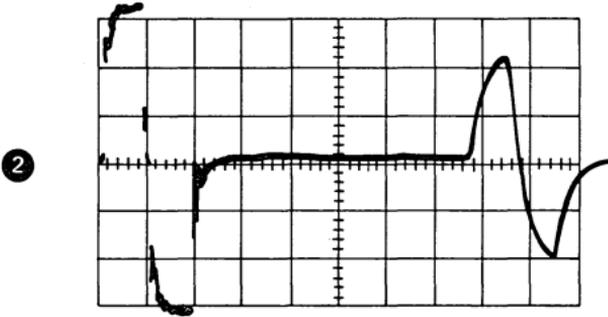
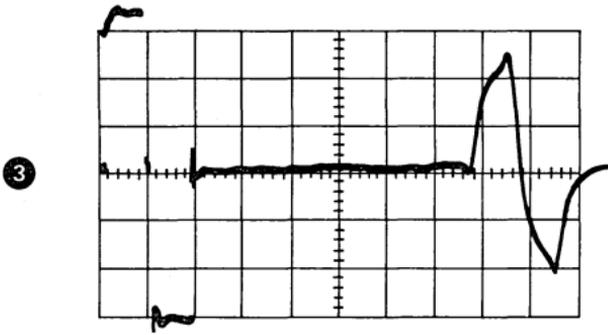
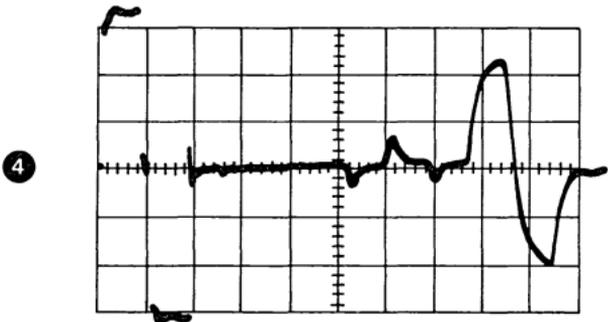
Figure 1-5. Waveforms of Various Cable Conditions

– Defective coax at beginning of 1500 ft (457 m).
-

– Defective coax at end of 1500 ft (457 m).
-

– Defective coax at approximately 1000 ft (305 m).

Note 2: Pictures shown are approximately 200 ft (61 m) per division.

Note 3: Pictures 2, 3 & 4 are only samples of defective cables.

1. Disconnect the coax cable being checked at both ends and leave unterminated.
2. Set counter test switch to off position.
3. Set mode switch to Bi Polar pulse.
4. Connect center conductor of coax to high side location on tester.
5. Connect shield to low side location on tester.
6. 453 scope settings should be as follows:
 - .5 usec time base
 - 1V per division
7. Probe center conductor at the 2790 tester end. Waveforms for various cable conditions (Figure 1-5) are as follows:

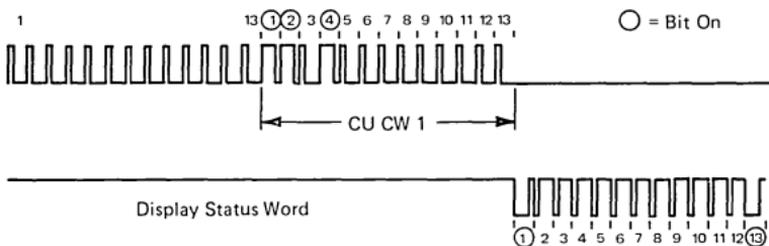
Oscilloscope Setup	3270 Unit Involved	Probed Pin	Word Shown On The Oscilloscope
Channel 1	3277	01A-A1G2J12	CU CW 1
Channel 2	3271	01A-A1N2S11	Display Status Word
Sync +			
Channel 1 Only			
5 μ sec/div			
5V/div

When operating the CLEAR, ENTER, PA, and PF keys, or using the light pen selector on a detectable field with immediate interrupt designator, the status of bits of the status word shown on channel 2 will vary according to related AID code.

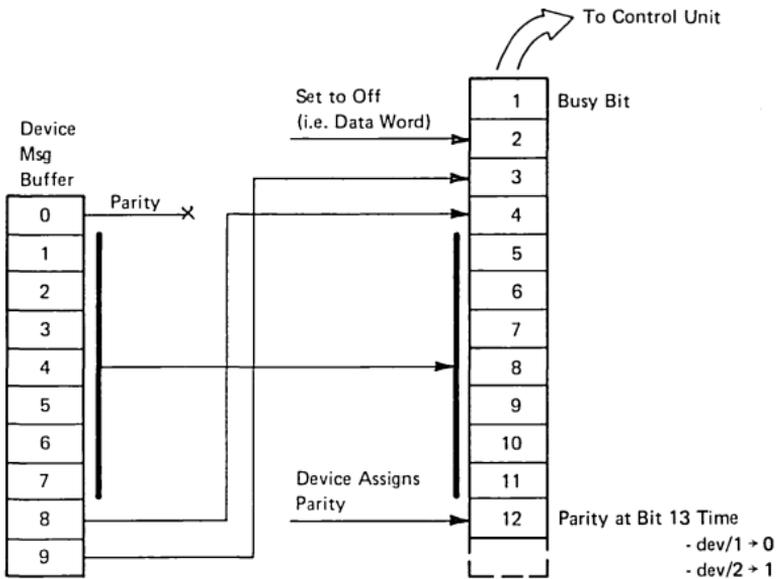
Figure 1-17. Device Buffer Transfer (Data Words) to Control Unit

Device SERDES is a 12 Position Shift Register

Message Buffer Bit Assignment (Figures 1-17 and 1-18)

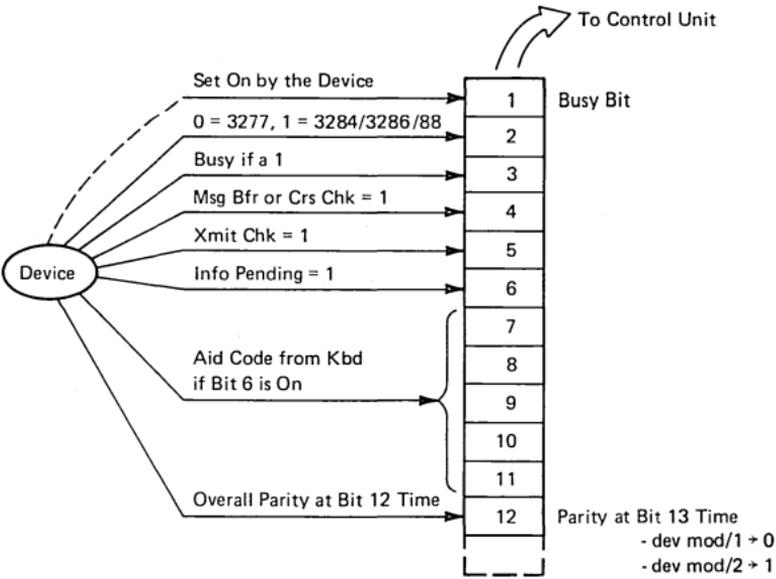
Figure 1-18. Status Word Sent by Device

Device SERDES is a 12-Position Shift Register

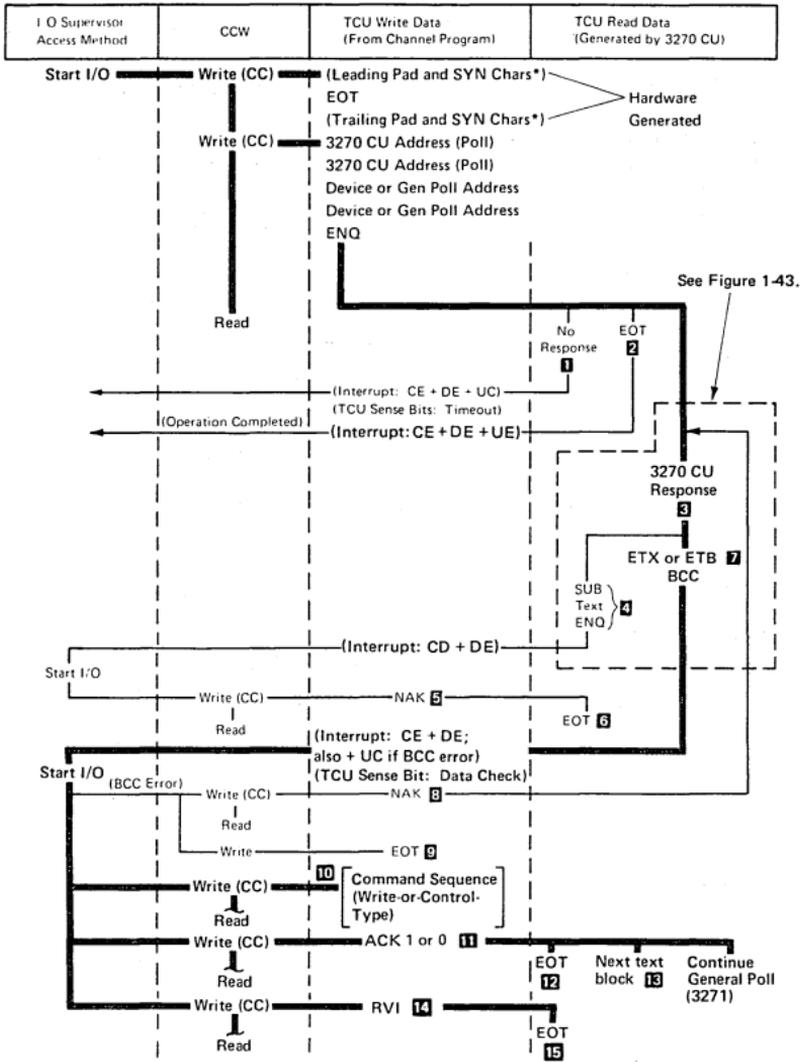
Figure 1-42 (Part 1 of 2). General Poll and Specific Poll, Sequence/Response Diagram

- 3** The device response is a function of the kind of device and its status. Types of responses include: Text, Status, and Test Request messages. (Refer to Figure 1-43.)

- 10** This transmission must be a write or control-type command sequence (described in Figure 1-45). A read-type command would violate BSC standards on Limited Conversational mode.

Figures 1-42 through 1-50 are sequence and response diagrams.

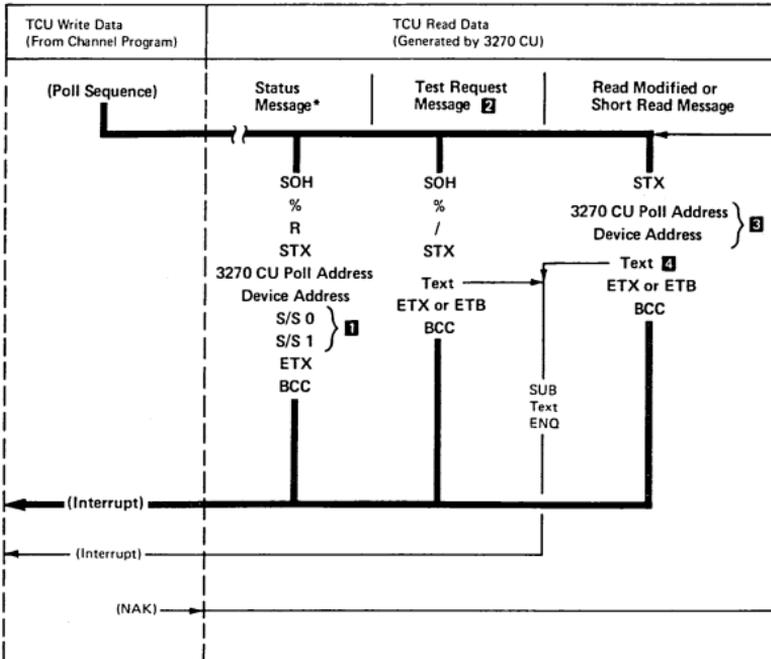
Figure 1-43 (Part 1 of 2). 3270 CU Message Response to Polling or Read Modified Command

*Response to General Poll or Specific Poll only (not program-generated Read Modified command)

- 11 A status message response is issued to a General or Specific Poll if (1) the 3270 CU has pending status (General Poll ignores Device Busy and device "unavailable" and, if 3271, continues polling of next device), or (2) if error status develops during execution of the poll. Status and Sense bit assignments are described in Figure 1-38.

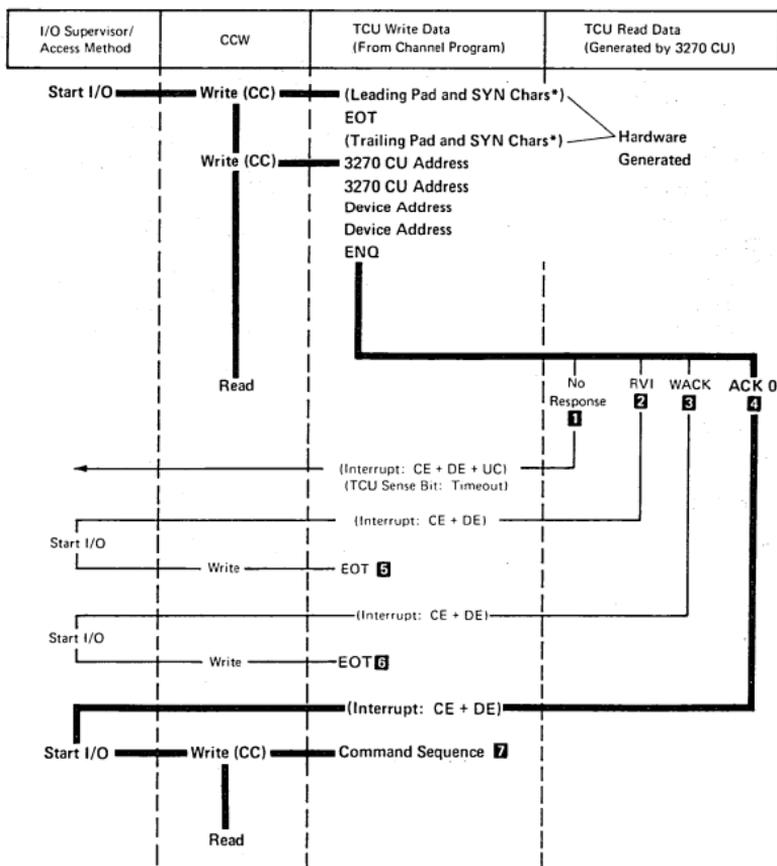
Figure 1-44 (Part 1 of 2). Selection Addressing, Sequence/Response Diagram

*Only the critical framing characters (sync pattern and pad) are shown. All other framing characters are also hardware-generated as required. See *SL General Information – Binary Synchronous Communications, GA27-3004*, for a complete description.

- 7** Refer to Figure 1-45 or 1-47 for the desired command sequence.

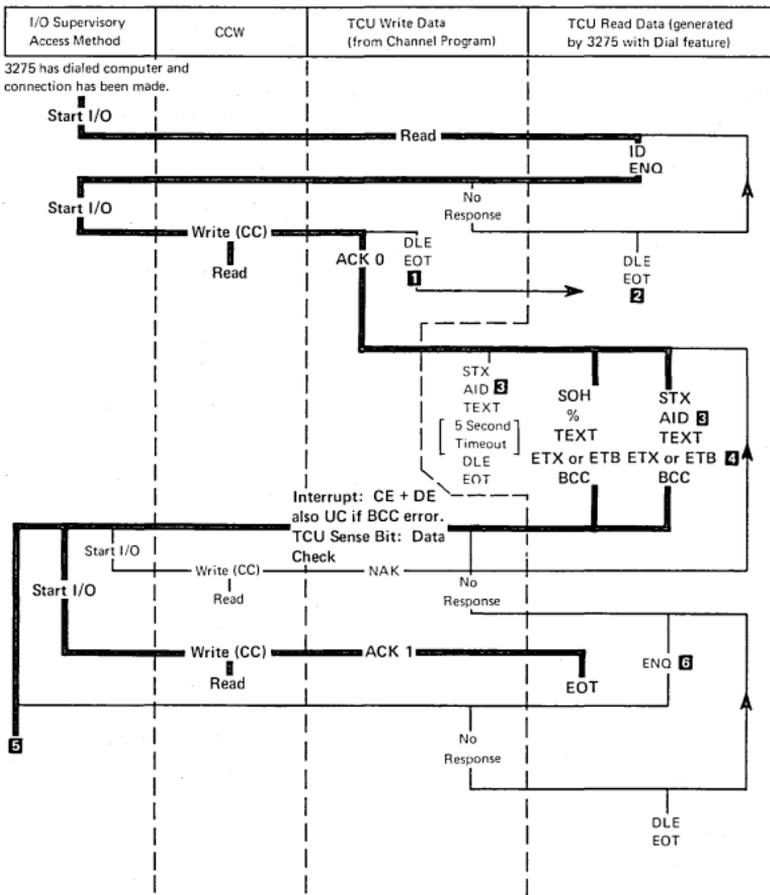
Figure 1-47 (Part 1 of 2). 3275-Initiated Transmission, Sequence/Response Diagram – Dial Feature

- 1** Upon correct reception of an invalid terminal ID, the computer disconnects. The TCU may optionally send DLE EOT before disconnecting. This is defined in the BSC rules as an "unusual termination".
- 2** The 3275 retries three times. When the number of retries is exhausted, the 3275 sends DLE EOT.
- 3** AID indicates which situation caused attention.
- 4** ETB is used to frame each block of a blocked text message, except the last block. ETX is used to frame the last block of a blocked text message.
- 5** The remainder of this sequence/response diagram is the same as that for a General or Specific Poll, as shown in Figure 1-42.
- 6** The 3275 as the master station solicits a response by sending ENQ. After the number of retries is exhausted, the 3275 acts as described in Note 2.

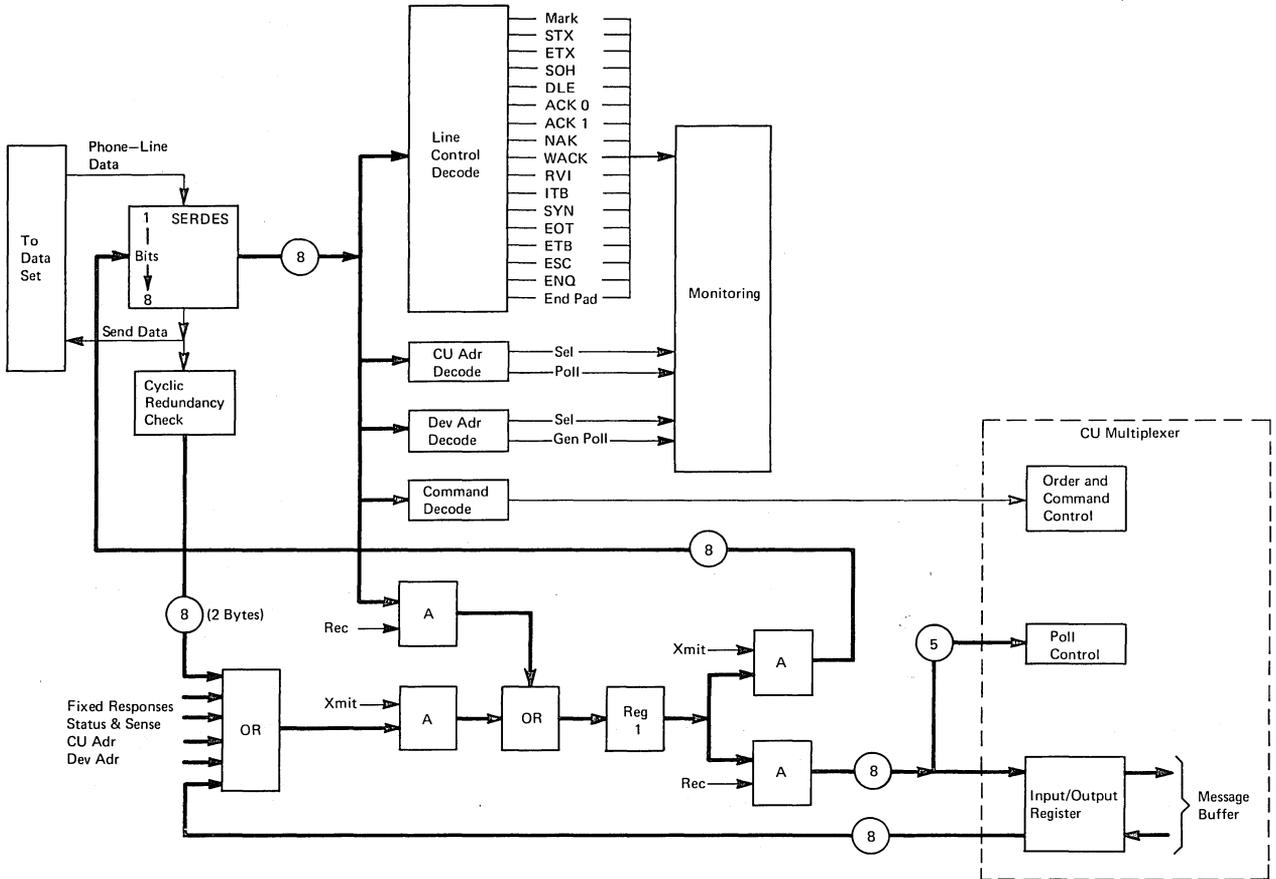
Figure 2-1 (Part 1 of 4). 3271 CU Functional Block Diagram

A. Data Flow of Remote Interface Portion

Figures 2-1 and 2-2 give the locations for the 3271 Control Unit.

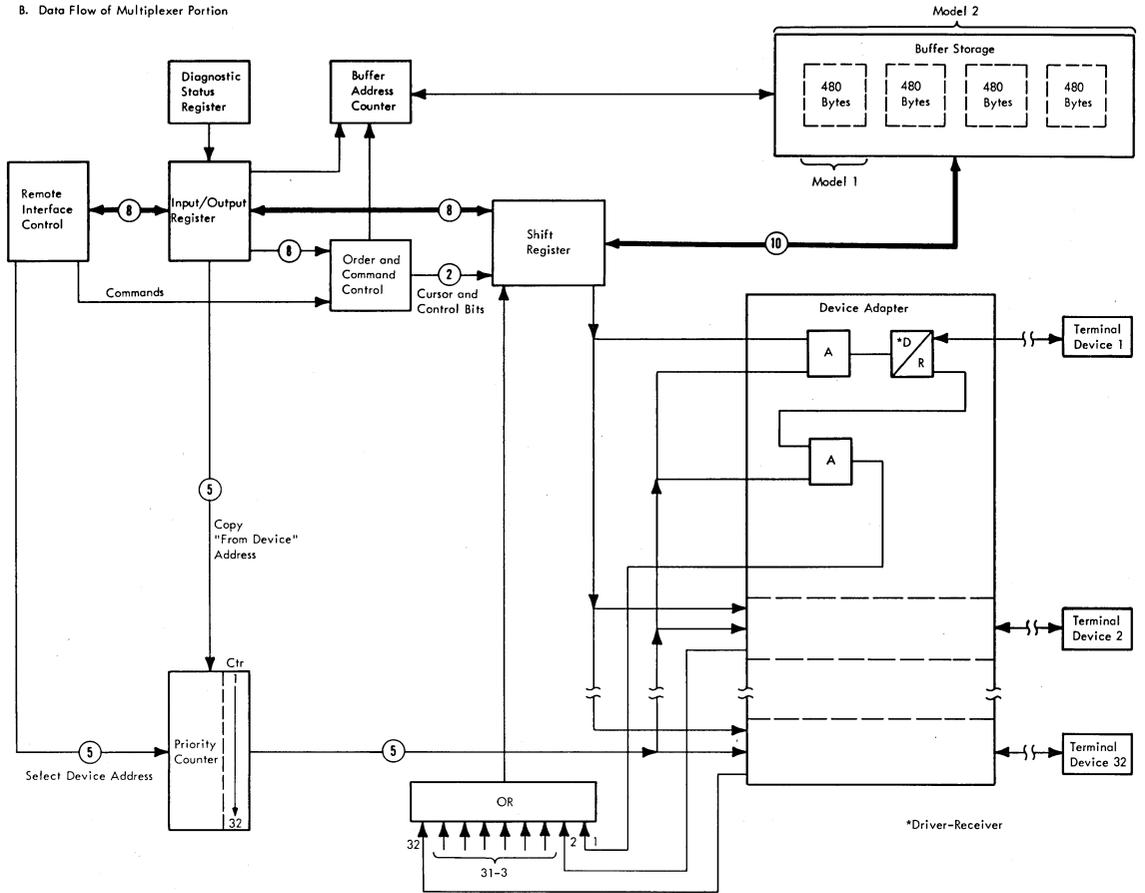
Figure 2-1 (Part 2 of 4), 3271 CU Functional Block Diagram

B. Data Flow of Multiplexer Portion

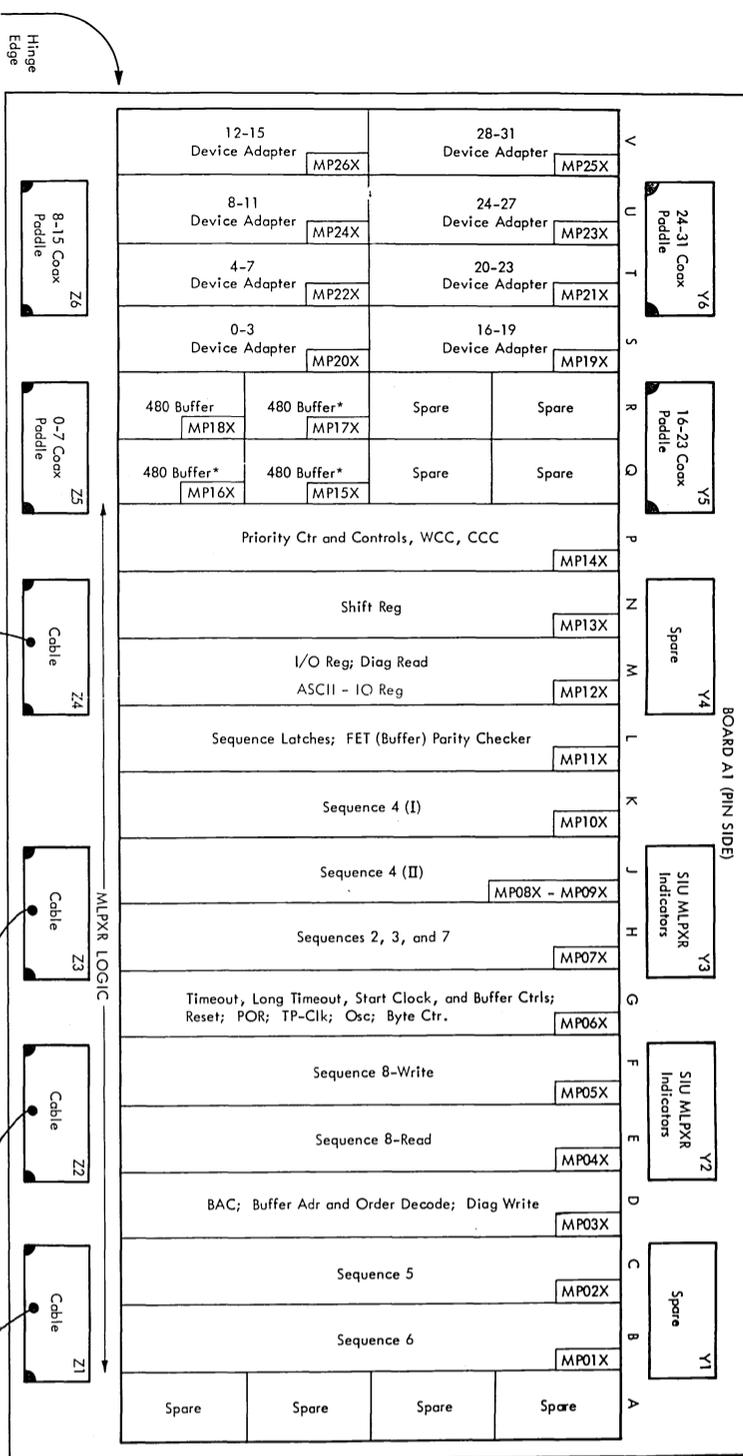
Figure 2-2. 3271 A-Gate Card Layout by Function

1. Number in parentheses is card type.
2. MP = MLPXR (multiplexer) ALD's.
3. ER = Remote Interface ALD's.

[Symbol] = Plugged on pin side

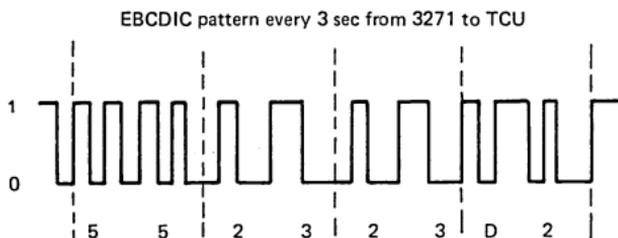
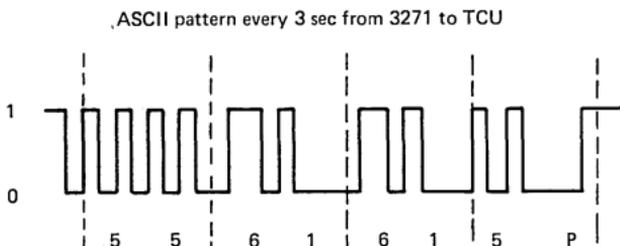
7. Scoping can now be performed at the TCU for the correct enquiry sequence from the 3271. Examples of scoping patterns are shown below:

Note 1: Data bytes appear to be reversed. This is normal because of the shifting of the SERDES shift register in the 3271 Control Unit.

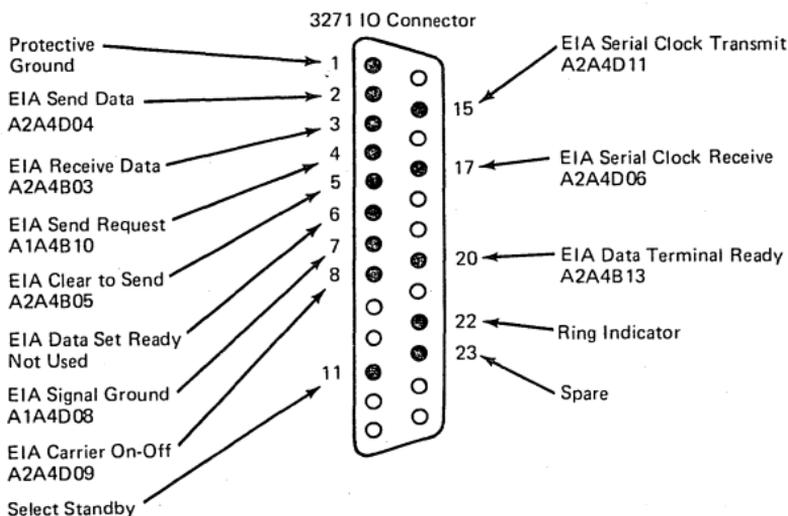
25-Pin Connector Mounted on 3271

EIA Line Name	EIA Pin No.	3271 Pin No.
Protective Ground	1	
Transmit Data	2	B2D02
Receive Data	3	B2M10
Request to Send	4	B2B02
Clear to Send	5	B2B09
Data Set Ready	6	Not Used
Signal Ground	7	B2D08
Carrier Detect	8	B2U04
Serial Clock Transmit	15	B2S08
Serial Clock Receive	17	B2M12
Data Terminal Ready	20	B2B13

Note: Signals from data set to 3271 measure +3V to +25V for up level and -3V to -25V for down level. Signals to data set from 3271 measure +3V to +8V for up level and -3V to -12V for down level.

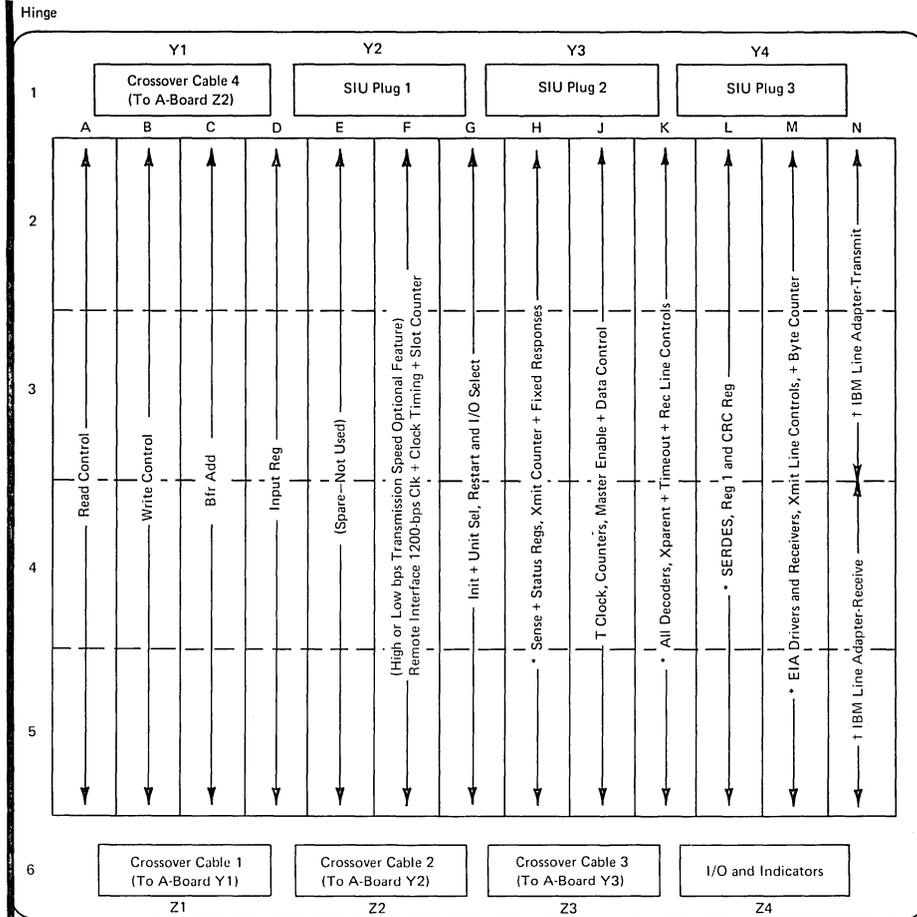
Figure 4-6. 3275 A-Gate Card Layout by Function (Display)

Model 1 Cards
 D2-480 Stor + Gate
 F2-Spare (Not Used)
 K2-Line Buffer and Char Gen

Legend:
 † When a magnetic card reader is attached, the keyboard cable plugs into socket Z4.

- A-Gate Card Layout by Function, Display (Fig. 4-6) 4-12
- A-Gate Card Layout by Function, Model 3 (Fig. 4-8) 4-14
- B-Gate Card Layout by Function, Dial (Fig. 4-10) 4-16
- B-Gate Card Layout by Function, Leased (Fig. 4-7) 4-13
- B-Gate Card Layout by Function, Model 3 (Fig. 4-9) 4-15
- Card Substitution List 4-17
- Display Data Flow (Fig. 4-1) 4-7
- EC Cross-Reference 4-23
- EIA Connections 4-34
- Initiated Transmission, Sequence/Response Diagram, Dial Feature (Fig. 1-47) 1-80
- Remote Commands 1-43
- Remote Interface and Control Unit Data Flow (Dial), ASCII (Fig. 4-5) 4-11
- Remote Interface and Control Unit Data Flow (Dial), EBCDIC (Fig. 4-4) 4-10
- Remote Interface and Control Unit Data Flow (Leased Line), ASCII (Fig. 4-2) 4-8
- Remote Interface and Control Unit Data Flow (Leased Line), EBCDIC (Fig. 4-3) 4-9
- Service Aids 4-30
- Symptom Fix List 4-3

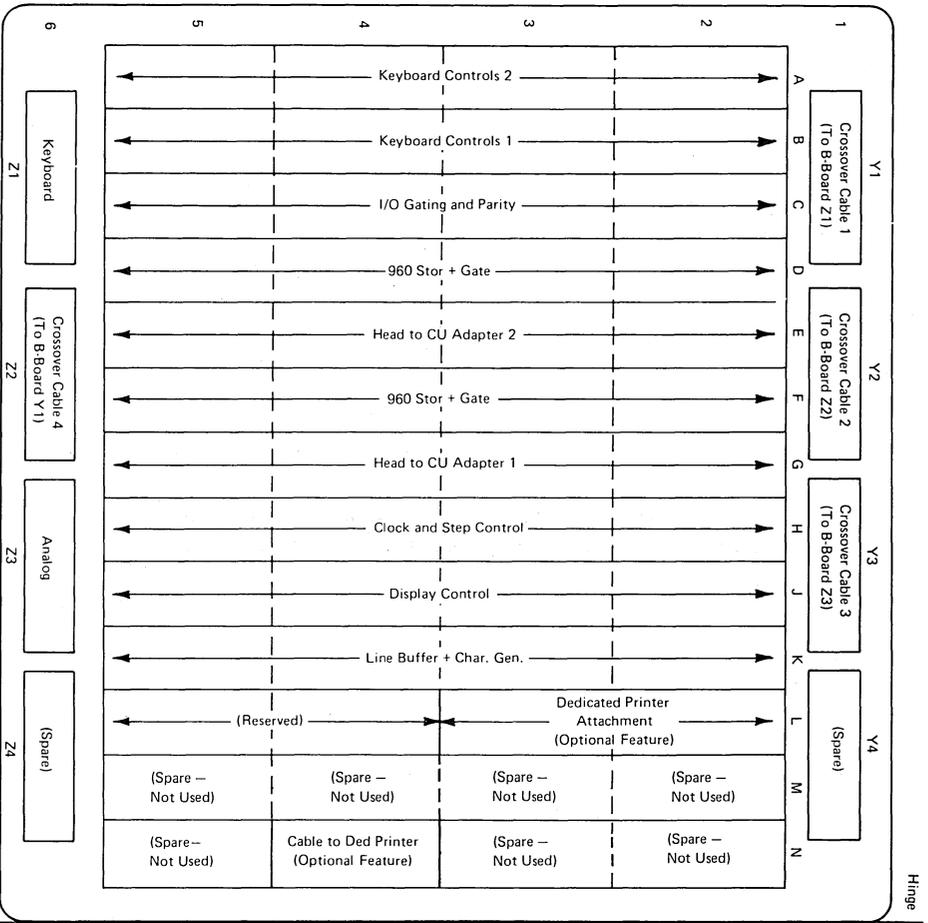
Figure 4-7. 3275 B-Gate Card Layout by Function (Leased)

† Locations N2 and N4 are empty when Line Adapter feature is not installed.

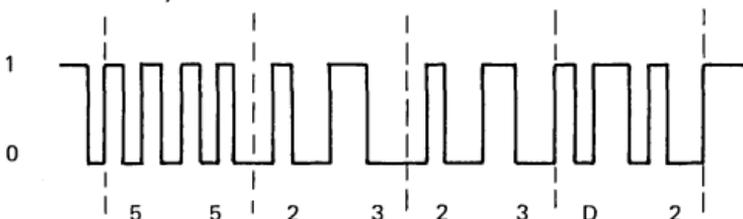
EBCDIC Pattern every 3 sec from 3275 to TCU

1. Data bytes appear to be reversed. This is normal because of the shifting of the SERDES shift register in the 3275.
2. SCOPE Timings
 - 1200-bps Rate - 5 ms/div
 - 2000-
 - 2400-bps Rate - 2 ms/div
 - 4800-bps Rate - 1 ms/div
 - 7200-bps Rate - .5 ms/div

6. Place SIU on/line off/line switch to on/line. The 3275 will now send the enquiry sequence down line to the TCU at the system site every 3 seconds if the timeout override switch on the SIU is placed in the NORMAL position.
7. Scoping can now be performed at the TCU (Receive data) for the correct enquiry sequence from the 3275.
8. For continuous uninterrupted transmission, jumper 01B-A1M2J13 to ground (D08).

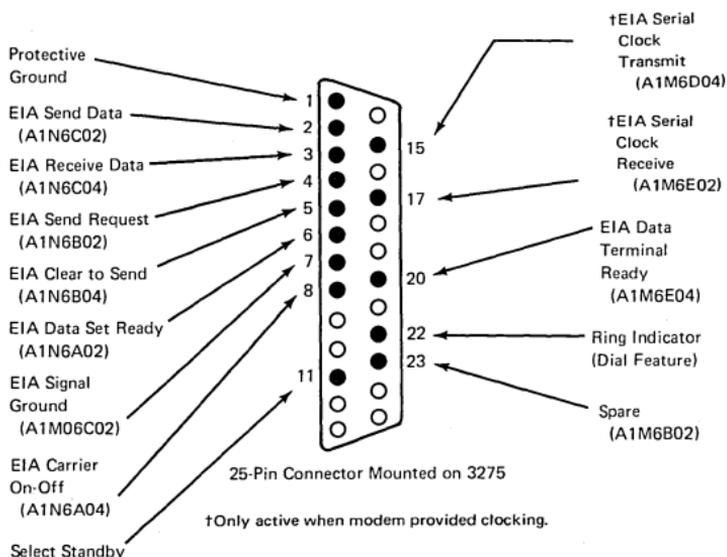
EIA Line Name	EIA Pin No.	3275 Leased Pin No.
Protective Ground	1	"Pigtail to frame ground from cable connector
Transmit Data	2	01B-M2D02
Receive Data	3	01B-M2M10
Request to Send	4	01B-M2B02
Clear to Send	5	01B-M2B09
Data Set Ready	6	Only used on Dial Feature
Signal Ground	7	01B-M2D08
Carrier Detect	8	01B-M2U04
Serial Clock Transmit	15	01B-M2S08
Serial Clock Receive	17	01B-M2M12
Data Terminal Ready	20	01B-M2B13
Ring Indicator	22	Only used on Dial Feature

Note: Signals from data set to 3275 measure +3V to +25V for up level and -3V to -25V for down level. Signals to data set for 3275 measure +3V to +8V for up level and -3V to -12V for down level.

Protective ground pin 1 does not pick up ground from 3270. Ground is the cable shield and is clamped to the 3270.

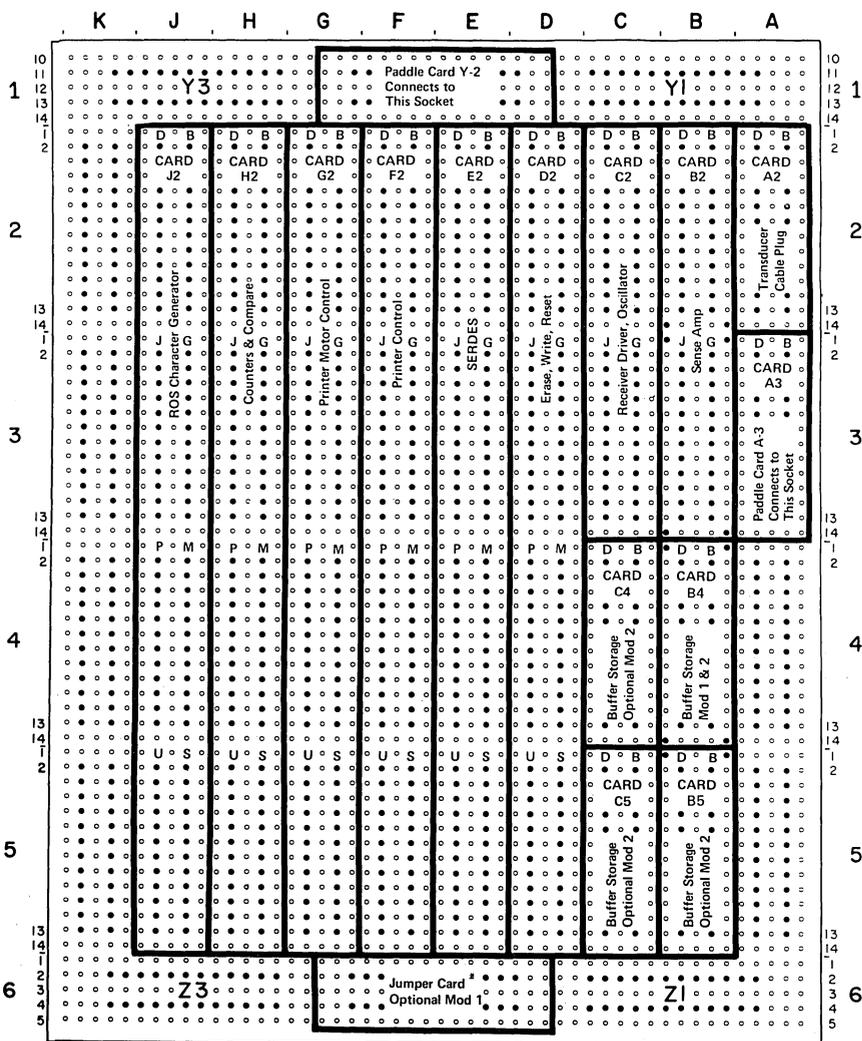
Figure 6-2. 3284/3286 Model 1 and 2 A-Gate Card Layout by Function

1/2 Board Card Layout (Pin Side)

* Jumper Card requires no external wiring.

Figures 6-1 through 6-7 give the locations for the 3284/3286 Printer.

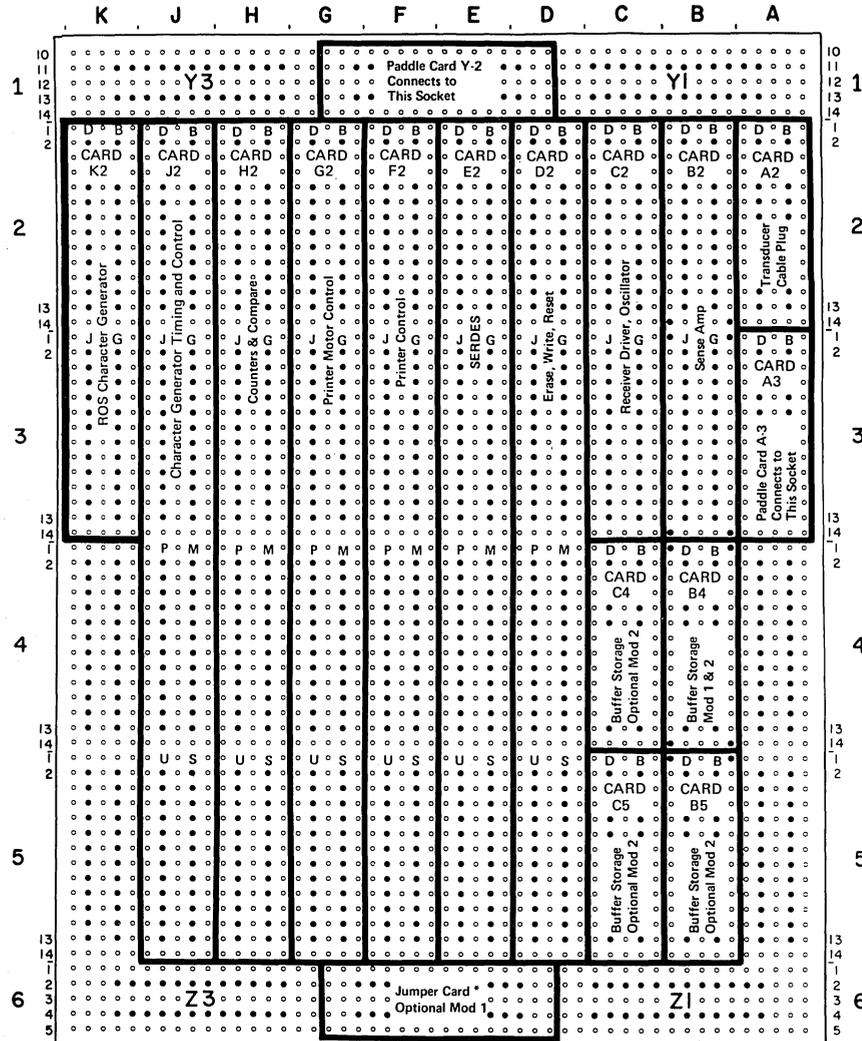
Figure 6-3. 3284/3286 Model 1 and 2 A-Gate Card Layout by Function - Dual Case

* Jumper Card requires no external wiring.

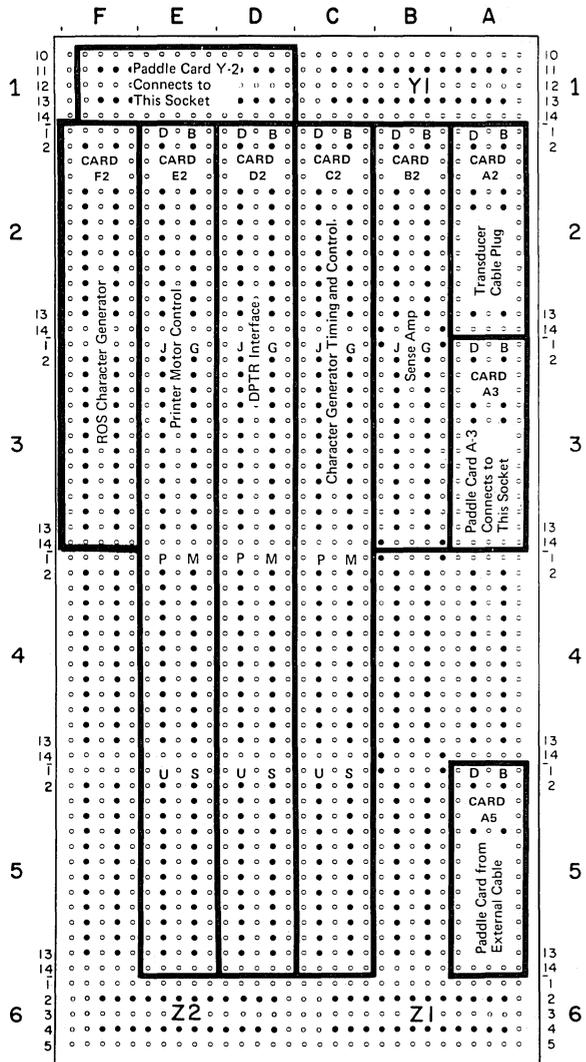
Figure 6-6. 3284/3286 Model 3 A-Gate Card Layout by Function – Dual Case

1/3 Board Card Layout (Pin Side)

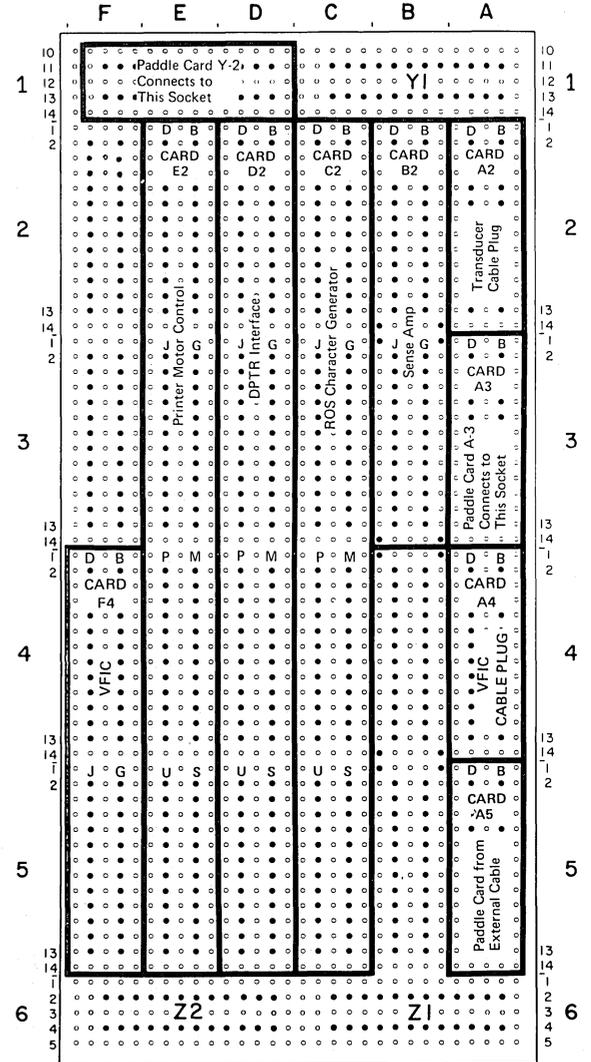
Figure 6-7. 3284/3286 Model 3 A-Gate Card Layout by Function – VFIC

1/3 Board Card Layout (Pin Side)

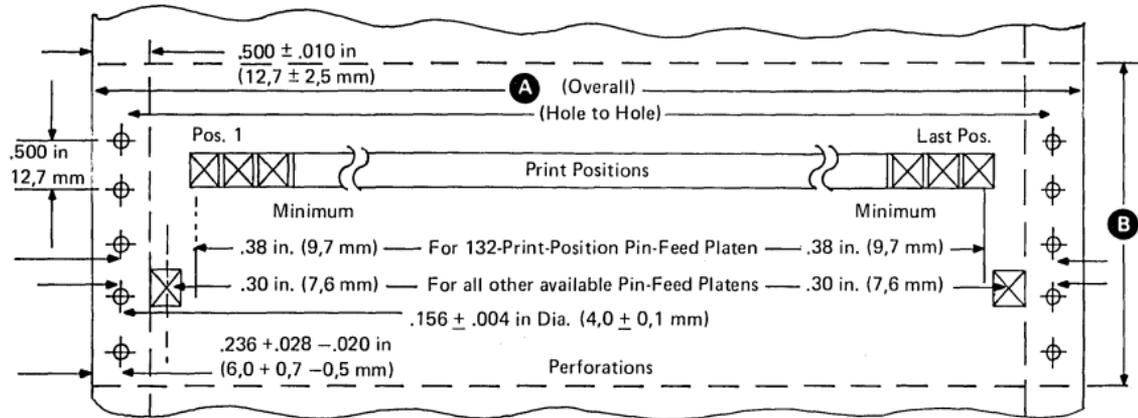
Figure 6-12 (Part 1 of 2). Forms Specifications

A Form Width

Model	Maximum Width			Minimum Width		
	Print Positions	Overall	Hole to Hole	Print Positions	Overall	Hole to Hole
3284, 3286	132	14.375 in. (365.1 mm)	13.875 in. (352, 4 mm)	120	13 in. (330,2 mm)	12.5 in. (317,5 mm)

12. Forms jamming may also be due to out-of-specification forms. Refer to Figure 6-12 for form specifications or to the *Forms Design Reference Manual*, GA24-3488.

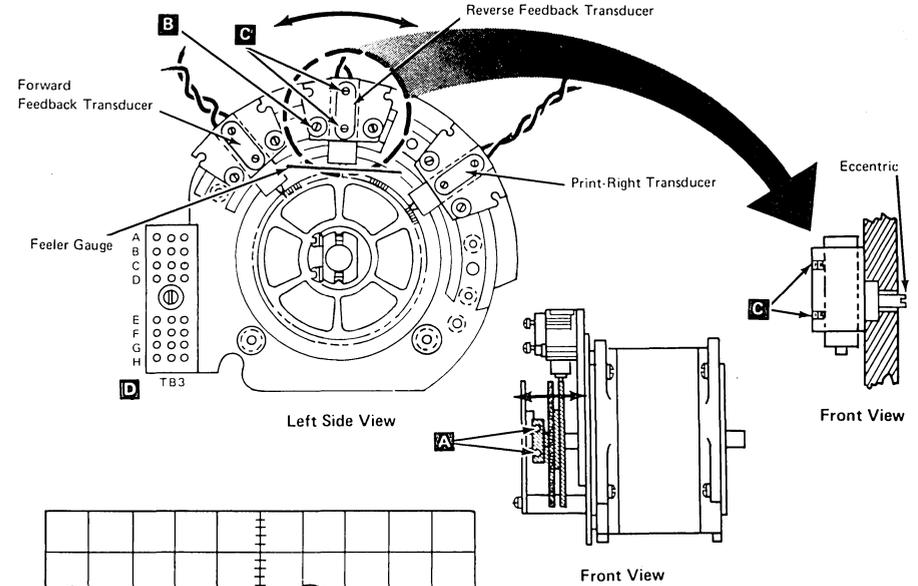
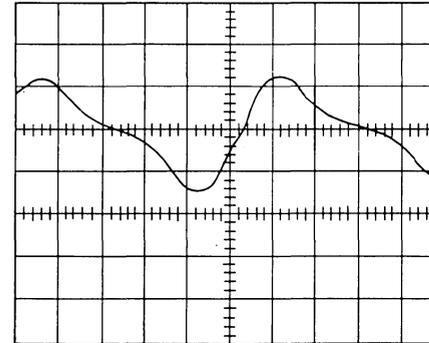
E Typical Transducer Output at TB3

One Cycle: 2.0 ms (3284)
1.2 ms (3286)
Volts/Division: 1V
Mode Channel: -1
Sync: Internal Coupling DC, Slope Plus
Source: Internal Channel 1 only.

Figure 6-13 gives the complete procedure for the preferred alternative adjustments of the transducer.

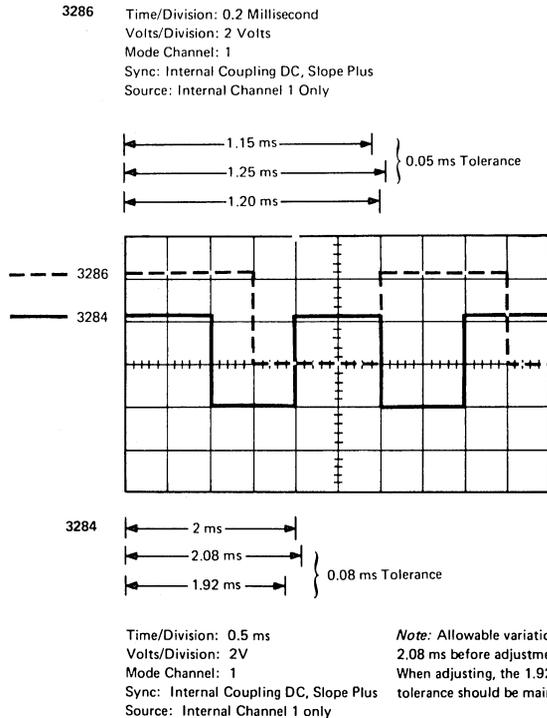
Figure 6-13 (Part 2 of 3). 3284/3286 Transducer-Adjustment Procedure

A Typical Speed Adjustment Trace

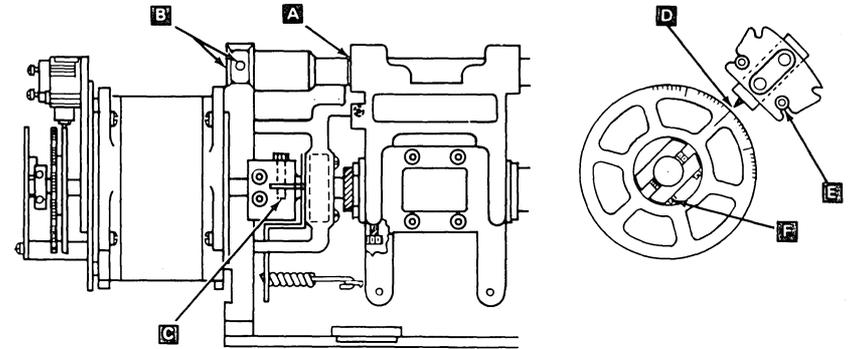
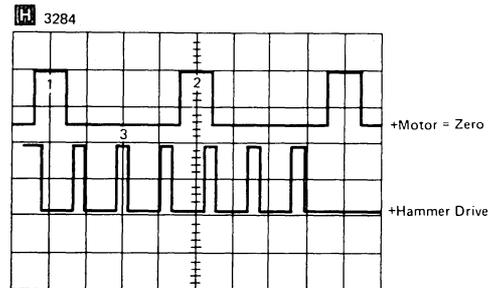
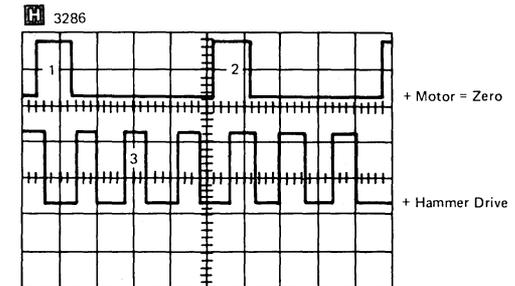
Figure 6-13 (Part 3 of 3). 3284/3286 Transducer-Adjustment Procedure

10. Jumper pin A1G2B06 to A1G2D08 Models 1 and 2, A1E2B06 to A1E2D08 Model 3 (-Slow Down Switch).
11. Connect pin A1J3B02 Models 1 and 2, A1C3B02 Model 3, to the "External Trigger Input" plug of the scope.
12. Sync the scope on a negative-going signal.
13. Look at the "+Motor is Equal to Zero" signal at pin A1G3D05 Models 1 and 2, A1E3D05 Model 3, with scope channel number 1.
14. Look at the "+Hammer Drive" pulses at pin A1J5B07 Models 1 and 2, A1C5B07 Model 3, with scope channel number 2.
15. Loosen the two mounting screws on the Print Right Transducer, and adjust the eccentric so that the third "Hammer Drive" pulse is centered between the first two "Motor Equal to Zero" pulses **H**.
16. Replace the emitter cover (2 screws).
17. Check margin switch adjustment (6.5.4 in MLTG).

Time/Division: 2.0 ms (3284)
Volts/Division: 2V
Mode Channel: Alternate
Sync: External Trigger
Negative Slope

Time/Division: 1.0 ms
Volts/Division: 2V
Mode Channel: Alternate
Sync: External Trigger, Negative Slope

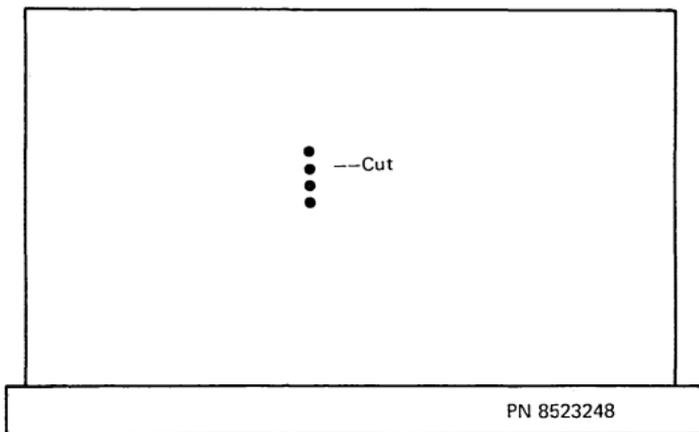
Hold the card with the shroud down and the component side facing you, then cut off the second pin from the top.

Card Location:
Models 1 and 2 A1G2
Model 3 A1E2

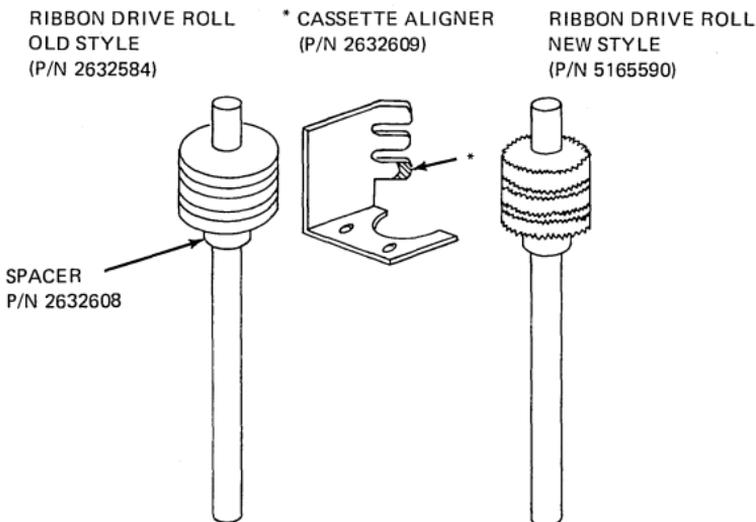
1. Remove the cassette aligner (PN 2632609), the ribbon drive roll (PN 2632584), and the spacer (PN 2632608). Scrap locally.
2. Install new cassette aligner (PN 2632609). Mount aligner flush with shoulder on mounting plate.
3. Install new ribbon drive roll assembly (PN 5165590). Adjust collar for minimum end play without binding.

* The cross-sectioned portion of the aligner has been removed on current level and only the current level aligner should be used with the new style drive roll.

1. Remove the cassette aligner (PN 2632609), the ribbon drive roll (PN 2632584), and the spacer (PN 2632608). Scrap locally.
2. Install new cassette aligner (PN 2632609). Mount aligner flush with shoulder on mounting plate.
3. Install new ribbon drive roll assembly (PN 5165590). Adjust collar for minimum end play without binding.

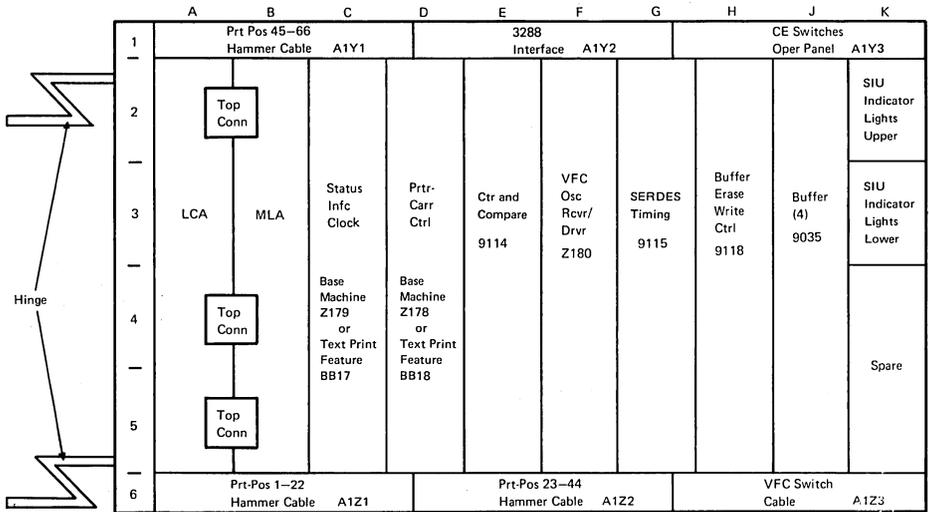
Figure 7-2. 3288 A-Gate Card Layout by Function

Logic Gate Front View Card Side

Logic Board
P/N 1657198

Figures 7-1 through 7-6 give the locations for the 3288 Line Printer.

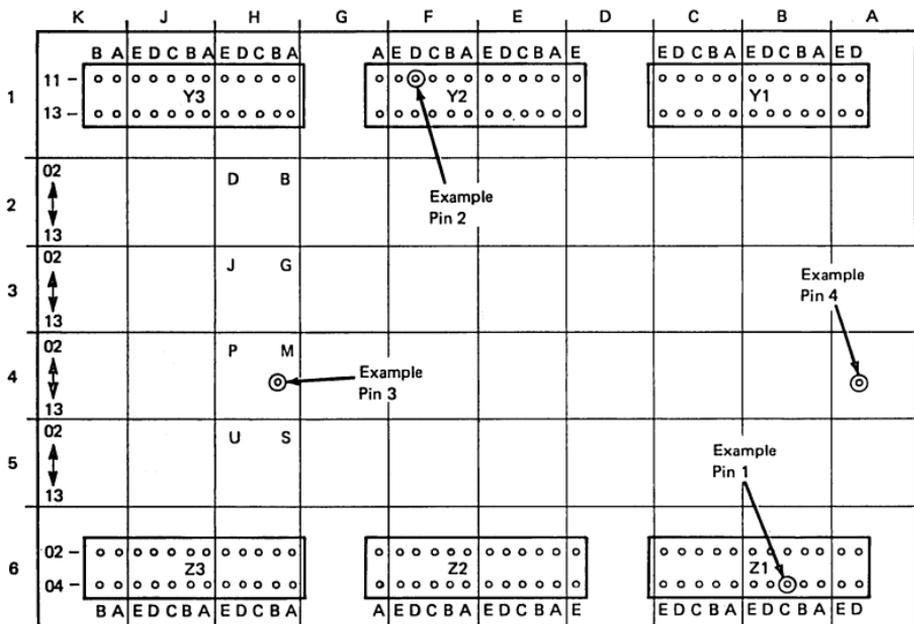
Logic Board Pin Layout
Pin Side

- Examples: Pin 1 ⇒ B6C04
 Pin 2 ⇒ F1D11
 Pin 3 ⇒ H4M06
 Pin 4 ⇒ A4D07
