**Maintenance
Handbook**

**IBM 3270 Information
Display System**

**IBM 3271 Control Unit
IBM 3272 Control Unit
IBM 3275 Display Station
IBM 3277 Display Station
IBM 3284 Printer
IBM 3286 Printer
IBM 3288 Line Printer**

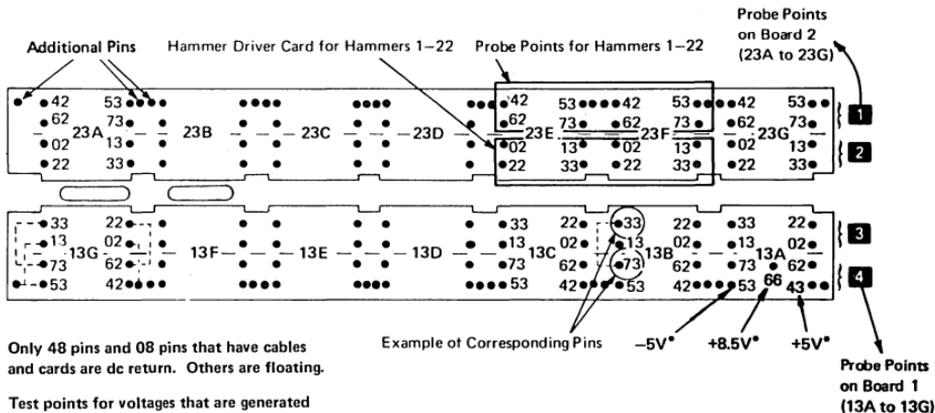
Figure 7-4. Printer Card Gate Layout

To determine a probe pin when given a signal pin, add 40 to the signal pin.

Example: Signal 13C06 - Probe 13C46.

Figures 7-1 through 7-6 give the locations for the 3288 Line Printer.

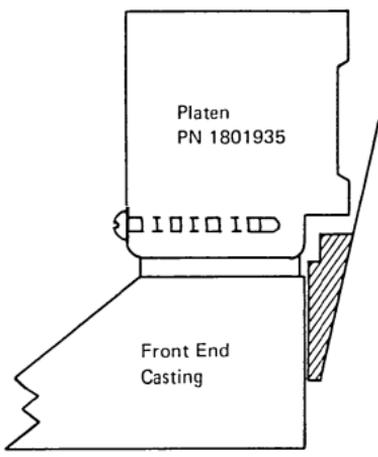
Guide Bearings
 Smooth PN 1821358
 Grooved PN 1800540

Shield
 PN 1794711

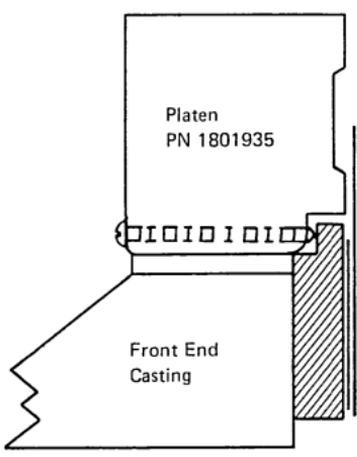
Guide Bearings
 Smooth PN 1794748
 Grooved PN 1794805

Shield
 PN 1794752

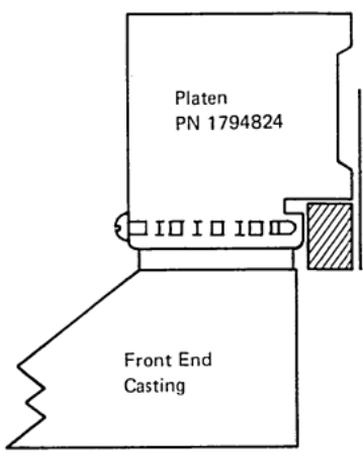
Guide Bearings
 Smooth PN 1794748

Shield
 PN 1794856

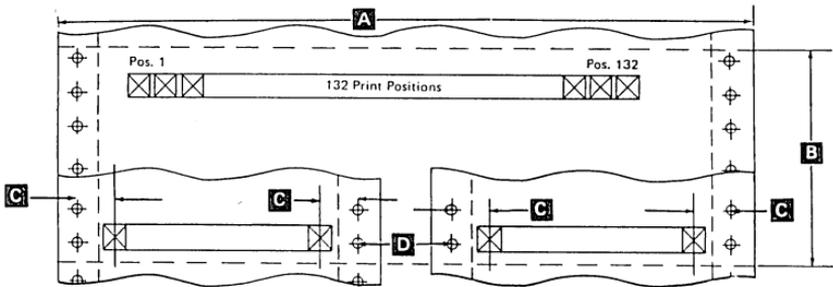
Figure 7-12. Overall Forms Dimensions

- | | Maximum | Minimum |

| A Form Width (Single- or Dual-Feed Carriage) | 15 in. (381 mm) See Note 10 | 3.5 in. (89.9 mm) |

Figure 7-12 gives the overall forms dimensions.

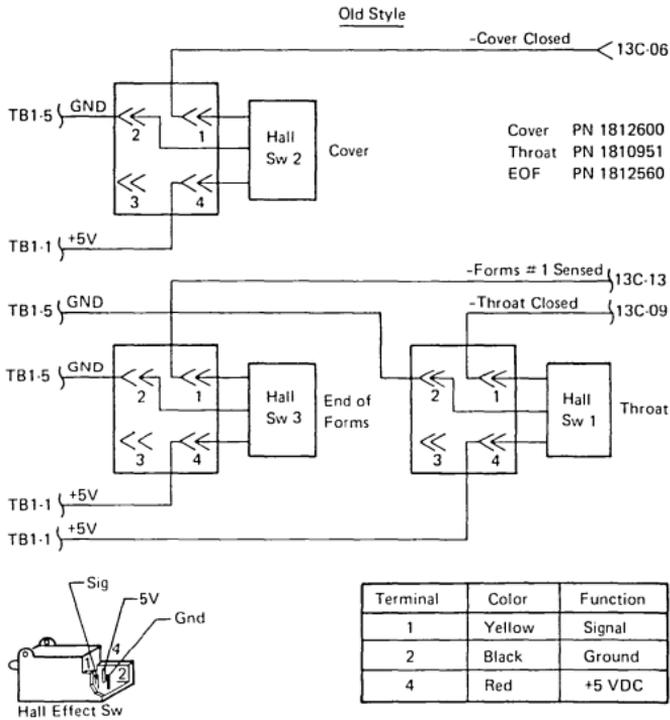
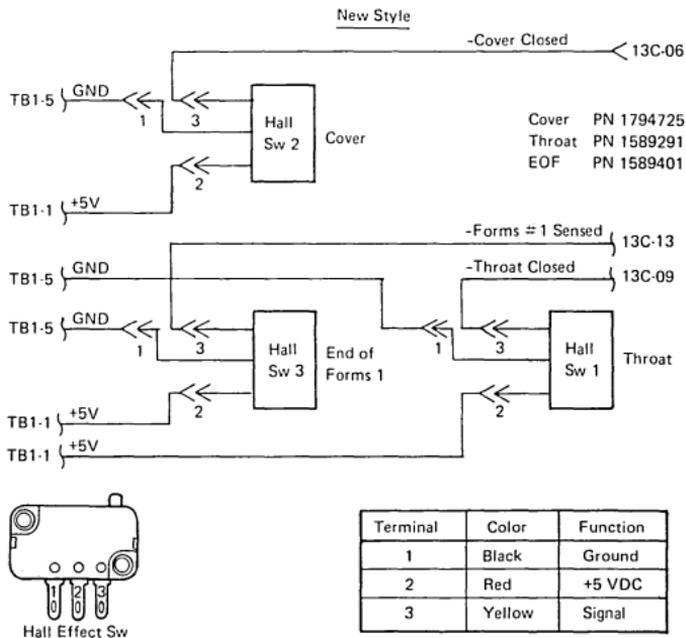
Figure 7-13. Cover/End of Forms/Throat (Hall Effect) Switches

Note: The old style and new style switches are not interchangeable.

Note: The cover interlock switch should be checked on each service call to verify that the belt stops when the cover is open.

Figure 7-13 illustrates the old and new style Hall Effect switches.

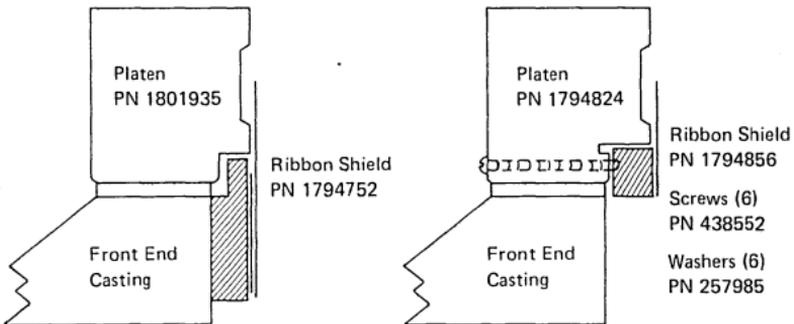
Figure 7-14. Platen/Ribbon Shield Assemblies

Forms jams and/or belt speed checks may be caused by a ribbon shield with an incorrectly formed metal guide. This can be detected by viewing the thin metal guide of the shield from the end. Good shields have a metal guide with a 7-degree bend that brings the guide to a vertical plane. Defective shields do not have a bend and cause interference with the paper (high drag through the throat area) and underscoring of characters on the last part of multipart forms. (See Figure 7-14.)

PN 1794711 is now obsolete. If you have a problem in this area, order the following: Gauge kit, B/M 1815365, is required when initially installing the new shield. See par. 6.33 of the MLTG, Form SY27-2401-2, or higher, for instructions on the use of the gauge kit.

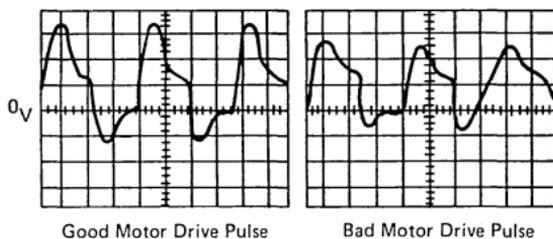
Figure 7-15. Print Belt Motor Drive Pulses

Dynamic Test: An oscilloscope can be used to provide an indication of correct stepper motor and belt operation. The scope pictured below (Figure 7-15) shows examples of good and bad drive pulses at the P-4 connector with the motor running. The P-4 connector has six positions. The four motor drive pulses can be obtained on the two double black and the two double yellow wires located on the P-4 connector.

Waveshape, as well as amplitude, can be an indication of a problem.

Scope setup: All pictures taken with a times 10 probe. Voltage: 2V/Div; Time: 1MS/Div; Trigger: Internal plus DC Input; Chan 1: Motor Drive Pulse (measured at P-4 connector).

C3 and C4 are located at the rear behind the electronics gate, or on the right side frame. C3 and C4 are 3 mfd. See diagram 8-19 in the MLTG for motor drive circuit.

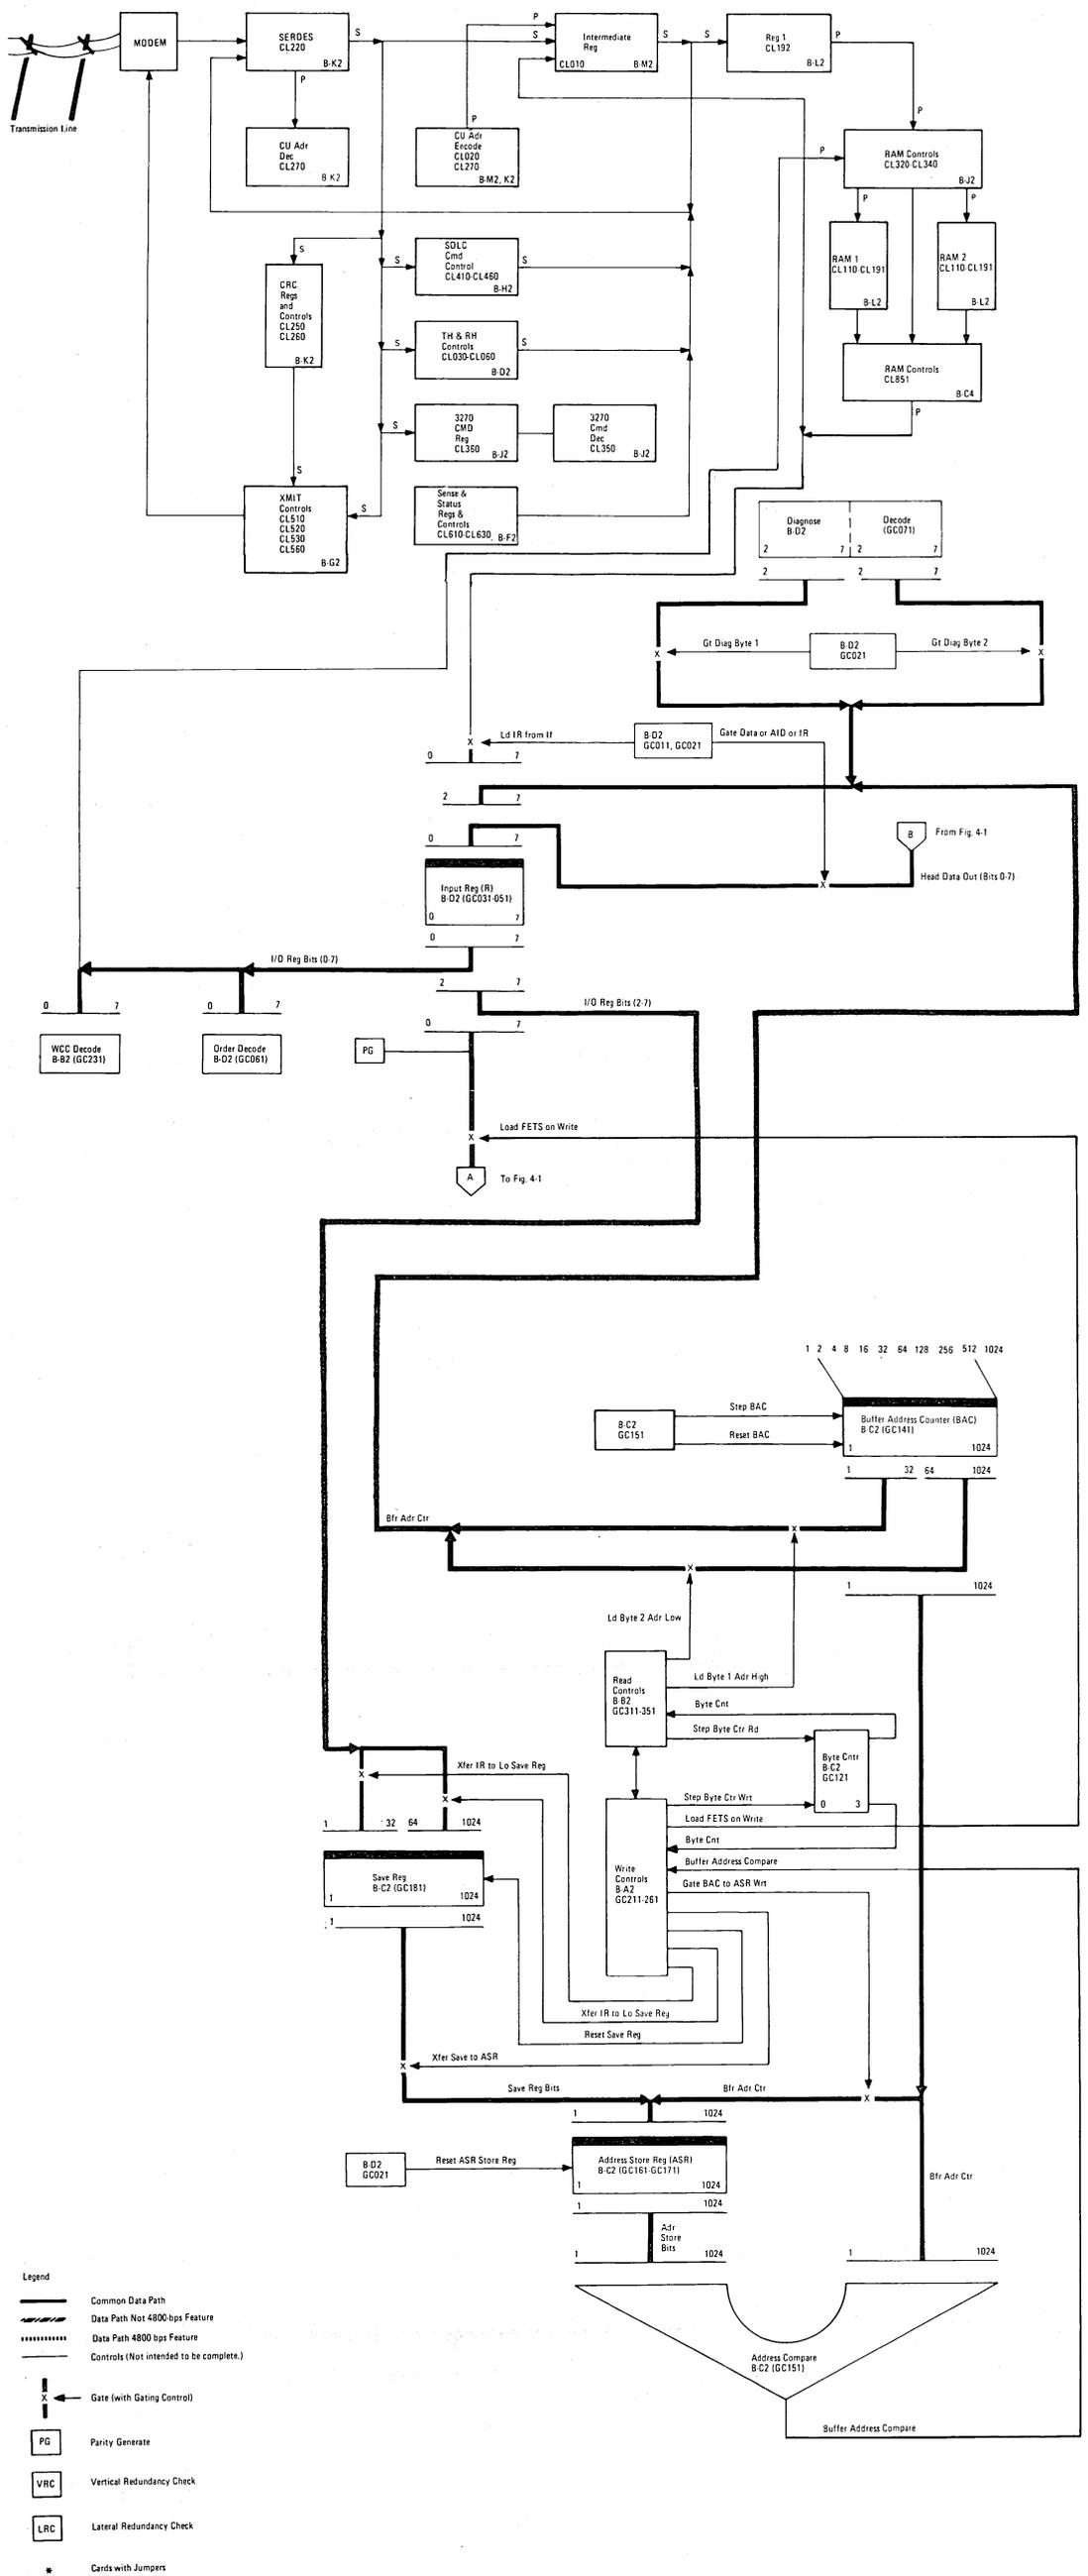
Figure 8-3. 3275 Model 11 and 12 Remote Interface and Control Unit Data Flow - EBCDIC

S = Serial data flow.
P = Parallel data flow.

See Figures 8-2 through 8-19.

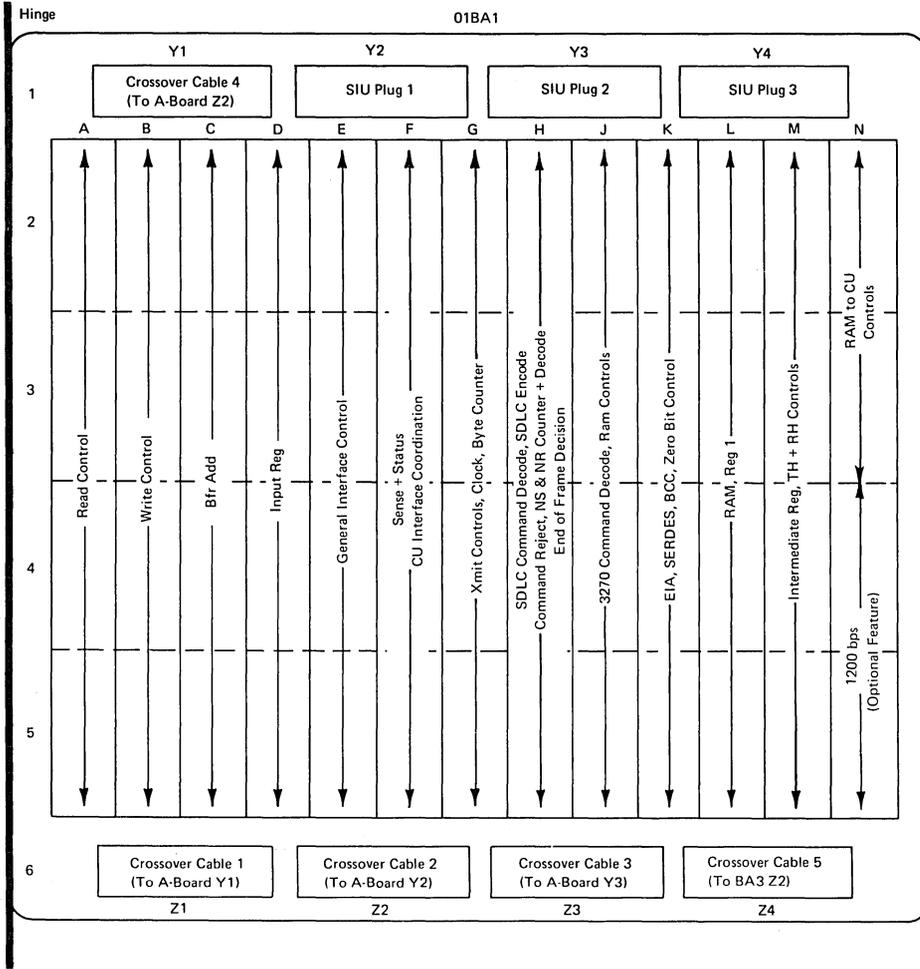
Figure 8-5. 3275 Model 11 and 12 Card Layout by Function – B-Gate

Note: When Integrated Modem feature is not installed, crossover cable 5 is removed and BA1Z4 is used for I/O and indicators.

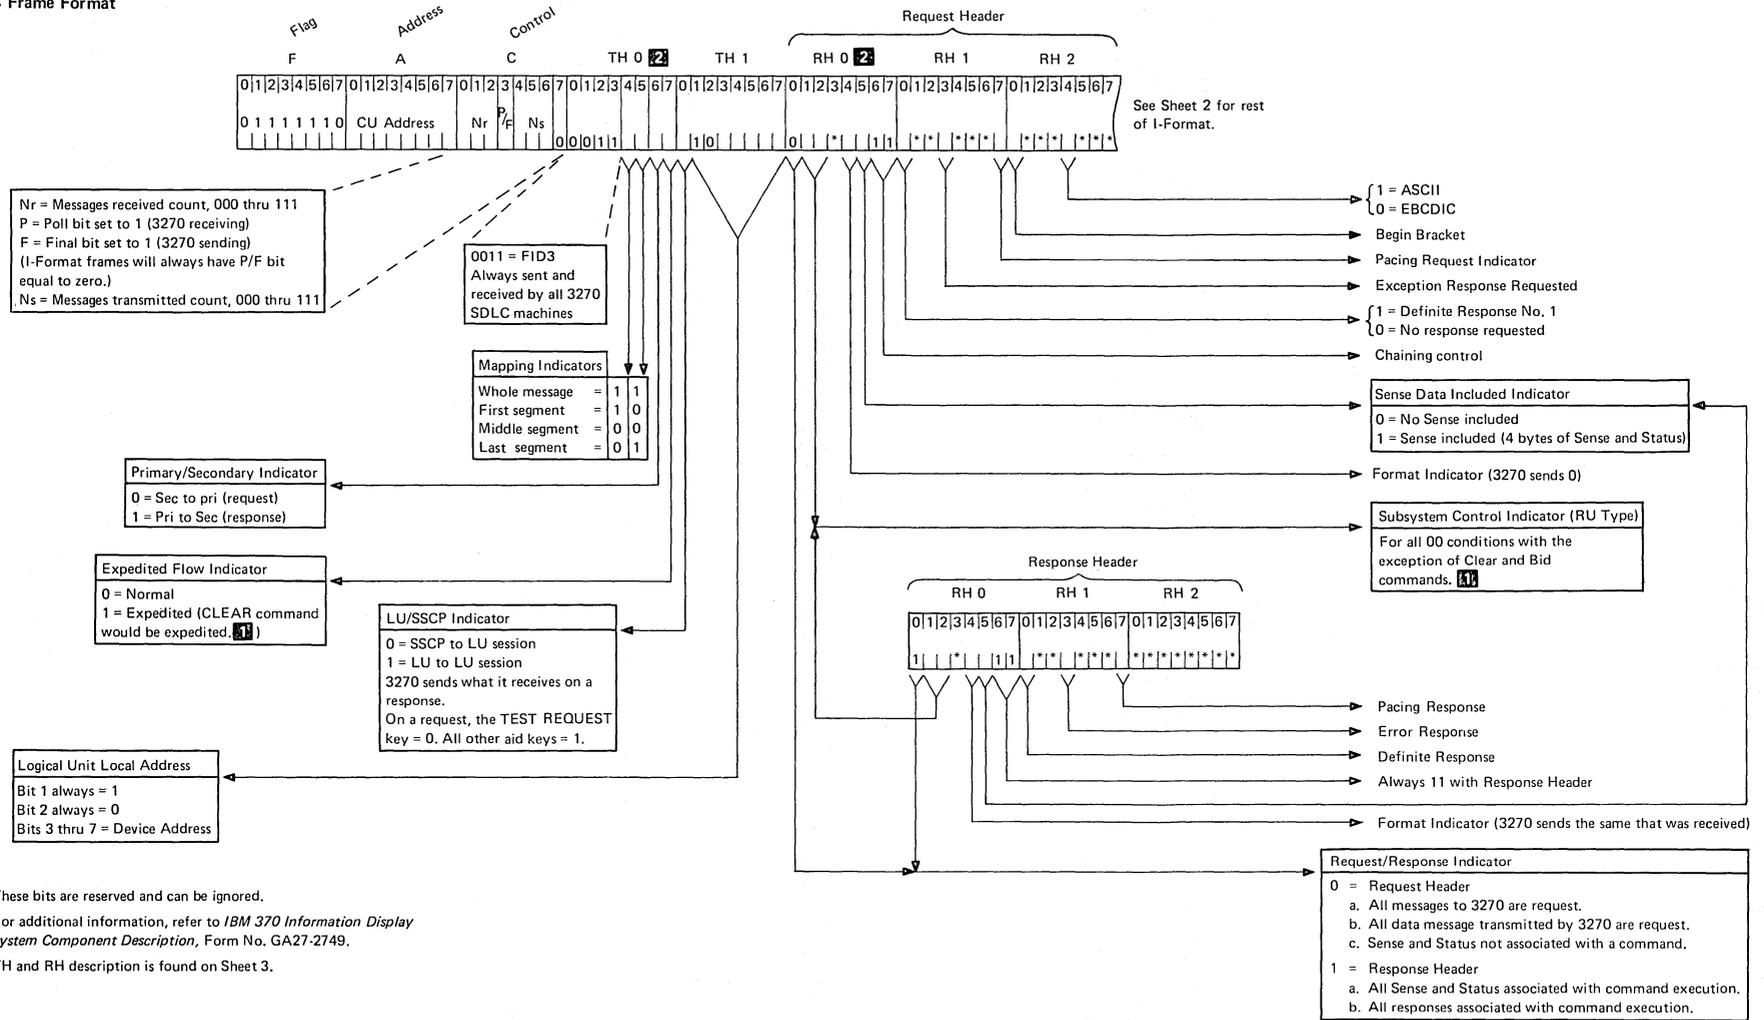
Figure 8-6 (Part 1 of 3). I-Format, Data Message

* These bits are reserved and can be ignored.
 1 For additional information, refer to *IBM 370 Information Display System Component Description*, Form No. GA27-2749.
 2 TH and RH description is found on Sheet 3.

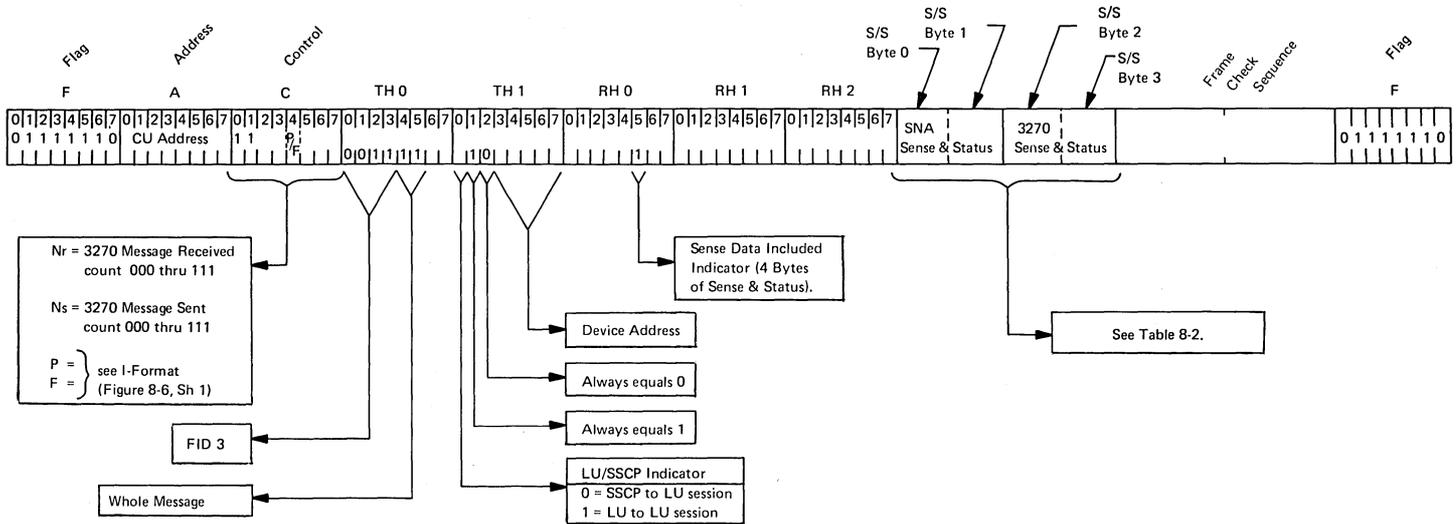
Figure 8-7. Sense/Status Message Format

Note: This chart is intended to show those bits that must be on for a S/S message. For all other bits, see I-Format, Figure 8-6, Sheets 1 and 2.

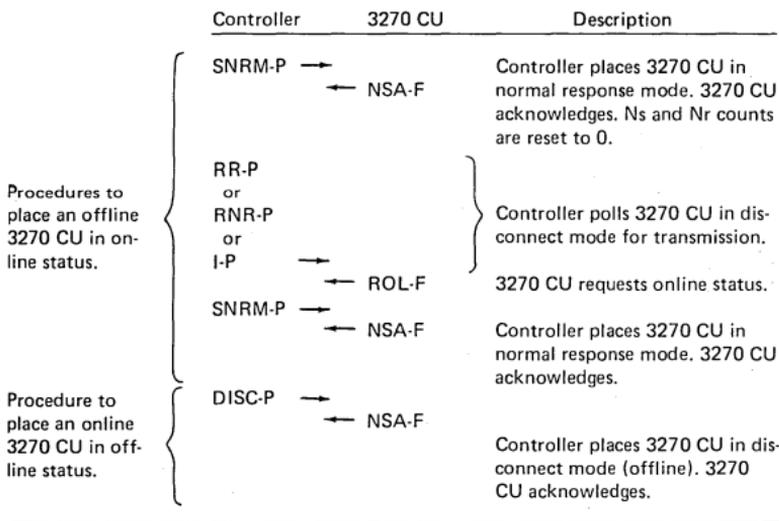
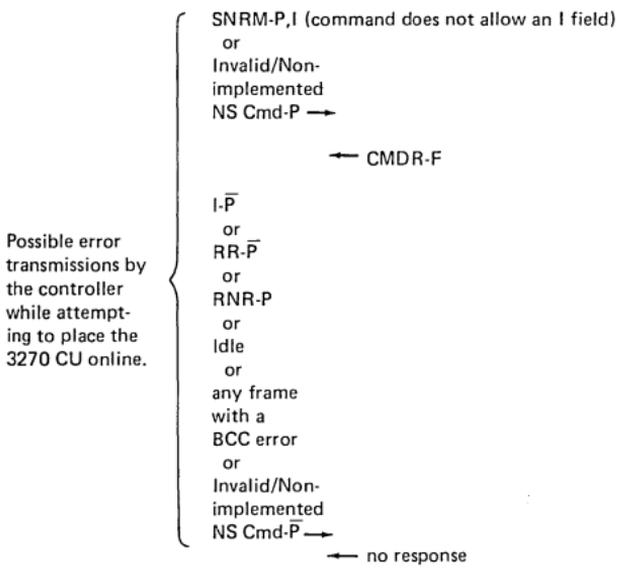
Figure 8-17. Online and Offline Sequence/Response Diagram

Note: Only SDLC bytes that are significant for the sequence being illustrated are shown in the diagram.

P/F=poll/final bit
I = information frame
dash (–) above a letter = not set to 1.

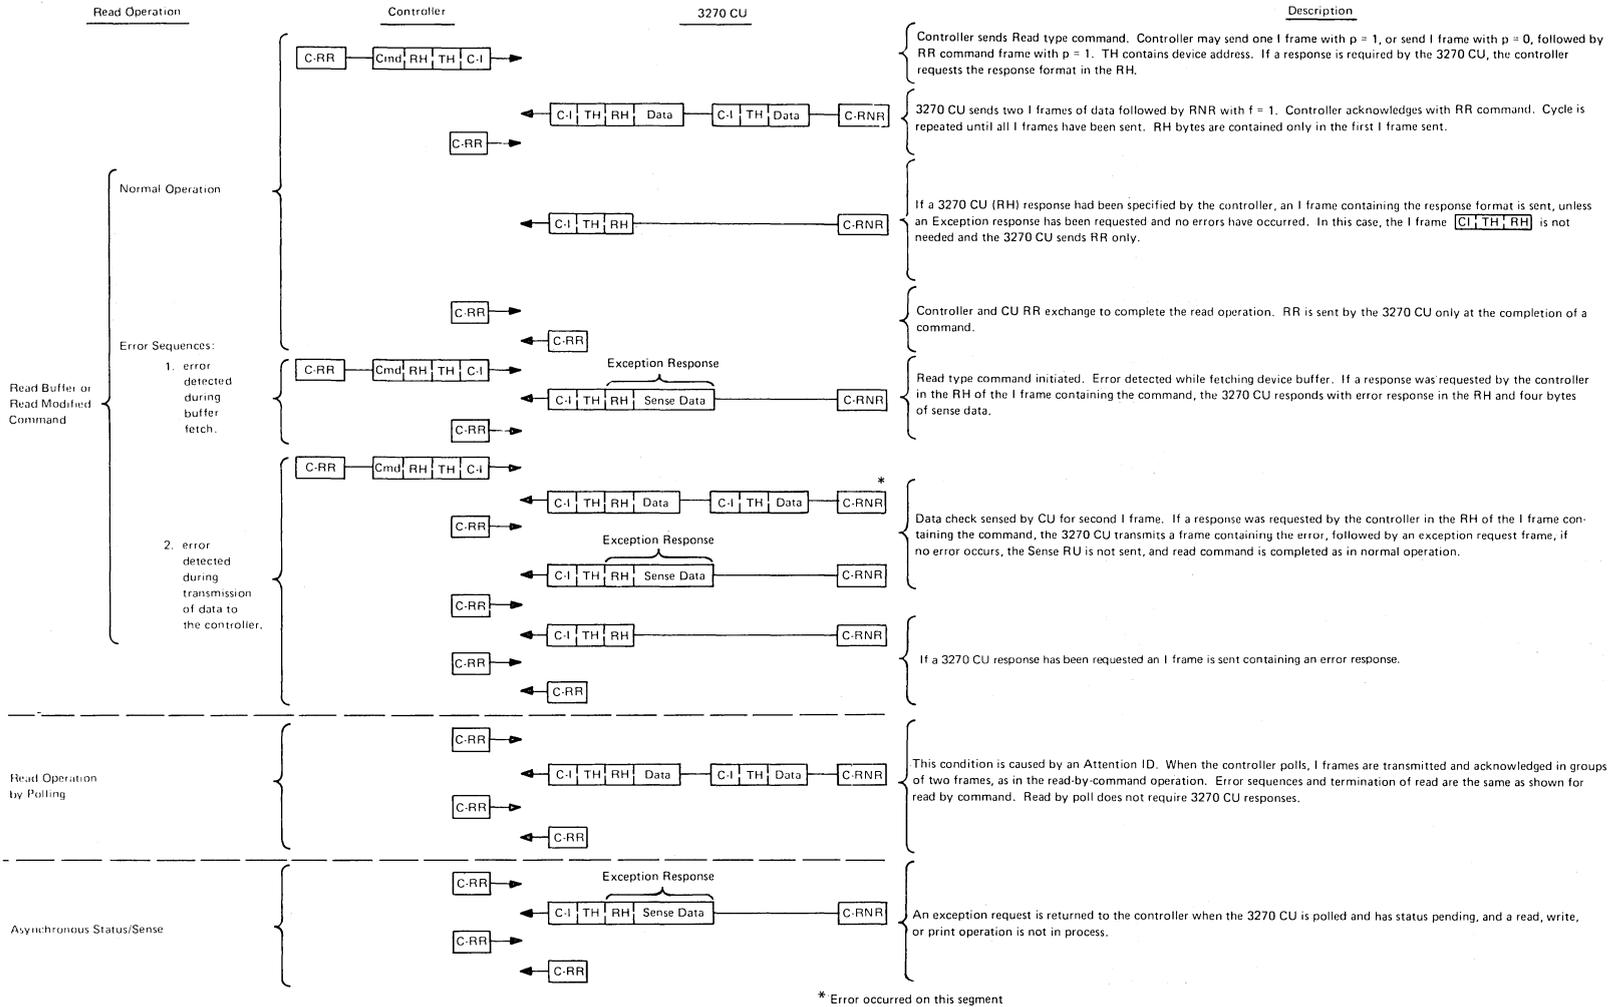
Figure 8-18. SDLC Read Type Command Sequence/Response Diagram

Note: A number of DR, EX, and P request/response formats are available.
