# DIGITAL StorageWorks HSZ50 Array Controller

## HSOF Version 5.1 Service Manual

Part Number: EK-HSZ50-SV.C01

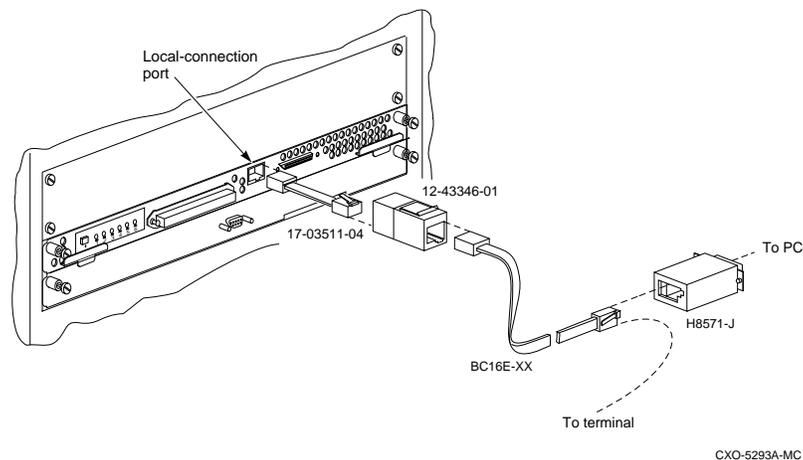
**Figure 2-1 Connecting a maintenance terminal**

1. Connect a maintenance terminal to the controller that does NOT require service, as shown in Figure 2-1.

1. If the controller is fully or partially functioning, connect a maintenance terminal to the controller. See Figure 2-1. If the controller is not functioning, try to restart the controller.

```
HSZ50>RESTART_OTHER
```
6. Attach a maintenance terminal to the new controller. See Figure 2-1.
7. Press and hold the controller's green reset (//) button, while inserting the program card. The program card eject button will extend when the card is fully inserted.
8. Release the reset button to initialize the controller.
9. Enter the following command at the CLI:

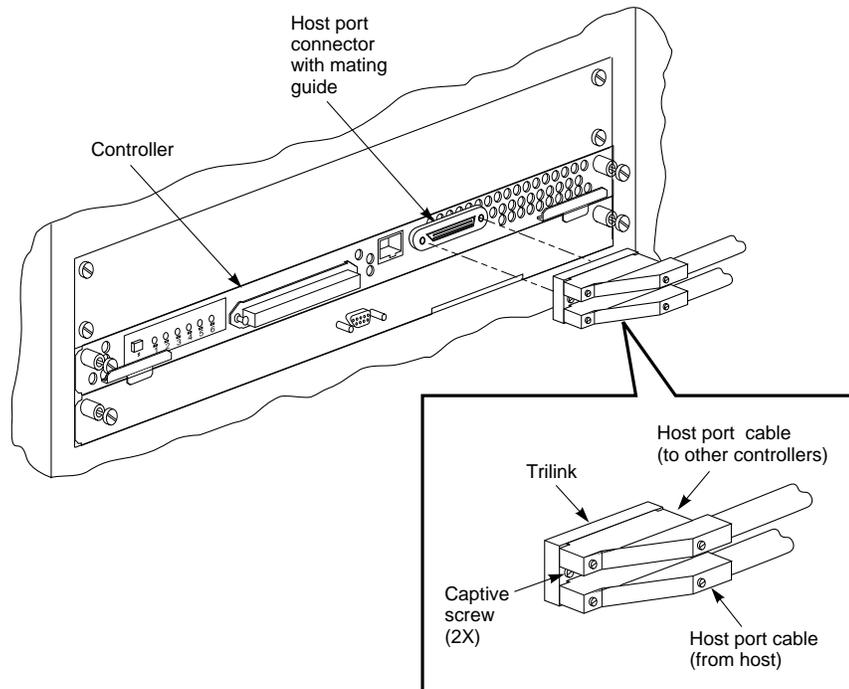
**Figure 2-2 Disconnecting the trilink connector**

11. Loosen the captive screws that secure the trilink connector to the controller requiring service. Do not remove the connector. See Figure 2-2.

9. Unsnap and remove the program card ESD shield. See Figure 2-3.
10. Eject the program card by pressing and holding the Reset button (//), then pressing the eject button next to the program card. Remove the program card and save it for the replacement controller. See Figure 2-3.
11. Loosen the captive screws on the trilink connector and remove the trilink. See Figure 2-2.
12. Loosen the captive retaining screws on the controller's front bezel.

where *n,n,n, n* are equal to all host port SCSI target IDs noted in Step 3.
5. Loosen the captive screws on the trilink connector and remove the trilink. See Figure 2-2.

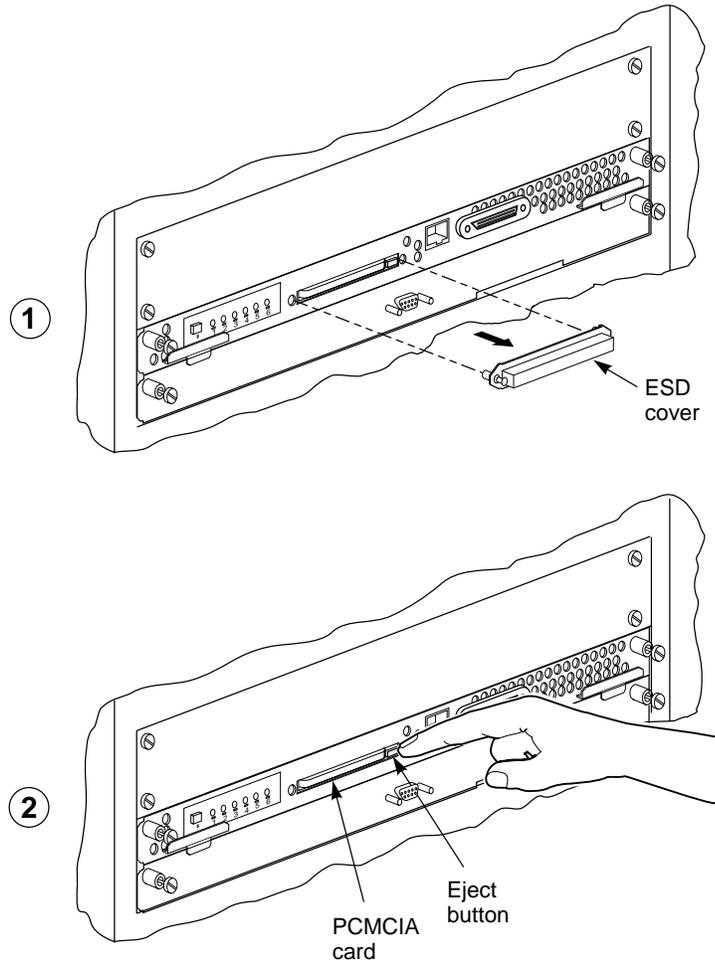
Figure 2-3 Removing the program card

5. Eject the program card by pressing and holding the Reset button (//), then pressing the eject button next to the program card. See Figure 2-3.
  - If you are not replacing the controller module, leave the program card in the ejected position.
  - If you are replacing the controller, remove the program card and save it for use in the replacement controller.

8. Unsnap and remove the program card ESD shield. See Figure 2-3.
9. Eject the program card by pressing and holding the Reset button (//), then pressing the eject button next to the program card. Remove the program card. Save it for the replacement controller. See Figure 2-3.

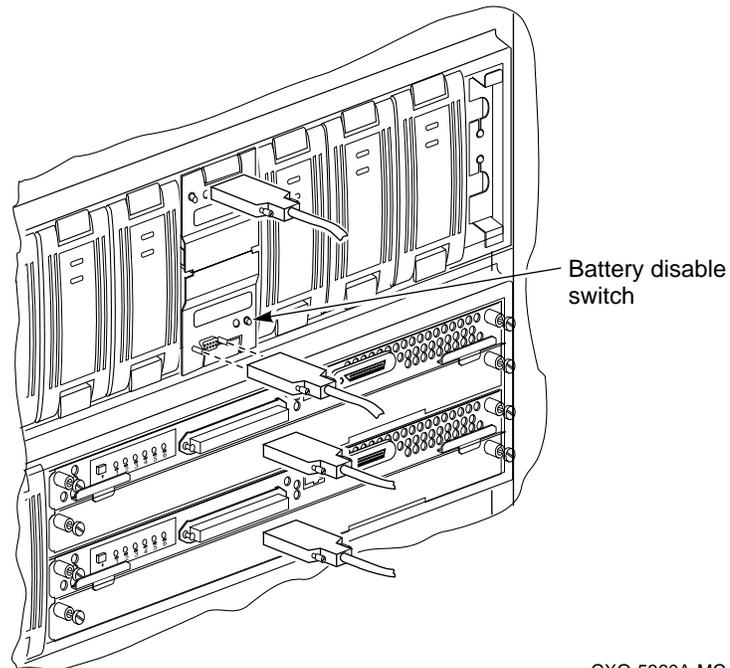
**Figure 2-4** Disconnecting the battery cable and disabling the ECB

8. Disable the ECB by pressing the battery disable switch. See Figure 2-4.

7. If you are replacing the cache module, loosen the screws on the ECB cable and disconnect the cable from the cache module. See Figure 2-4.
8. Disable the ECB by pressing the battery disable switch on the battery module front panel. See Figure 2-7.

12. Disconnect the battery cable at the failed ECB and connect it to the new ECB. See Figure 2-4. Until you are ready to install the SBB containing the new ECB in the cabinet, you can put the SBB containing the new ECB anywhere the cable will reach.

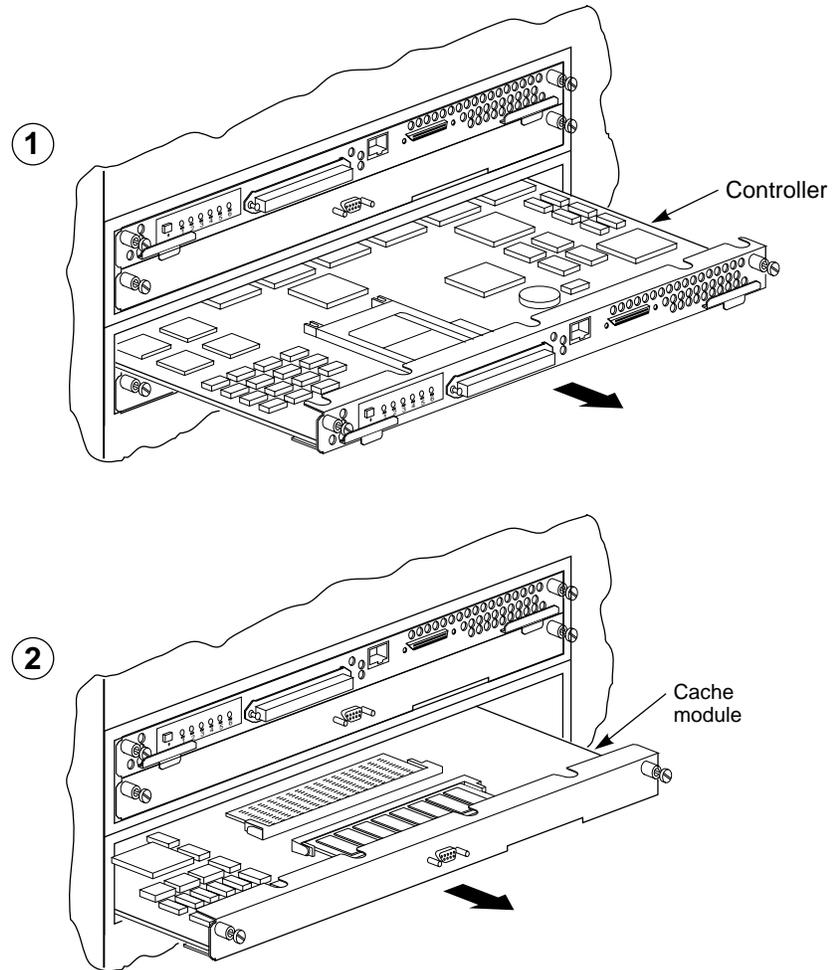
**Figure 2-5 Removing controllers and cache modules**

9. Slide the defective controller out of the shelf and note its location. See Figure 2-5.

11. If you are replacing the cache module, remove it now. See Figure 2-5.

13. Loosen the controller from the shelf backplane with a gently rocking motion. Slide the controller module out of the shelf, noting in which rails it was seated. See Figure 2-5.
14. If you are replacing the cache module, loosen the screws on the cache module's front bezel.
15. Loosen the cache module from the shelf backplane with a gentle rocking motion and slide the module out of the shelf. See Figure 2-5.

10. Loosen the controller from the shelf backplane with a rocking motion. Slide the controller module out of the shelf, noting in which rails it was seated. See Figure 2-5.

11. If you are replacing the cache module, loosen the screws on the cache module's front bezel.
12. Loosen the cache module from the shelf backplane with a rocking motion and slide the module out of the shelf. See Figure 2-5.

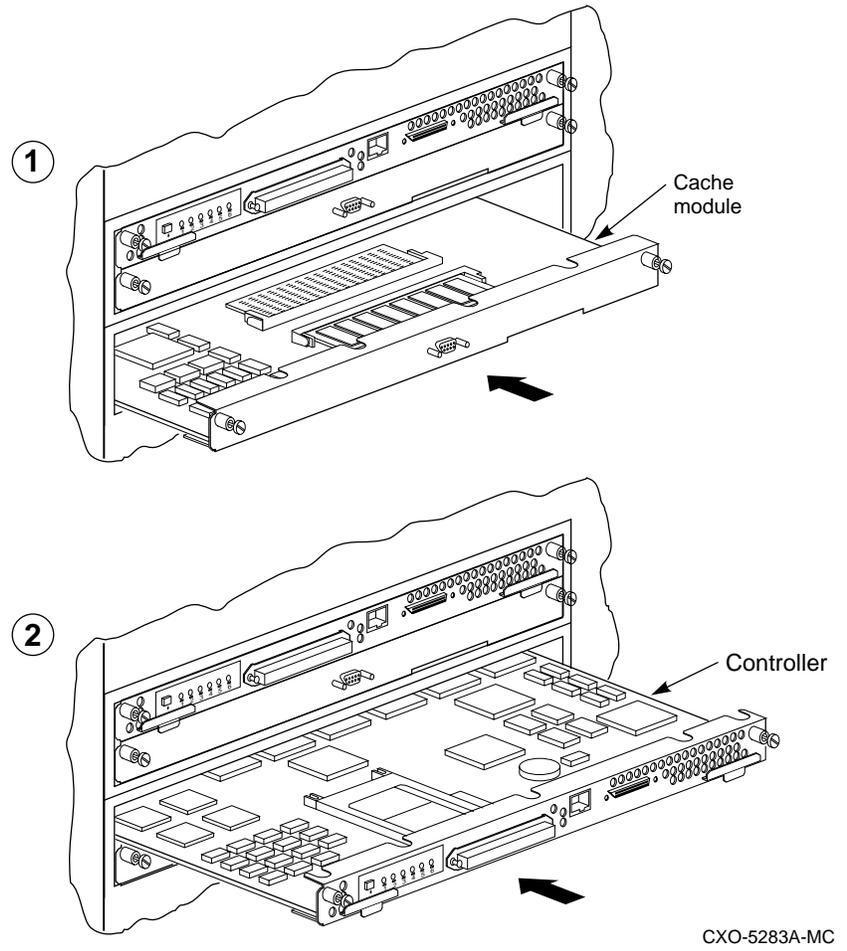
Figure 2-6 Installing controllers and cache modules

5. Insert the cache module by sliding it straight in along the rails and then push firmly to seat it in the backplane. See Figure 2-6.
6. Insert the controller module by sliding it straight in along the rails and then push firmly to seat it in the backplane. See Figure 2-6.

1. If you removed the cache module in the previous procedure, slide the new cache module into the shelf making sure you are using the correct slot.
2. Slide the new controller module into the shelf using the same rails from which you removed the module. See Figure 2-6.

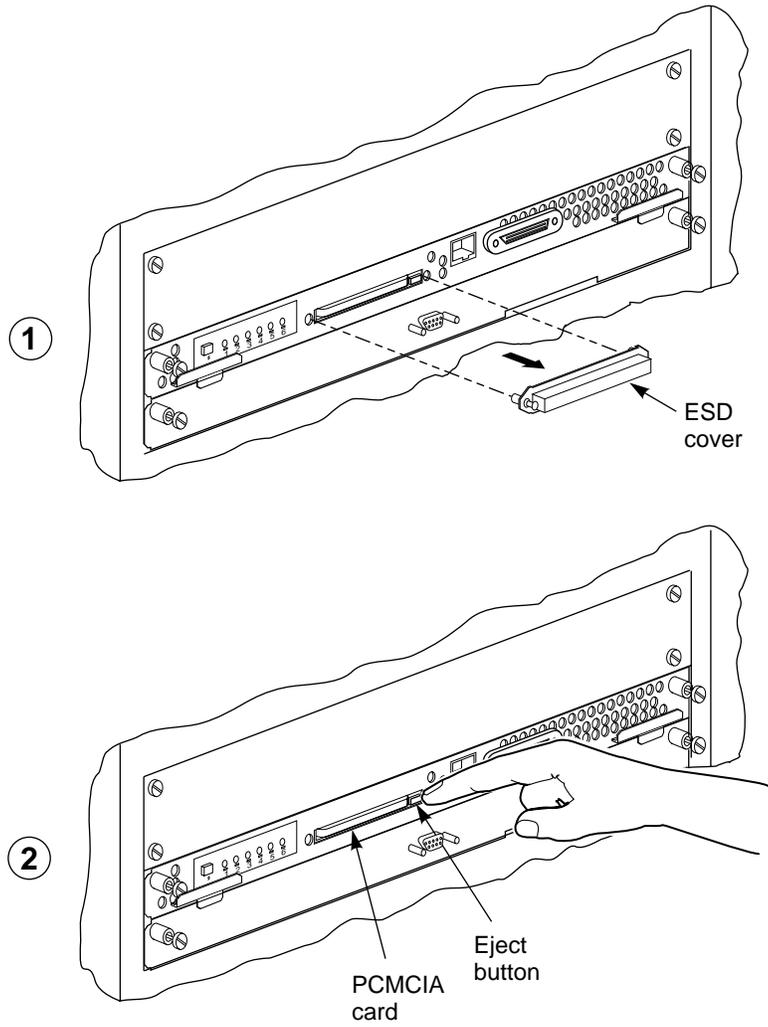
Figure 2-8 Installing the program card

3. Tighten the captive screws on the front bezel of both the controller and cache modules.
4. Reconnect the ECB cable to the cache module and tighten the mounting screws on the cable.
5. Reconnect the power cords to the controller power supplies.
6. Attach a maintenance terminal to the new controller.
7. Press and hold the controller's green reset (//) button, while inserting the program card. The program card eject button will extend when the card is fully inserted. See Figure 2-8.

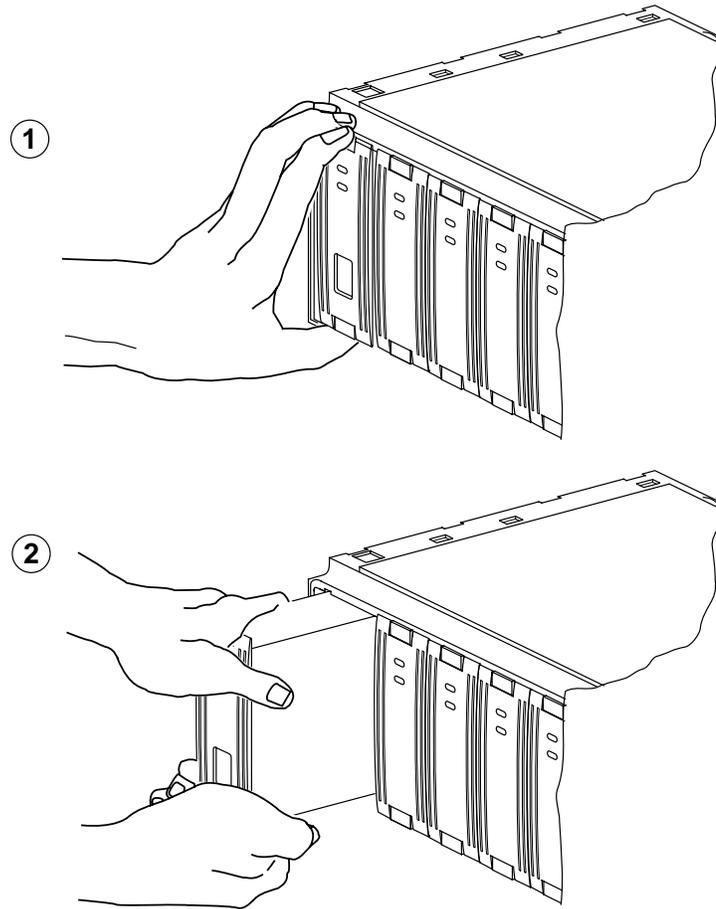
**Figure 2-9 Removing the power supply**

4. Disconnect the power cords from the power supply.
5. Press the two mounting tabs together to release the power supply from the shelf and partially pull it out of the shelf. See Figure 2-9.
6. Use both hands to pull the power supply out of the shelf. See Figure 2-9.

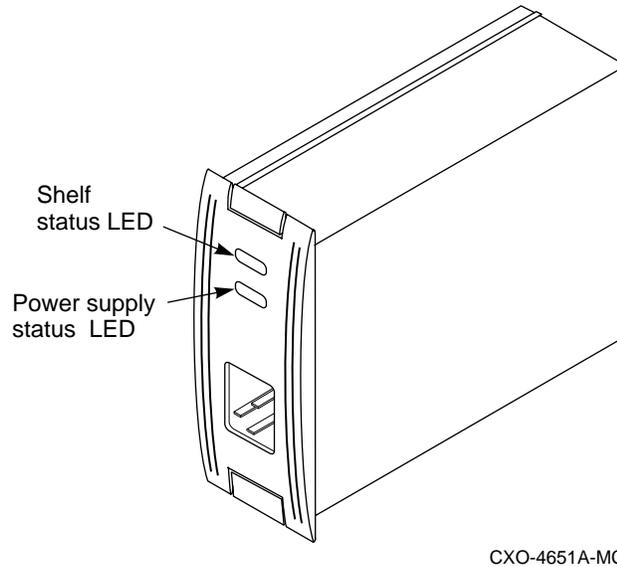
**Figure 2-10 Power supply fault indicators**

3. Observe the power and shelf fault indicators to make sure they are on. See Figure 2-10.

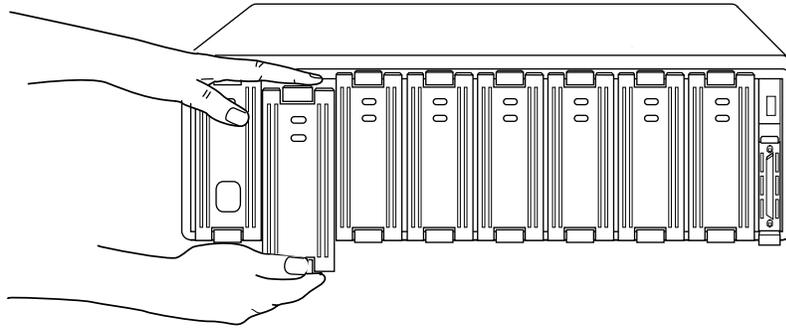
**Figure 2-11 Removing a disk drive**

5. If the failed device is part of a failedset, delete it from the failedset. If the failed device is part of a spareset, delete it from the spareset.
6. If the device is part of a storageset or unit, remove the device from the storageset or unit.
7. Once the device is no longer part of a storageset or unit, delete the disk name you determined in Step 3.
8. Determine which disk drive has failed using the procedures in Chapter 1, “Troubleshooting”, of this manual.
9. Press the two mounting tabs together to release the disk drive from the shelf and partially pull it out of the shelf. See Figure 2-11.

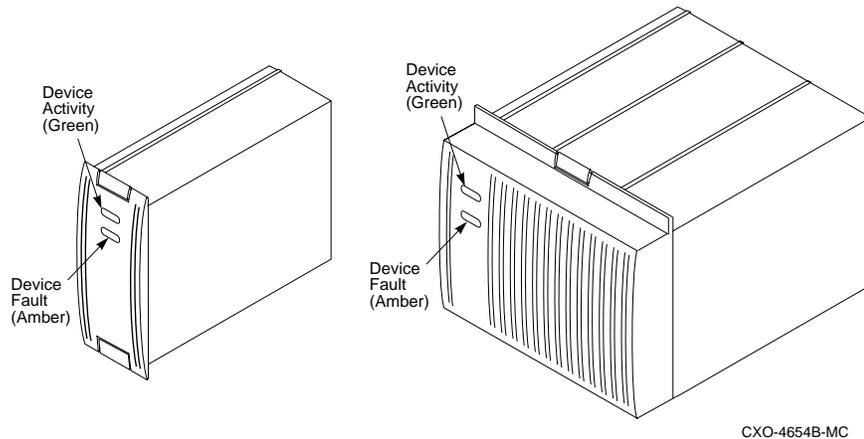
**Figure 2-12 Default indicators for 3.5- and 5.25-inch SBBs**

10. Using both hands, pull the disk drive out of the shelf.
11. Align the replacement disk drive with the shelf rails.
12. Push the disk drive all the way into the shelf until the locking tabs snap into place.
13. Observe the status LED for the following indications. See Figure 2-12.
  - The device activity (green) LED is either on, flashing, or off.
  - The device fault (amber) LED is off.

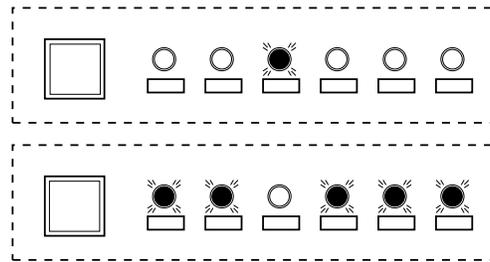
**Figure 2-13 OCP LED patterns**

1. Determine the failed device using the procedures in Chapter 1, “Troubleshooting”, of this manual.
2. Quiesce the port by pressing the OCP button for that port.
3. When the OCP LEDs flash in an alternating pattern the device port is quiesced. For example, when you quiesce device port three and I/O has halted, the OCP LEDs are flashing in an alternating pattern, as shown in Figure 2-13.

4. At the replacement tape drive, press the two mounting tabs together to release the device from the shelf and partially pull it out of the shelf.
5. Use both hands to pull the device out of the shelf.
6. Quiesce the port again. Look for the OCP indicators depicted in the diagram in Step 3 of this procedure.
7. Align the replacement device with the shelf rails and insert the new device.
8. When the controller recognizes the device, the port light will be turned off and the system will return to normal operation.

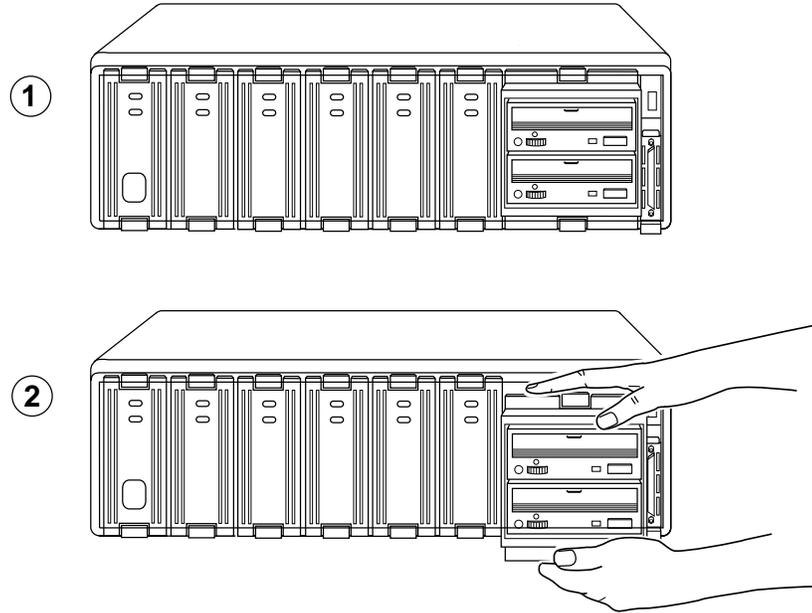
**Figure 2-14 Removing the CD-ROM drive**

5. Press the two mounting tabs together to remove the SBB from the shelf. See Figure 2-14.

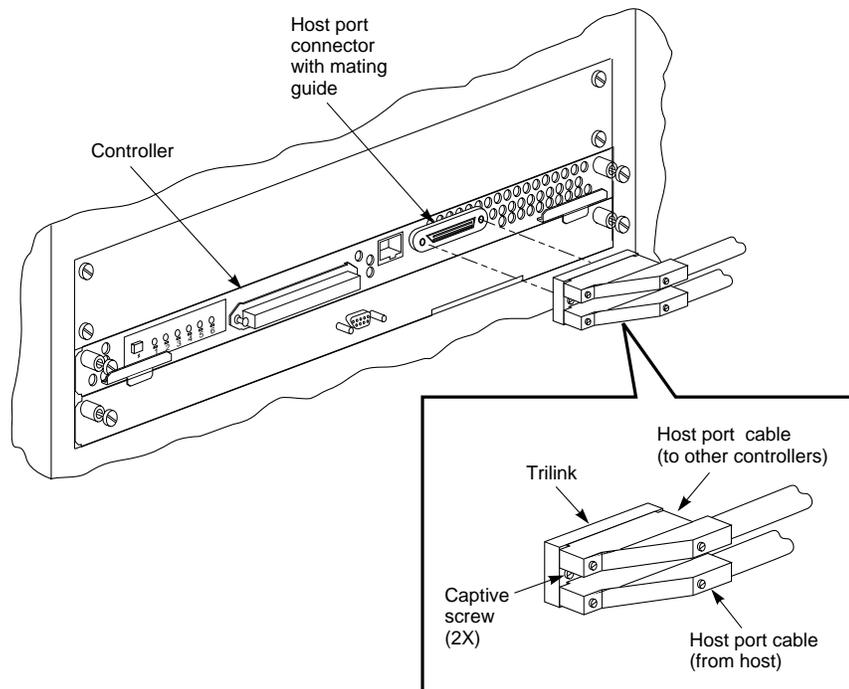
**Figure 2-15 Disconnecting the SCSI host cable**

1. Halt all I/O activity using the appropriate procedures for your operating system.
2. Dismount all units using the procedures for your operating system.
3. Disconnect the failed SCSI host cable from the host or other device.
4. Shut down the controller/controllers.
5. Loosen the captive screws on the trilink connector at the controller's front bezel. Disconnect the cable from the trilink connector. See Figure 2-15.

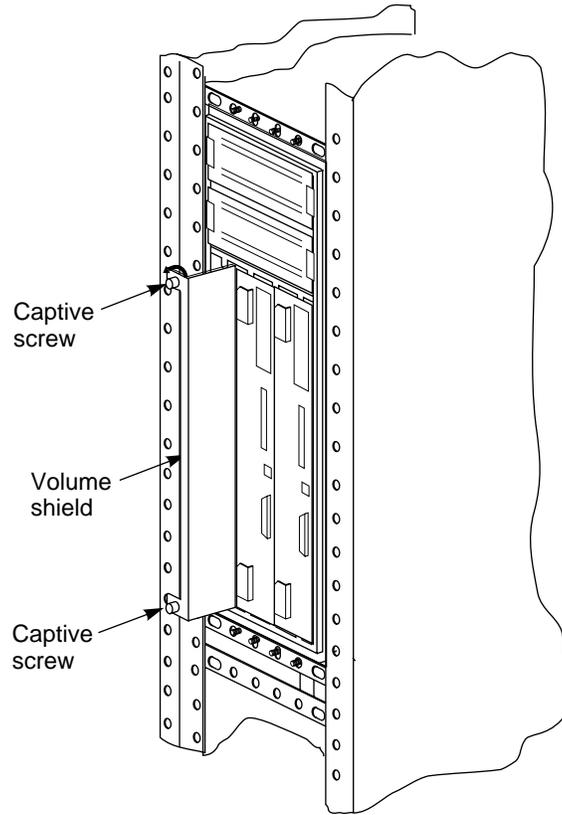
**Figure 2-16 Removing the volume shield**

1. Make sure the controller/controllers have been properly shut down.
2. Remove each controller and cache module using the procedure described in “Replacing a Controller and Cache Module in a Single Controller Configuration” in this chapter.
3. Loosen the two captive screws on each side of the volume shield and remove the shield. See Figure 2-16.

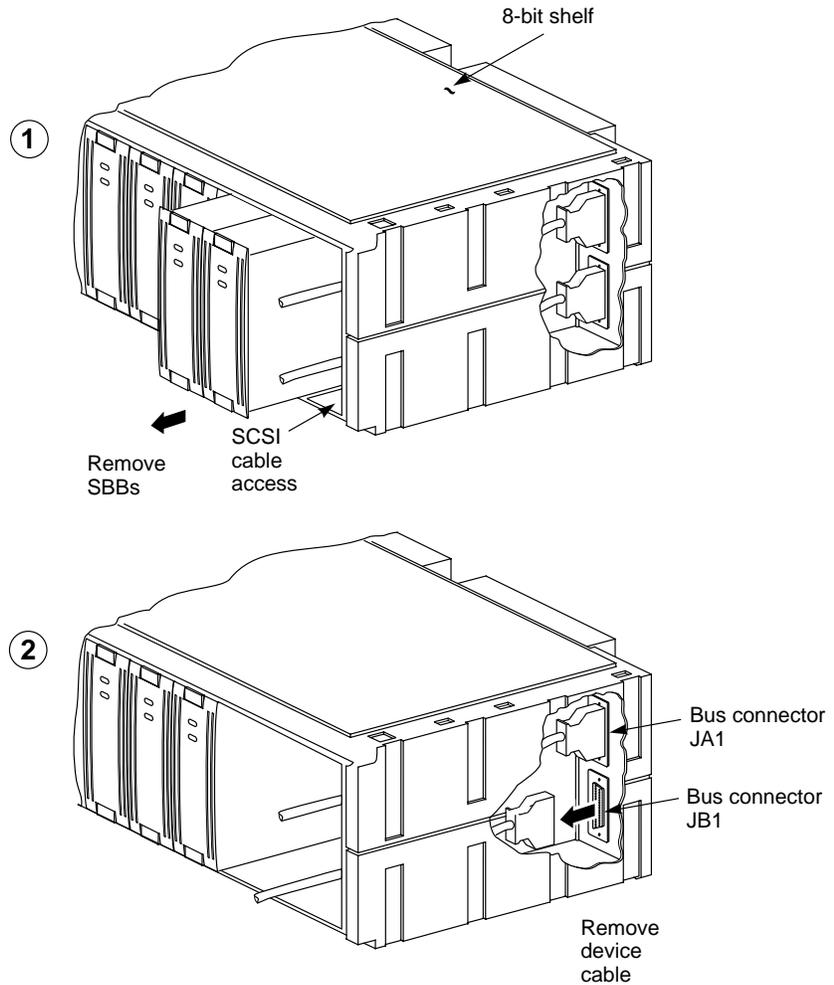
**Figure 2-17 Access to the SCSI cables**

5. Before removing the disk drives from the device shelf, let the drive spin down for at least 30 seconds. Gyroscopic motion from a spinning disk may cause you to drop and damage the disk.
6. Remove any SBBs necessary to gain access the SCSI cable. See Figure 2-17.

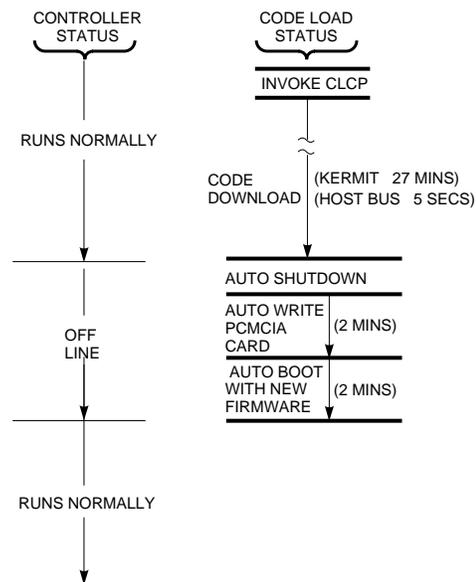
**Figure 3-1 Single controller code load method**

Figure 3-1 shows a flow diagram of the single controller code load method.

After the CLCP utility is invoked, the controller continues to run normally while the code is downloaded from host console or PC terminal program. This process may take from several seconds (for a host bus download) to 35 to 45 minutes (for a download performed via the maintenance terminal port). The only time the code load process interrupts device service is for a period of about 4 minutes, while the program card is written and the controller initializes with the new software.

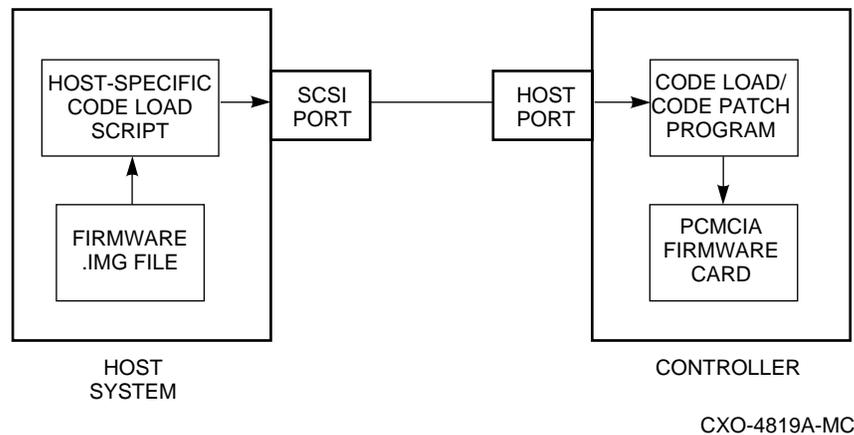
**Figure 3-2 Host port code load operation**

As shown in Figure 3-2, the user employs a download script running in the host to communicate with CLCP utility.

The user invokes the CLCP utility via the CLI, and when prompted, instructs the host to download the binary software image to the controller using the download script. The controller rewrites the software in its program card using the downloaded software image.

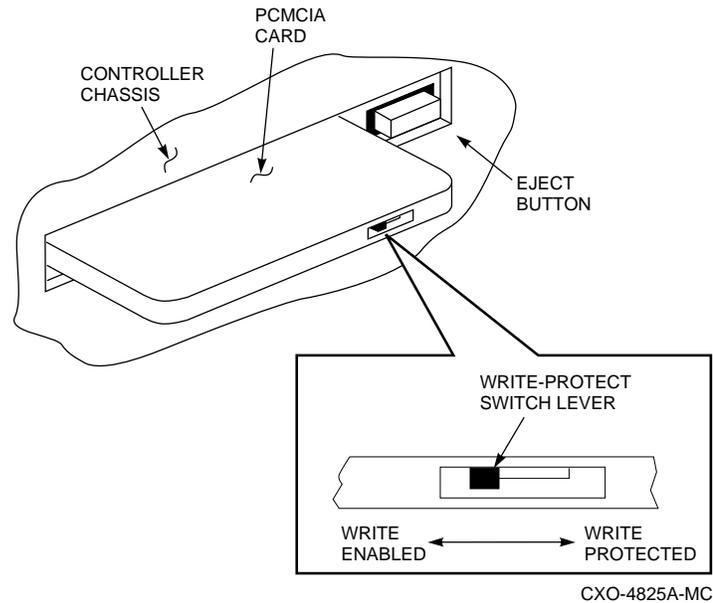
**Figure 3-3 Write enable the program card**

1. Locate the program card on the controller module.
2. Locate the write-protect switch on the outer edge of the card.
3. With a small pointed object, carefully slide the switch lever away from the eject button. See Figure 3-3.

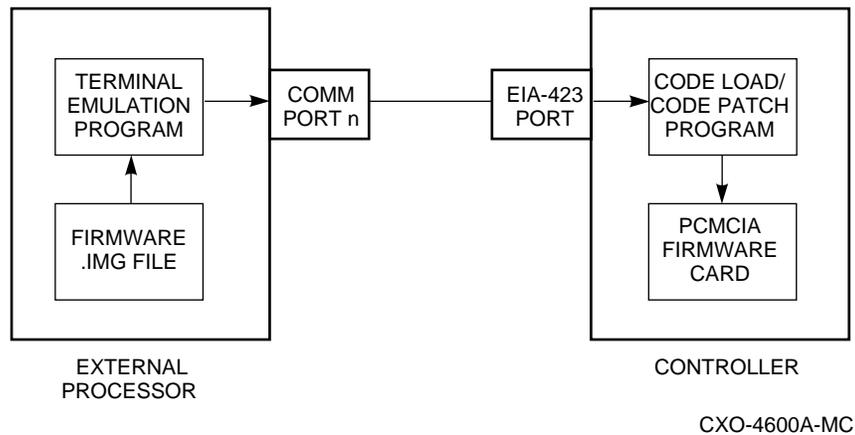
**Figure 3-4 Terminal port code load operation**

As shown in Figure 3-4, an external processor containing a binary image of the controller software is connected to the controller's maintenance port. The external processor is typically a personal computer (PC). The user employs a terminal emulation program running in the external processor to communicate with the CLI in the controller. The user invokes the CLCP utility via the CLI.

When prompted by the CLCP utility, the user instructs the terminal emulator program to download the binary software image to the controller using the KERMIT line protocol. The controller rewrites the software in its program card using the downloaded software image.

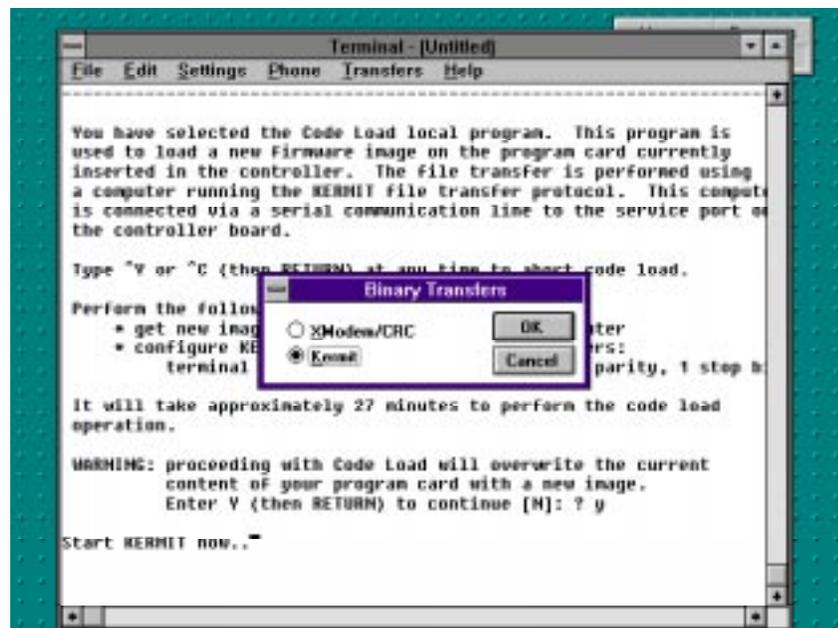
**Figure 3-5 Binary transfer protocol selection**

10. Select the KERMIT transfer protocol and click on the OK button. See Figure 3-5.
11. Your external processor and the serial link to the controller are now ready to download the new software image to the controller.
12. Remove the program card ESD cover.

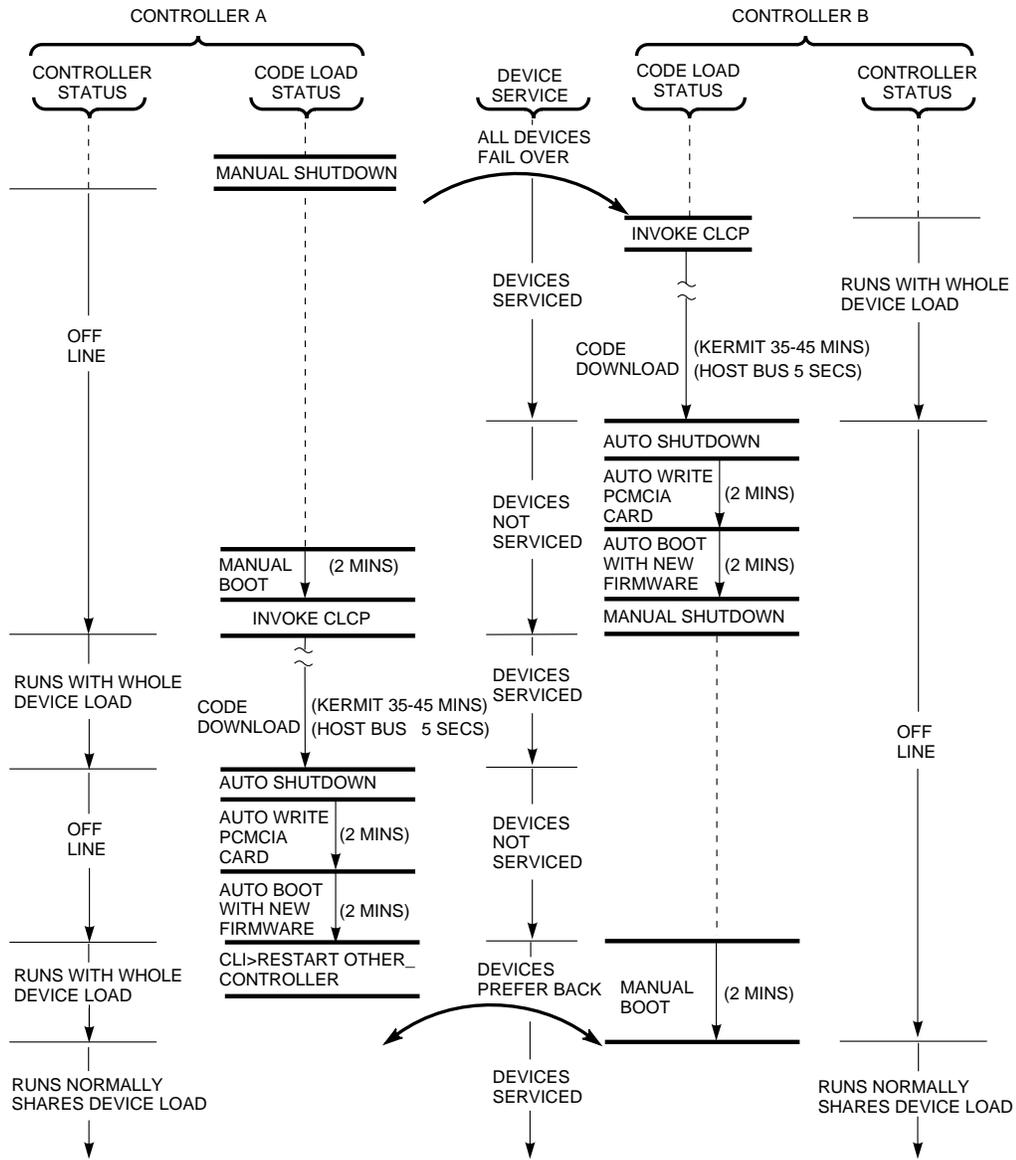
Figure 3-6 The sequential upgrade method

The sequential upgrade code load method for dual-redundant configurations is illustrated in Figure 3-6. This method is *required* for major software upgrades.

The sequential upgrade method forces an interruption to device service. To avoid a situation in which the two controllers are running different software versions, each is shut down, while the other is code loaded. As shown in Figure 3-6, there are two periods of time when both controllers are off line. During these periods, devices are not serviced, and the subsystem is off line. I/O activity also should be halted during the code load operation.

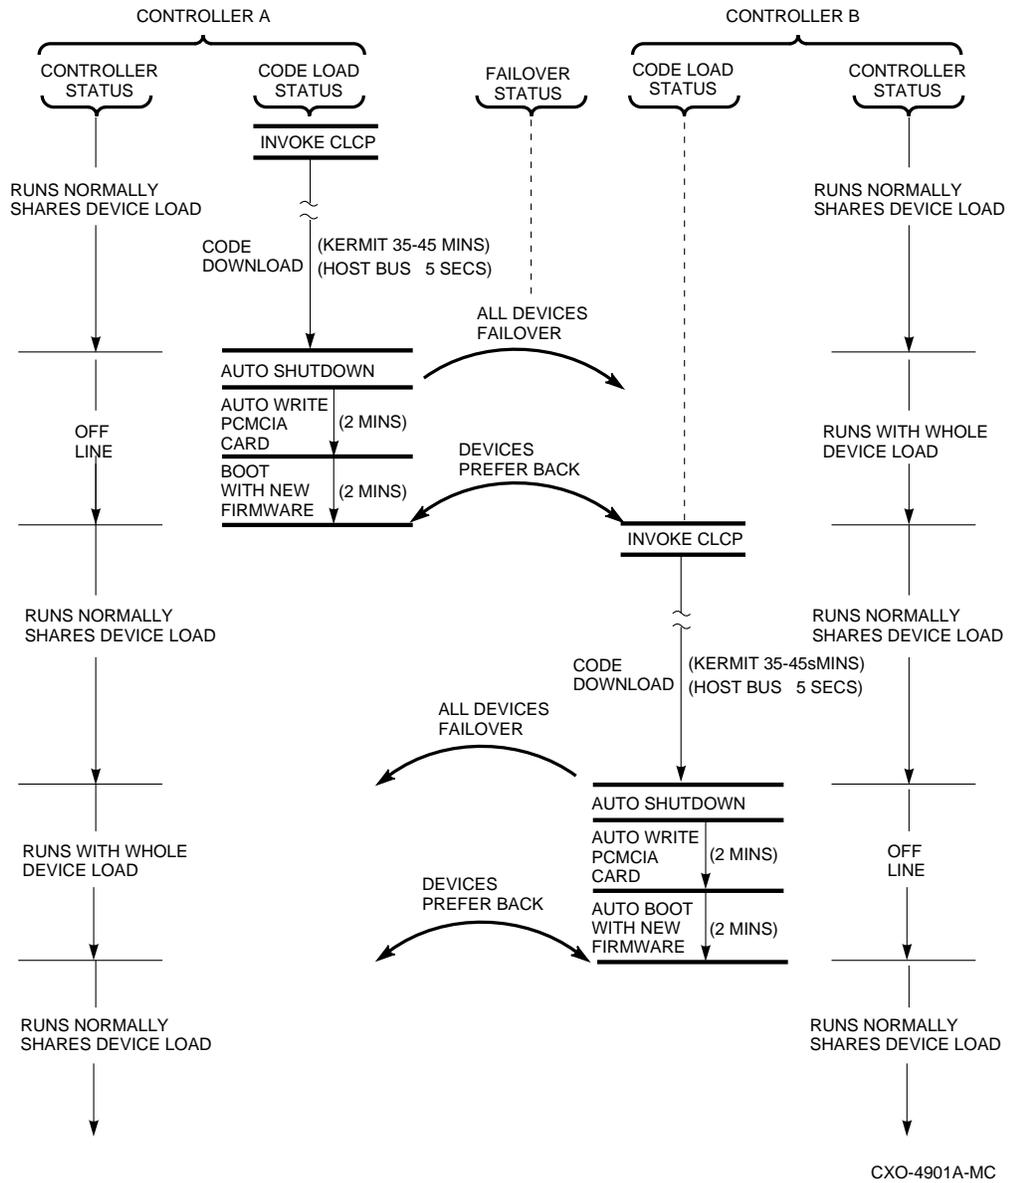
Figure 3-7 The concurrent upgrade method

The concurrent upgrade code load method proceeds without any interruption to device service. See Figure 3-7. The shut down that occurs just after the code download causes a failover of all devices to the other controller. During the period when the program card is being written and the controller initializes, the other controller maintains control over the subsystem. While there might be a slight degradation in performance, the subsystem continues to operate during the controller code load operation.

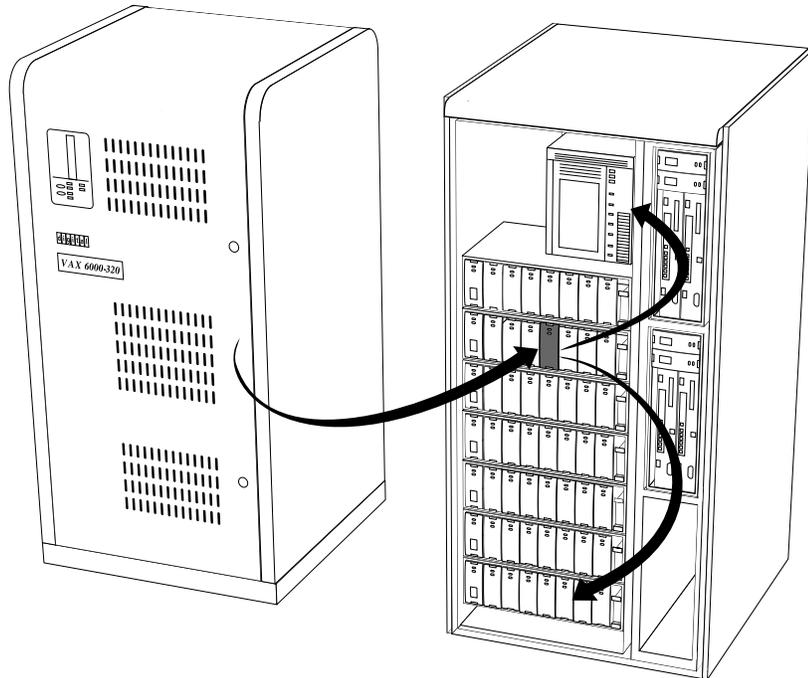
**Figure 3-8** Installing new firmware on a disk or tape drive

Installing new firmware on a disk or tape drive is a two-step process as shown in Figure 3-8. First, copy the new firmware from your host to a disk drive in your subsystem, then use HSUTIL to distribute the *firmware* devices in your subsystem.

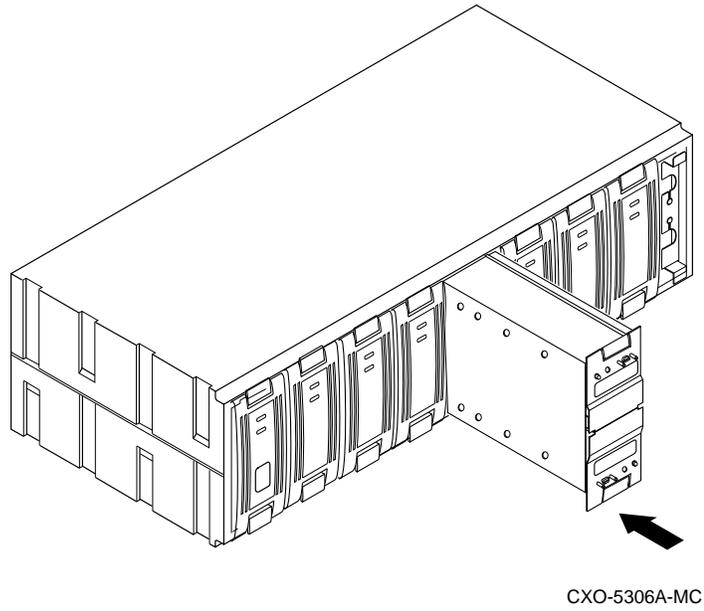
**Figure 3-9 Installing an SBB battery module**

2. Connect a maintenance terminal to the controller.
3. Install an external cache battery SBB into a convenient device slot. See Figure 3-9.
4. Install the controller power supplies into the controller shelf. See Figure 3-10.

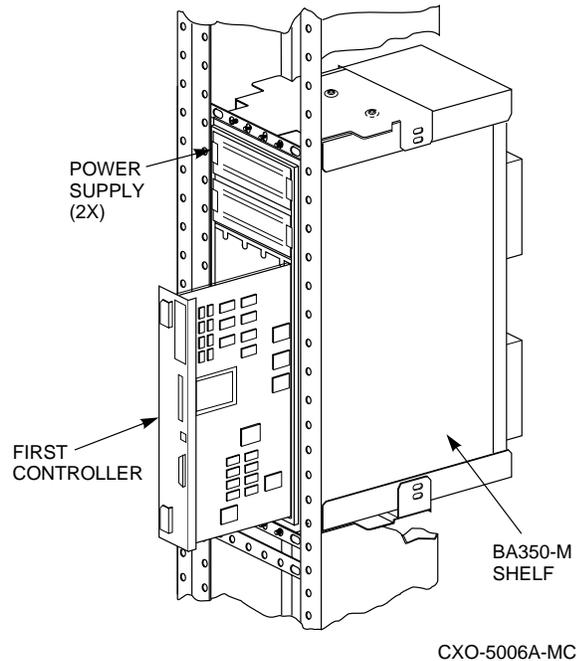
**Figure 3-11 Installing a single controller (SW800 cabinet)**

5. Slide the cache module into the appropriate slot in the controller shelf with a gentle rocking motion to help seat the module.
6. Install the controller module into the shelf slot that corresponds to SCSI ID 7. See Figure 3-11.

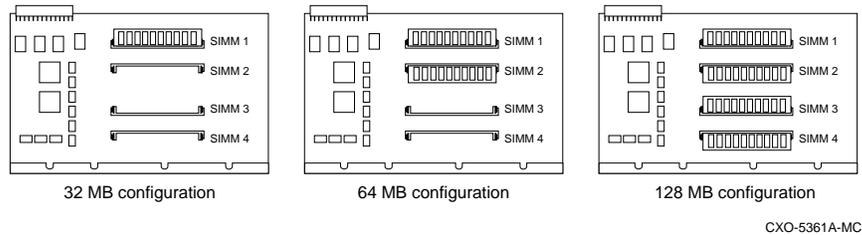
**Figure 3-12 Cache configurations for cache Version 3**

9. Loosen the captive screws on front bezel of both cache modules.
10. Loosen the cache modules from the shelf using a gentle rocking motion and slide the cache modules from the controller shelf.
11. Refer to Table 3-4 and Figure 3-12 and install as many SIMM cards into each cache modules as required.

The cache board is marked by SIMM slot numbers as shown in Table 3-4.

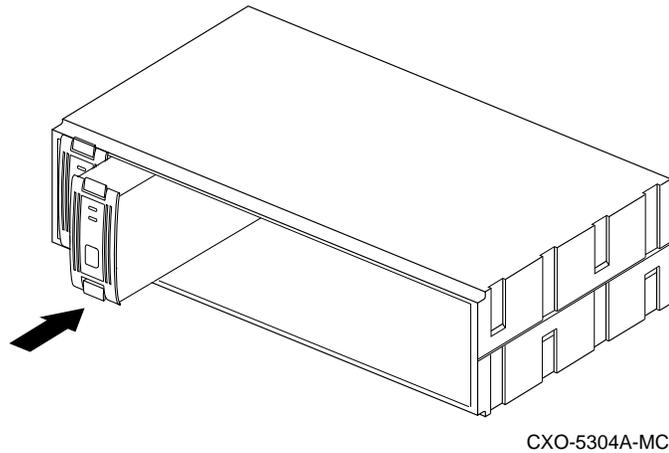
**Figure 3-13** Installing a power supply

1. Orient the power supply so that the status indicators are at the top. Firmly push the power supply into the shelf until the mounting tabs snap into place. See Figure 3-13.

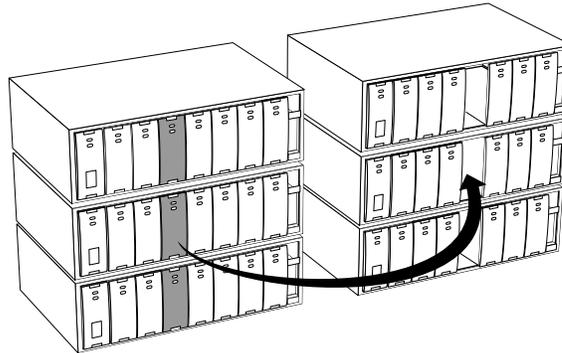
**Figure 4-1 Moving a storage set from one subsystem to another**

You can move a storage set from one subsystem to another without destroying its data. You also can follow these steps to move a storage set to a new location within the same subsystem. See Figure 4-1.

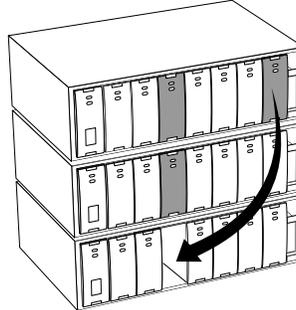
**Figure 4-2 Moving storage set members**

You may want to move a storage set member and its data from one PTL location to another to maintain the symmetry in your subsystem. For example, if a RAID set member fails and is replaced by a disk drive in the spareset, you could move the replacement member into the column that contains the RAID set. See Figure 4-2.

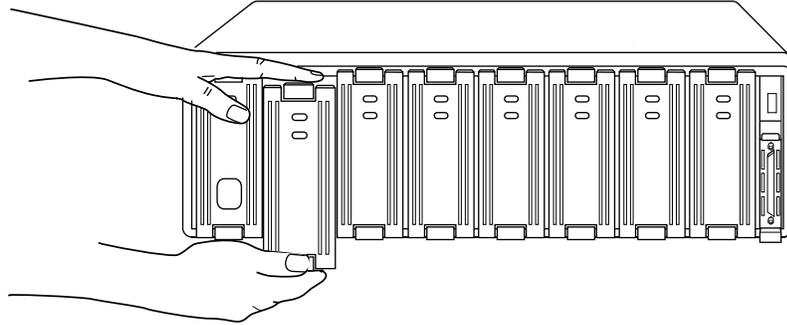
**Figure 5-1 Removing a 3.5-inch disk drive**

4. Halt all I/O activity to the disk drive using the appropriate procedures for your operating system.
5. Press the two mounting tabs together to release the disk drive from the shelf and partially pull the disk drive out of the shelf. Allow the disk drive to spin down. See Figure 5-1.

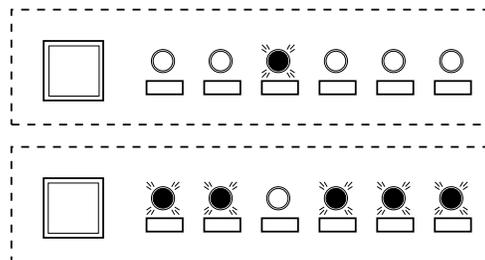
**Figure 5-2 OCP LED patterns**

1. Halt all I/O activity to the tape drive using the appropriate procedures for your operating system.
2. Quiesce the appropriate device port by pushing the device port button on the controller's OCP (operator control panel).
3. When the OCP LEDs flash in an alternating pattern the device port is quiesced. For example when you quiesce device port 3 and I/O has halted, the OCP LEDs are flashing in an alternating pattern as shown in Figure 5-2.
