Prepared by:
Network Storage Solutions
Hewlett Packard Company

Upgrading the MSA1000 for Enhanced Features

***Abstract:** This white paper outlines step-by-step procedures to upgrade an MSA1000 and its components to enable enhanced features*

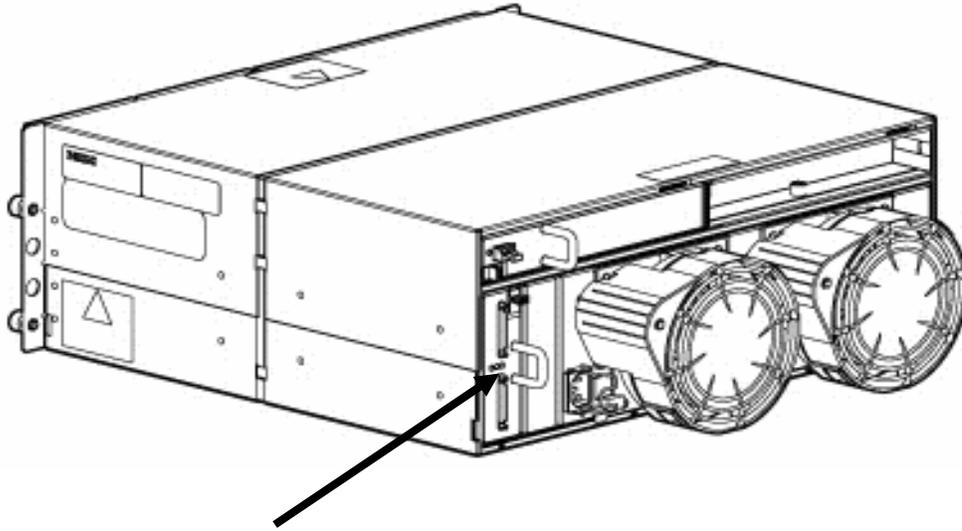
To determine the manufacturer of the EMU in the MSA1000, the MSA1000 will have to be powered off (make sure there is no I/O running from a server to the MSA1000 before powering it off). At the back of the MSA1000 chassis, remove the SCSI cables (if attached) on the SCSI Interconnect board (located on the left of the MSA1000 unit) – see drawing below:

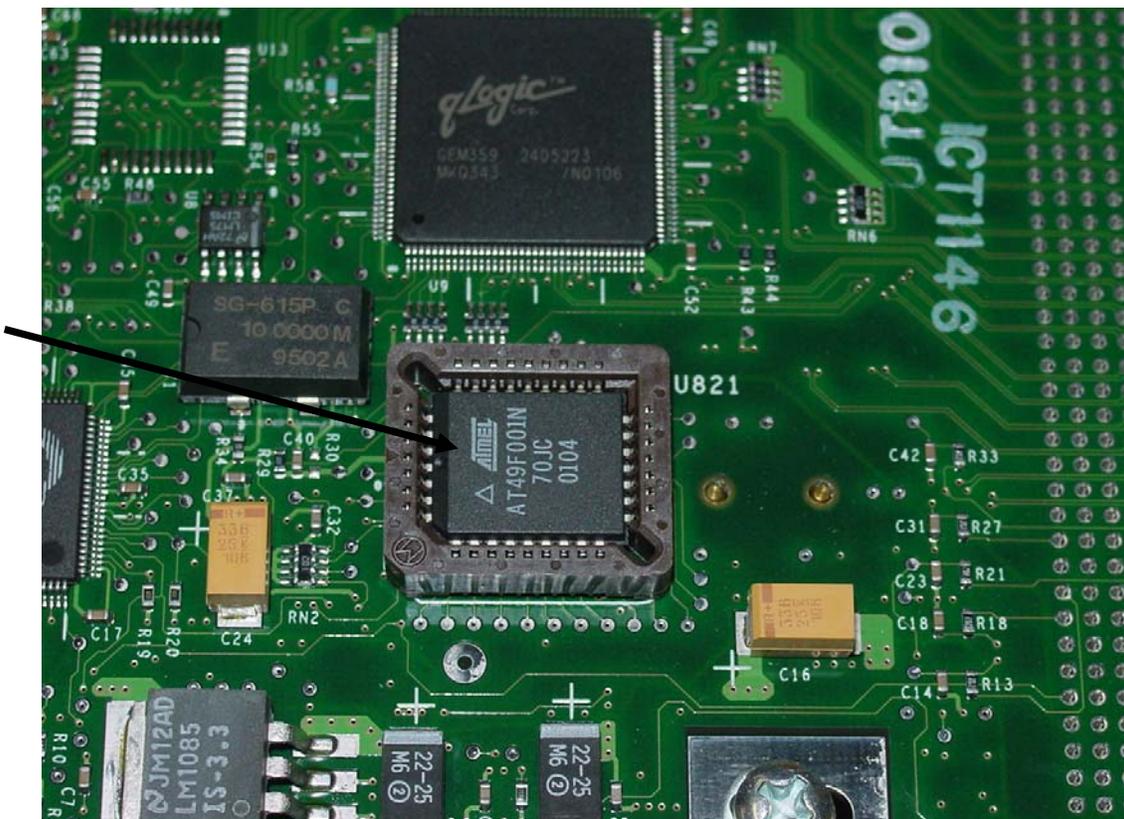
Once the cables have been disconnected, remove this card from the back of the MSA1000 chassis by simultaneously pushing down on the quick release latch mechanism and pulling the card out. Once the card is out, set it down on a flat surface, metal part of the card face down. If the SCSI ports on the card are facing to the left, the EMU EEPROM is located towards the bottom right section of the printed circuit board. It is the only chip on the board that is located in a solder-less connector.

Once the chip is located, look closely at the wording on the chip. If the chip reads **AMD**, this chip is flashable, and the upgrade procedures can continue. **If the chip reads ATMEL, this chip is NOT flashable. Please call HP Customer Services to have this board replaced.**

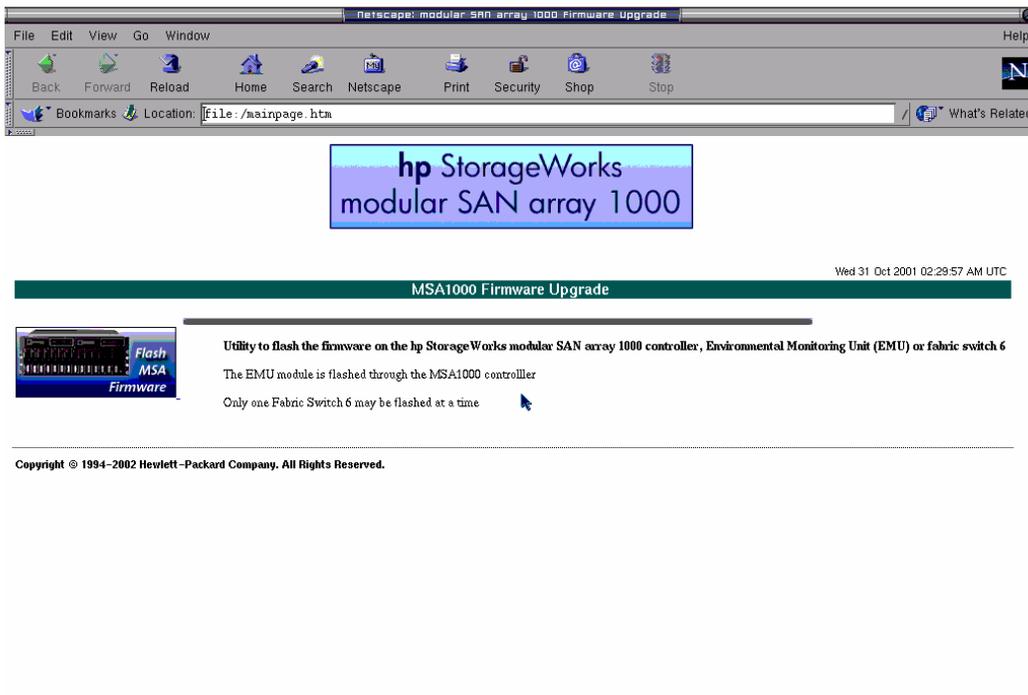
The first step involved in flashing the MSA1000 firmware is to power down all servers that are connected to the MSA1000. Please follow appropriate methods to bring down applications, servers, clusters, etc. Place the MSA1000 Firmware Upgrade CD in a server's CD ROM drive (that is connected to the MSA1000), and power up the server. The server will boot to the MSA1000 Firmware Upgrade CD. When the utility is fully booted, the MSA1000 utility screen will appear with the options to flash the MSA1000 firmware, the Environmental Monitoring Unit, or the Fabric Switch6 (if installed).

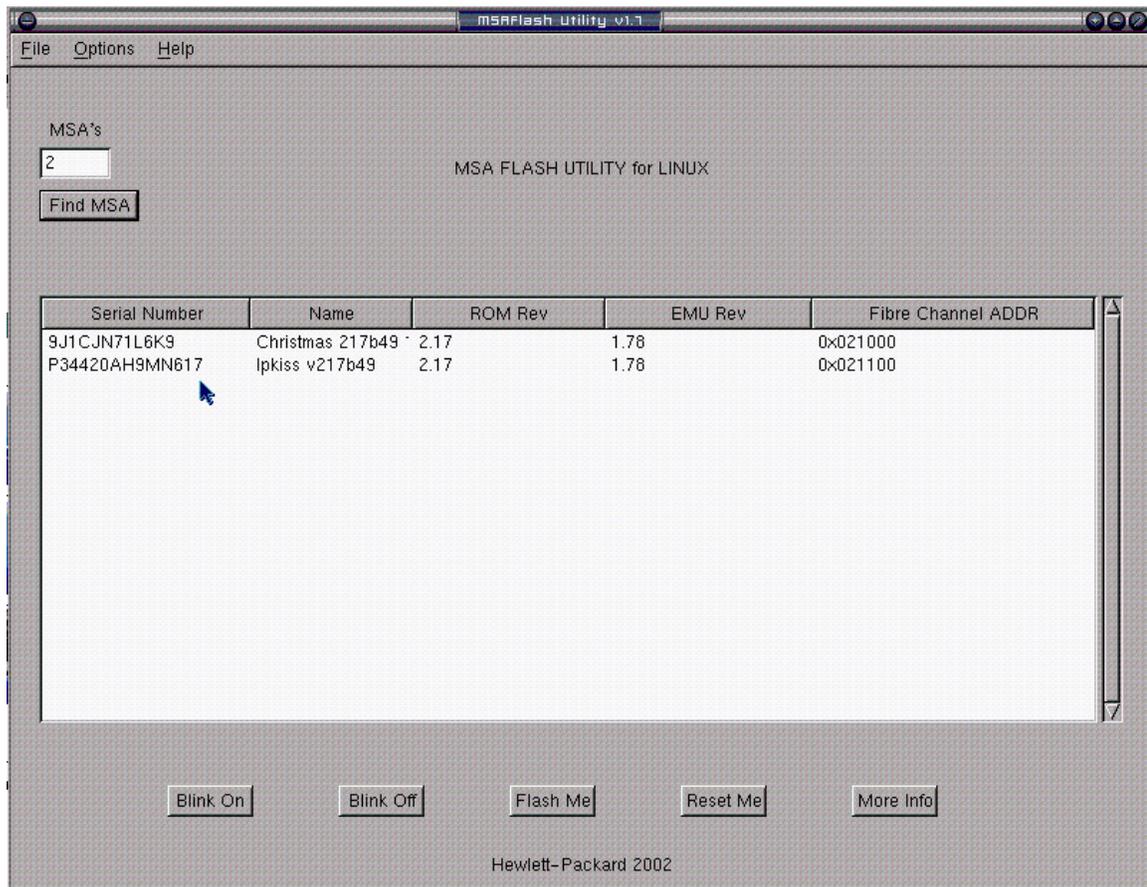
Select the Flash MSA Firmware option – The screen will look like this: Click on the **Find MSA** button. Note that the MSA Flash Utility found two MSA1000's on the SAN.

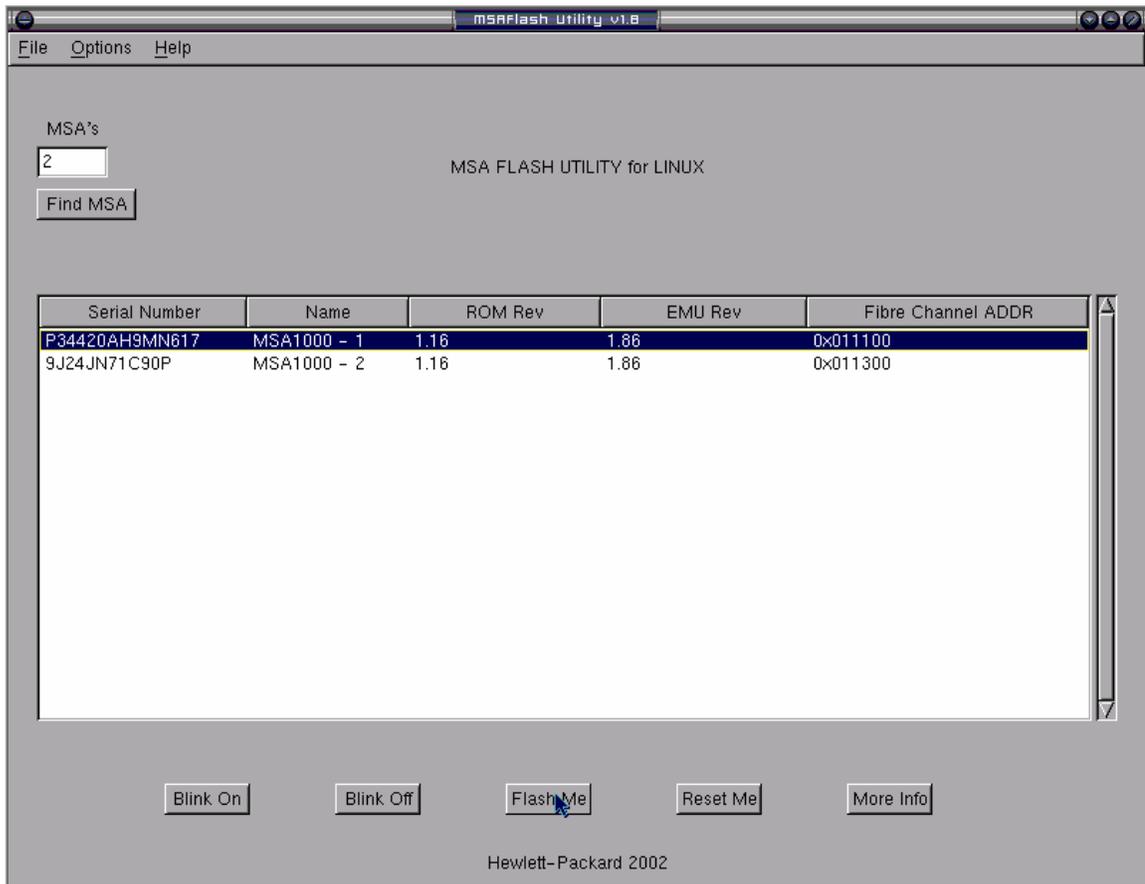
Select the controller you wish to flash the firmware of by highlighting it with a single click. Then, click on the **Flash Me** button. Your screen will appear as follows:

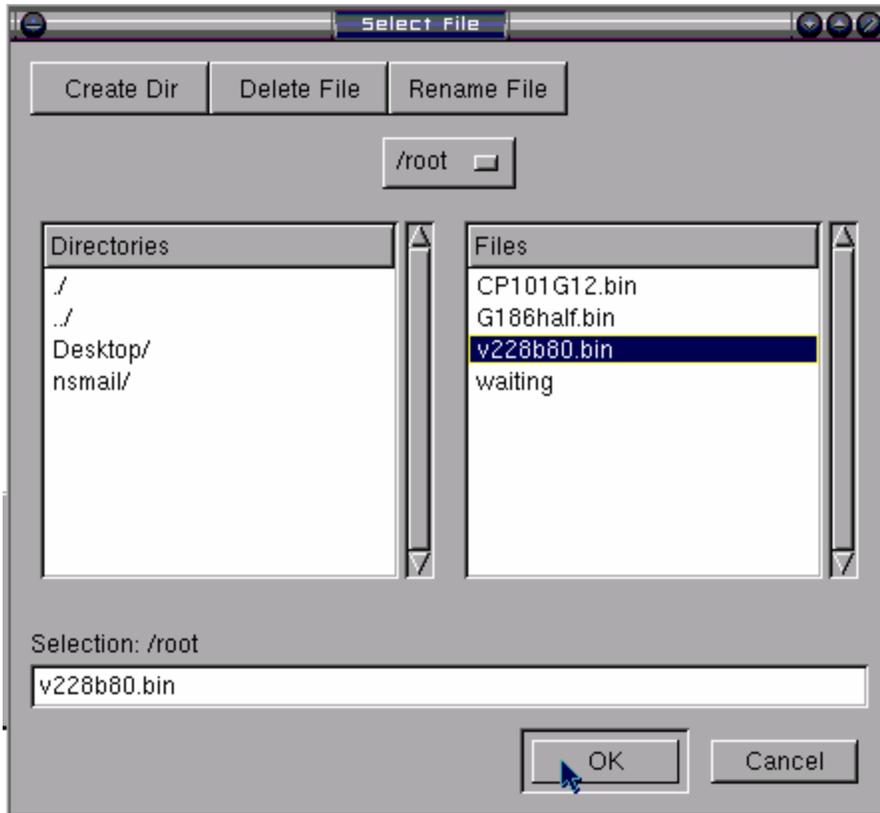
After clicking on the **Flash Me** button, a directory window will appear. From this window, select the firmware file for the MSA1000 (currently v228b80.bin), and click on the **OK** button. The MSA1000 firmware file will begin with a “v” and have a .bin extension.

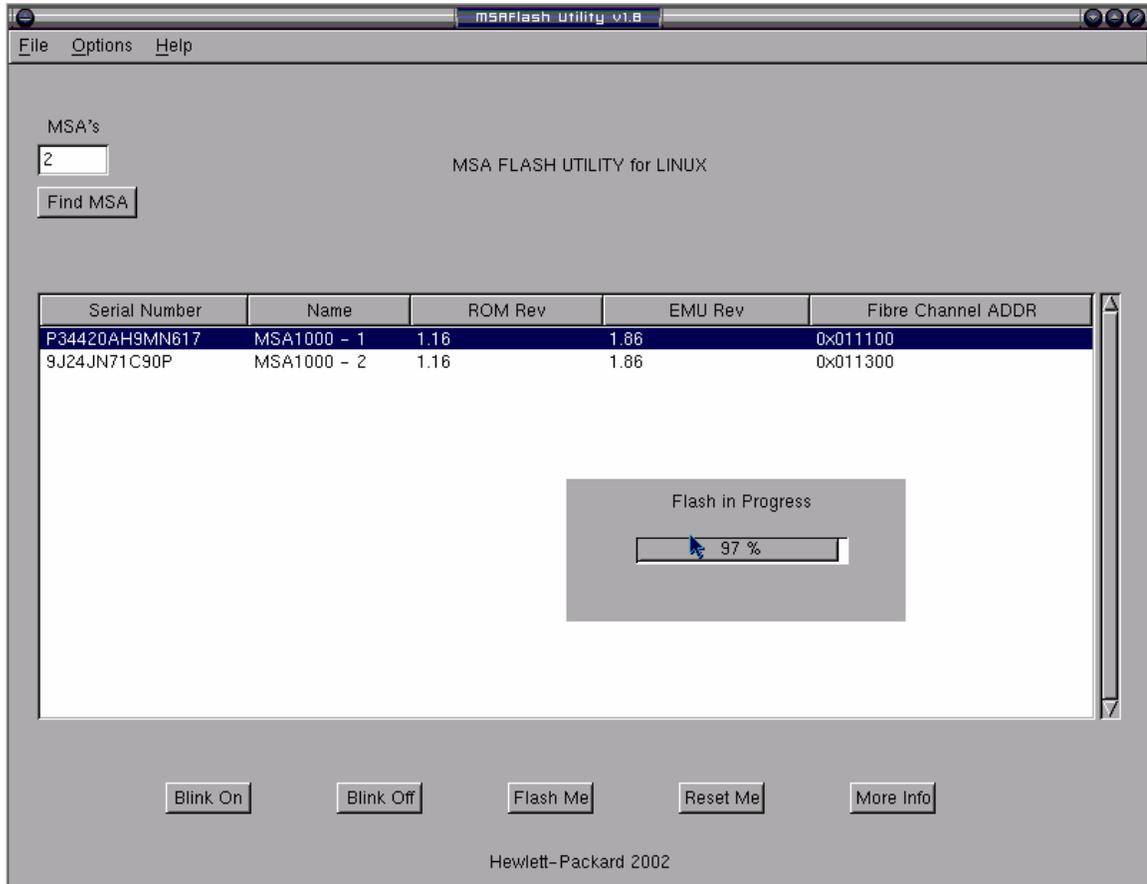
A progress indicator will appear, giving status of the firmware update.

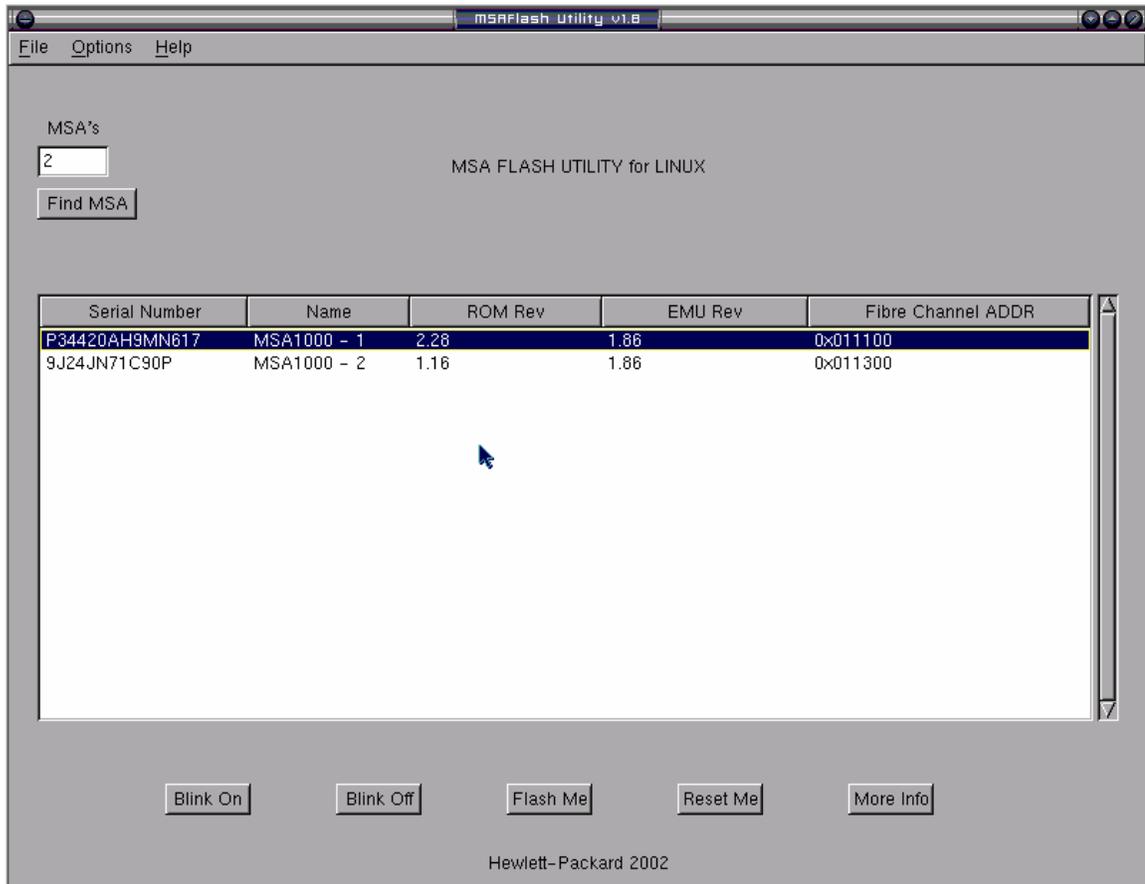
From this main menu, highlight the controller that was just flashed, and click on the **Reset Me** button (the MSA1000 controller has to be reset (rebooted) for the firmware changes to take effect. The reset of the MSA1000 controller will take 2 – 5 minutes.

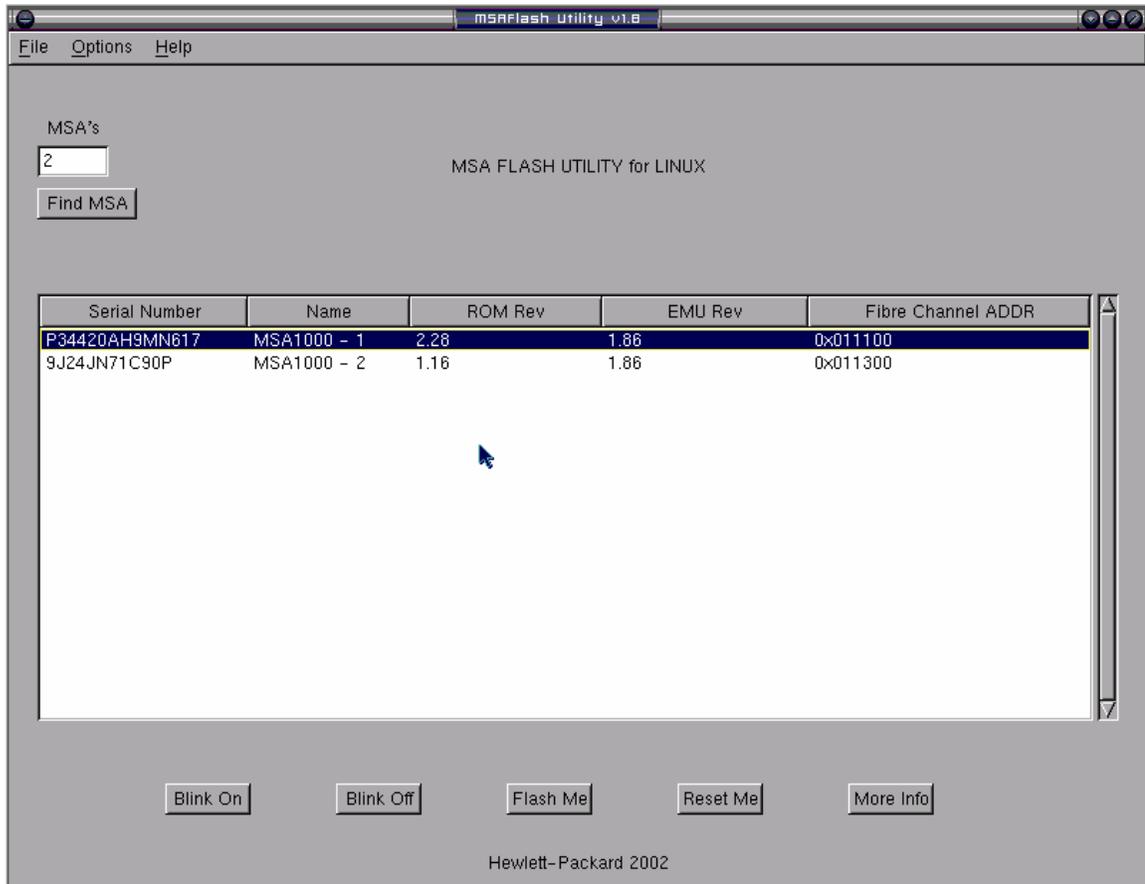
Once the MSA1000 controller has finished its reboot, clicking on the **Find MSA** button on the main menu will force a rescan, and display the MSA1000 controllers that are found. Notice that the Firmware had been updated from revision 1.16 to revision 2.28 (2.28 was the latest version as of the writing of this paper).

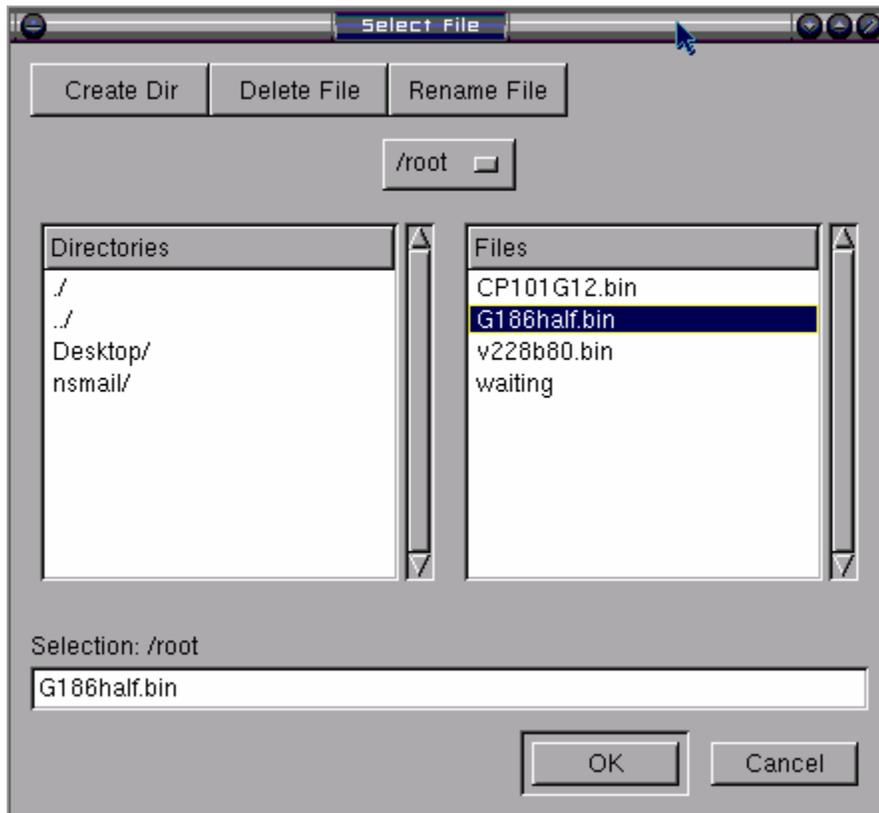
Once the MSA1000 controller is selected, click on the **Flash Me** button. A directory window will once again appear, allowing you to select the EMU firmware update file (currently G186half.bin). Highlight this file, and then click on the **OK** button.

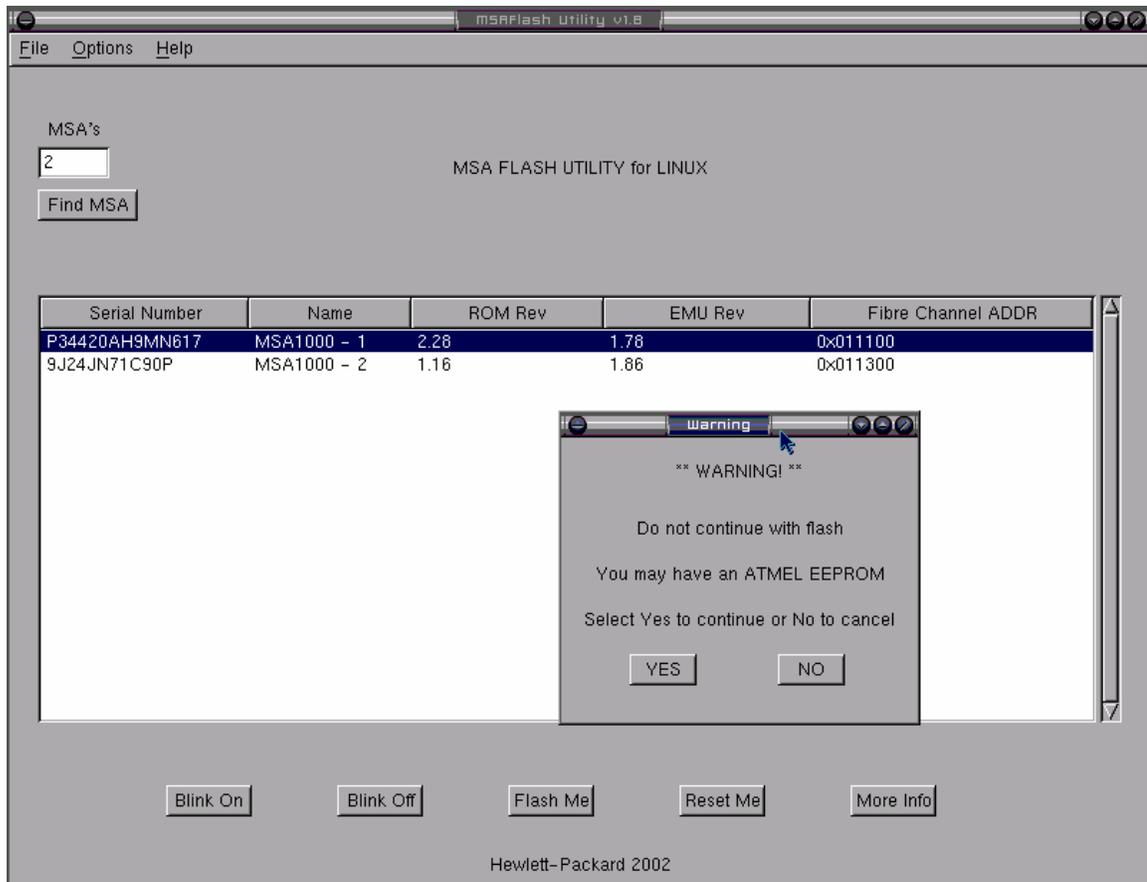
Warning: Please review the Prerequisites section (page 3) of this paper. DO NOT continue with the EMU firmware upgrade if you have not verified EMU firmware level and EMU EEPROM manufacturer per the Prerequisites section. If you have verified the firmware version and the EMU EEPROM manufacturer, click on the **YES** button to continue. If this has not been verified, click on the **NO** button to cancel. Review Prerequisites section (page 3).

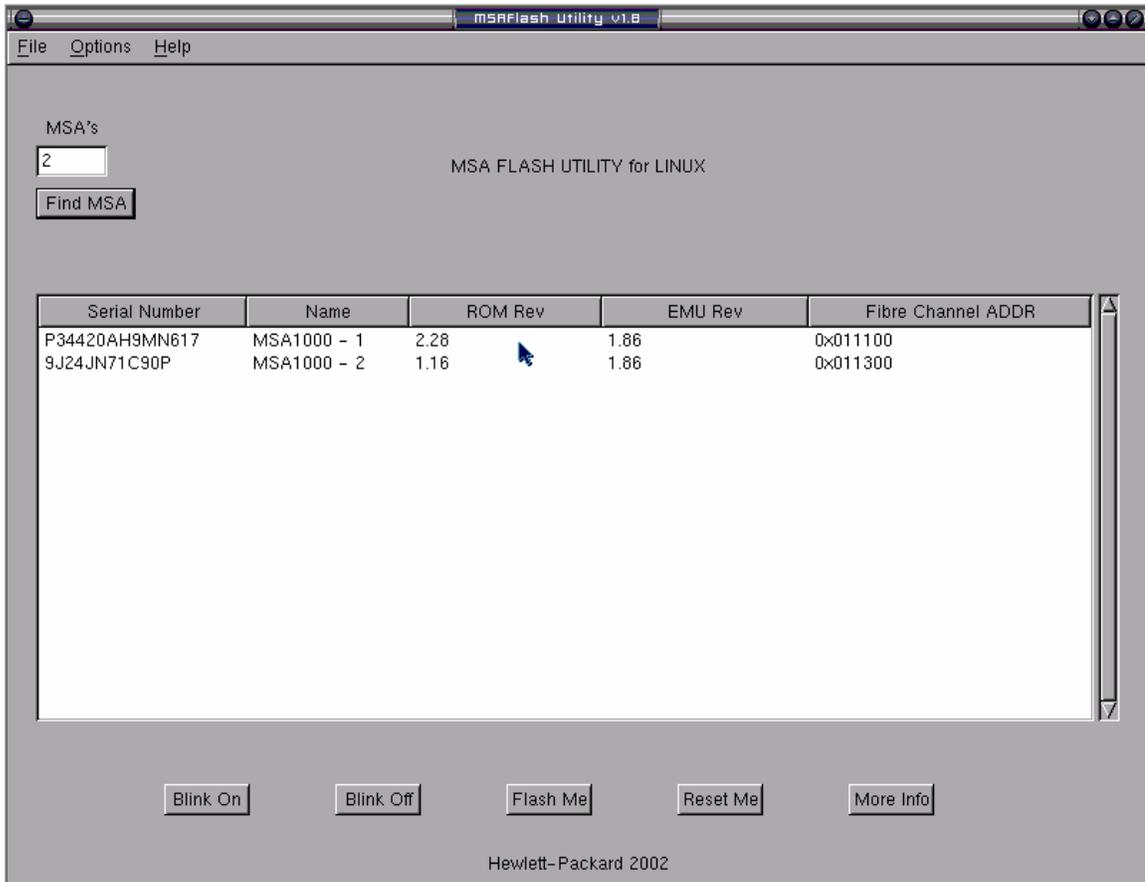
The MSA1000 controller will take several minutes to reset. After a successful reset, click the **Find MSA** button to force a rescan of the MSA1000 controllers. After the rescan, you will notice that the EMU firmware version has been updated.

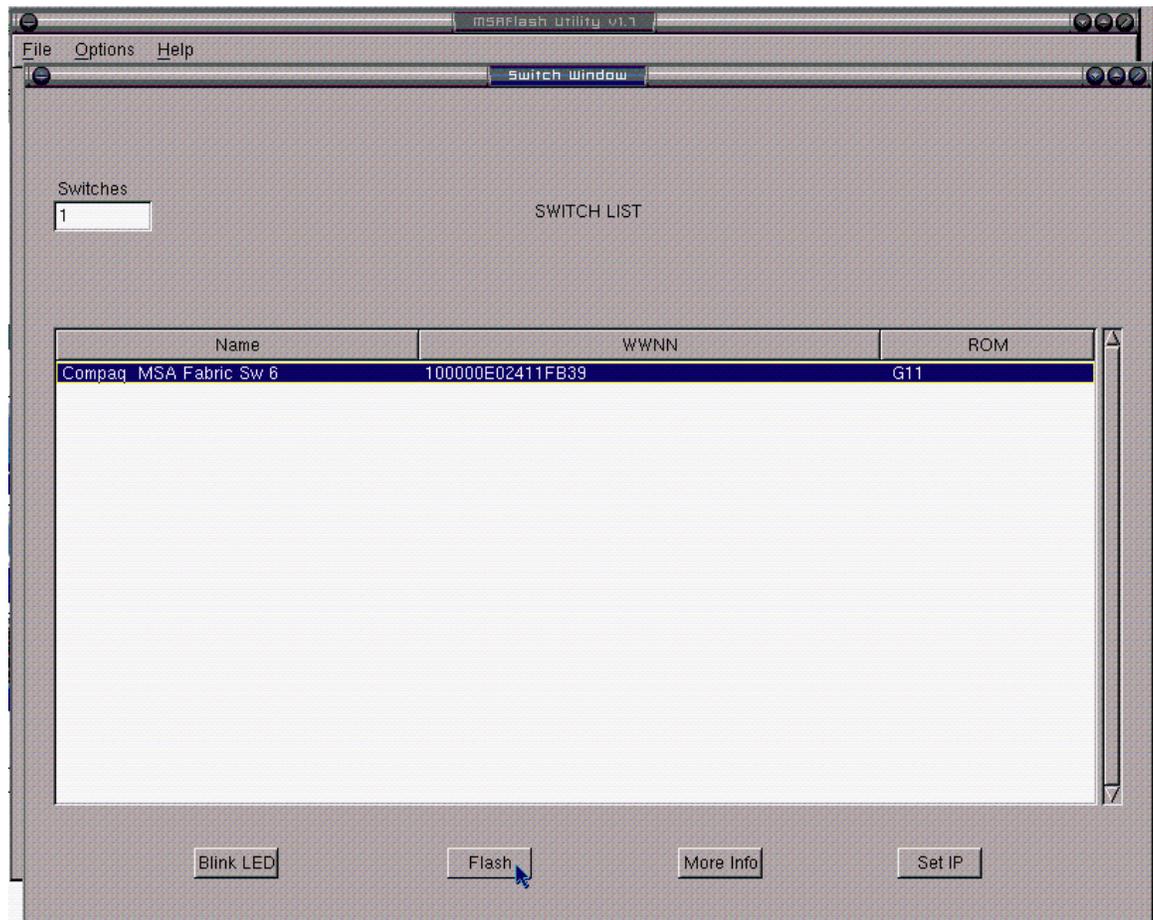
4. This will display a list of available switches to flash. In this case, there is only one switch available to flash. Highlight the desired switch, and then click the **Flash** button.

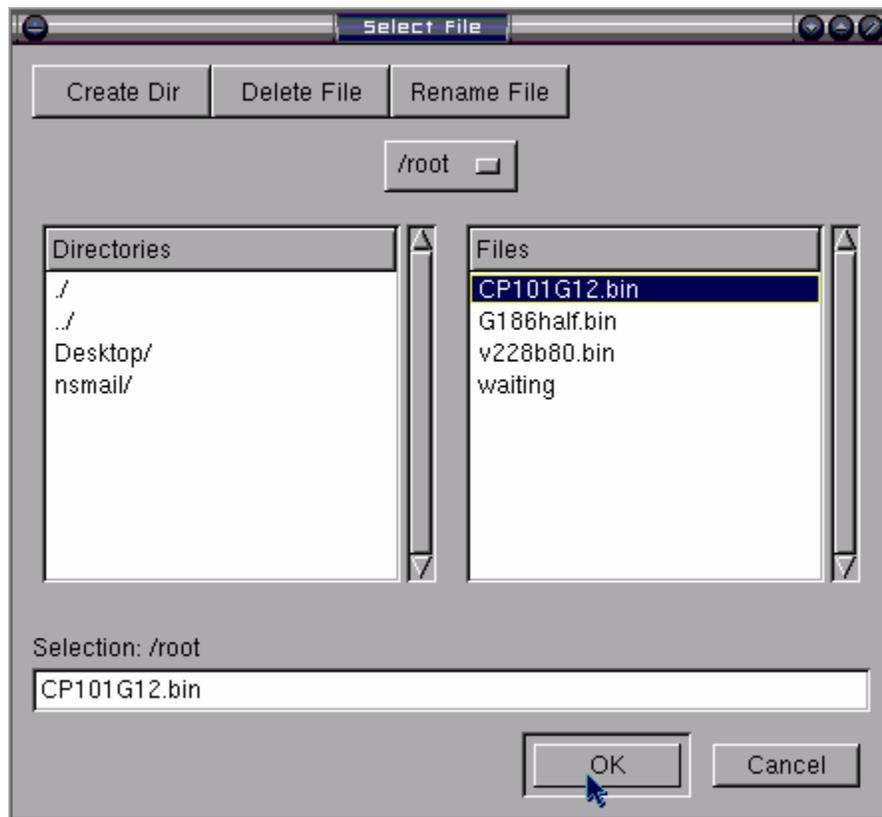
5. The next prompt is for the switch firmware upgrade source file. By default, the listing is from the CD. Highlight the firmware file (in this case CP101G12.bin), and click on the **OK** button.

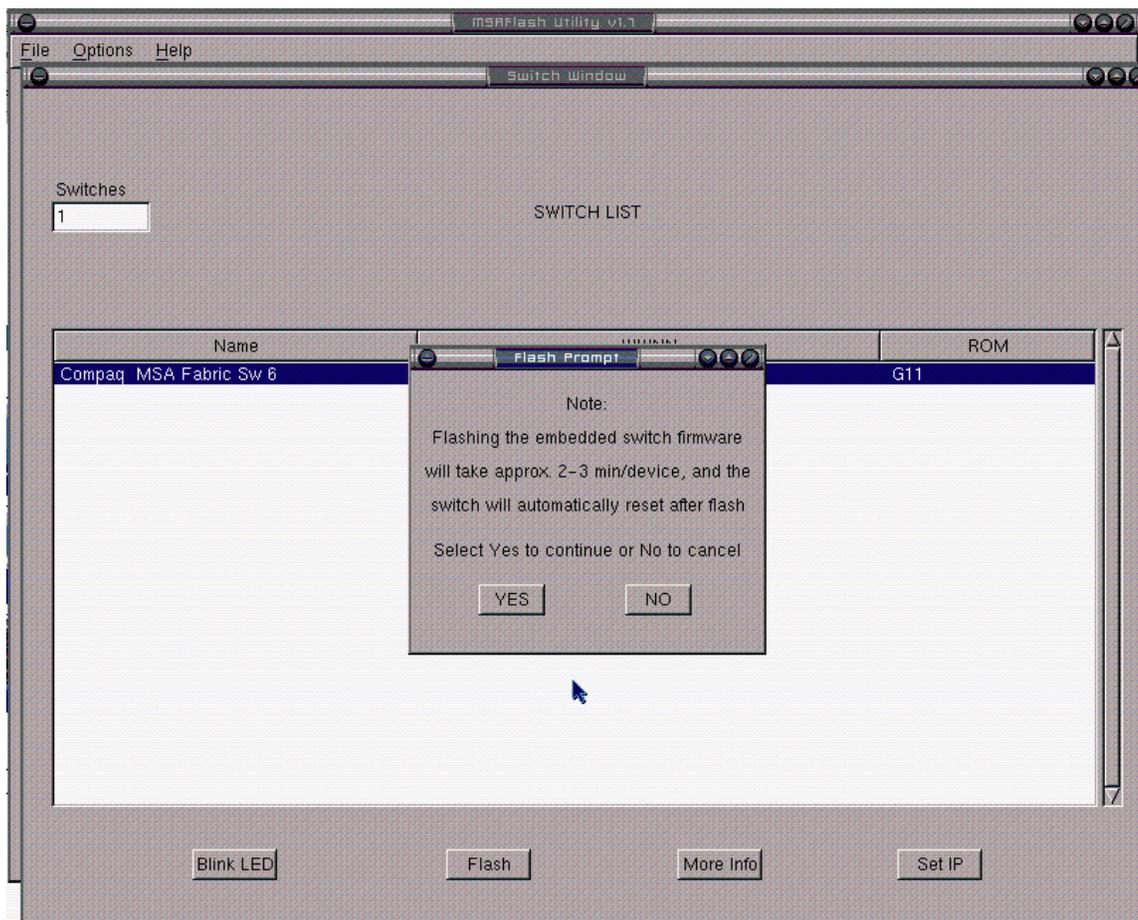
- A message will pop up explaining that the firmware flash of the embedded switch will take approximately 2 – 3 minutes. Click on **YES** to begin the firmware flash.
