Brocade Fabric OS v4.2.1a Release Notes_v1.0

This release is a patch release that contains fixes to a small number of additional issues found since the release of Fabric OS v4.2.1. Aside from these changes, this release is functionally identical to the Fabric OS v4.2.1 release. Furthermore, Brocade Fabric OS v4.2.1 is functionally identical to Fabric OS v4.2.0, except for the following enhancements and new features required to support the SilkWorm 3016 for use in the **IBM @server® BladeCenter™**:

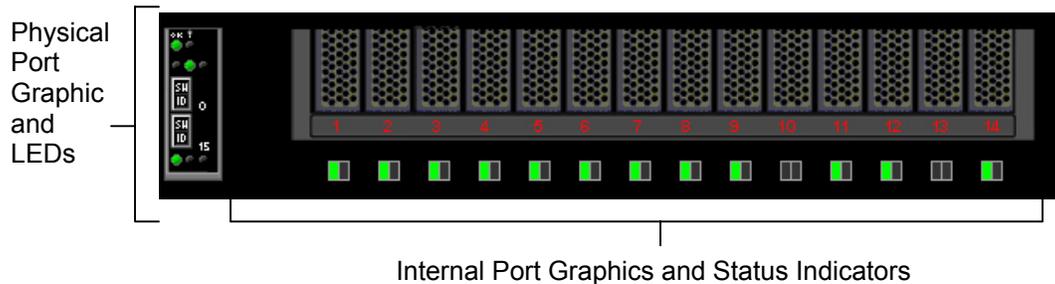
Figure 1: Brocade SilkWorm 3016 Switch Graphic

Note that ports 1 through 14 and the associated status indicators in Figure 1 represent ports internal to the **IBM® server® BladeCenter™** that connect to the 14 server slots.

The switch graphic for the Brocade SilkWorm 3016 switch consists of the following:

- External ports and status LEDs
- Internal ports and status indicators
- Switch status LEDs

Advanced Web Tools has a new graphic to represent the SilkWorm 3016 switch (see Figure 1).

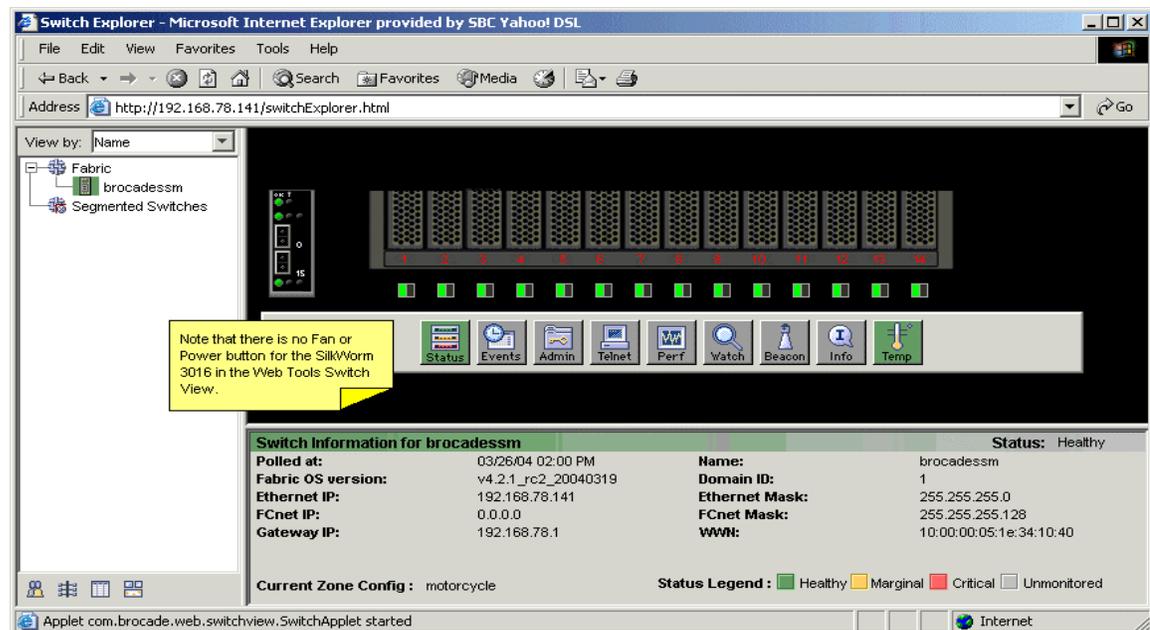
The Switch View for the SilkWorm 3016 switch does not have a Fan button or a Power button, as there is no fan or power supply associated with the SilkWorm 3016 (see **Error! Reference source not found.**).

Figure 2: Switch View of the SilkWorm 3016 Switch

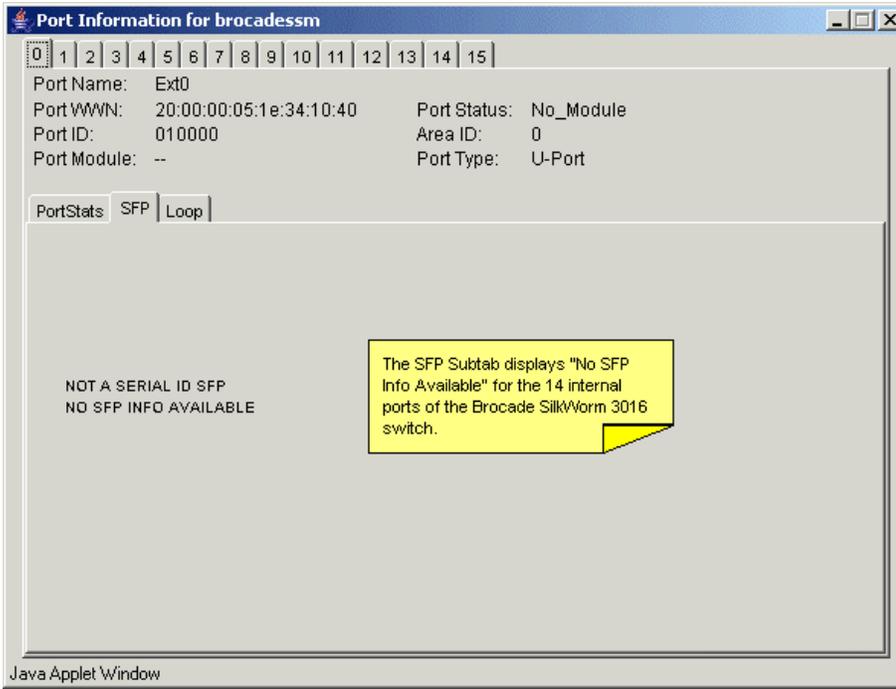
The **SFP** subtab on the **Port Info** dialog displays “NO SFP INFO AVAILABLE” for the 14 internal ports of the Brocade SilkWorm 3016 switch (see **Error! Reference source not found.**).

Figure 3: SFP Subtab in the Port Info Dialog for the SilkWorm 3016 Switch

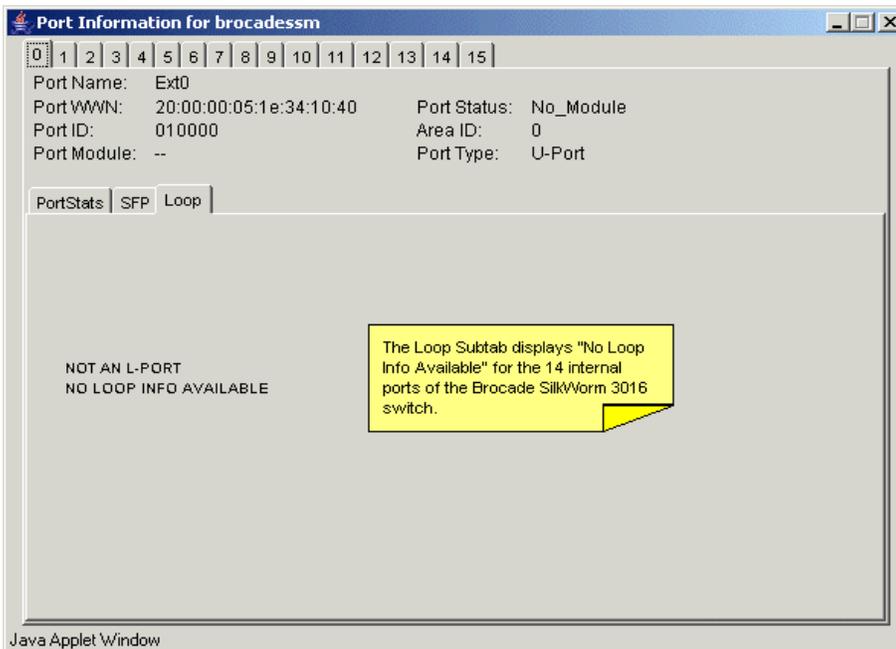
The **Loop** subtab on the **Port Info** dialog displays “NO LOOP INFO AVAILABLE” for the 14 internal ports of the Brocade SilkWorm 3016 switch (see **Error! Reference source not found.**).

Figure 4: Loop Subtab in the Port Info Dialog for the SilkWorm 3016 Switch

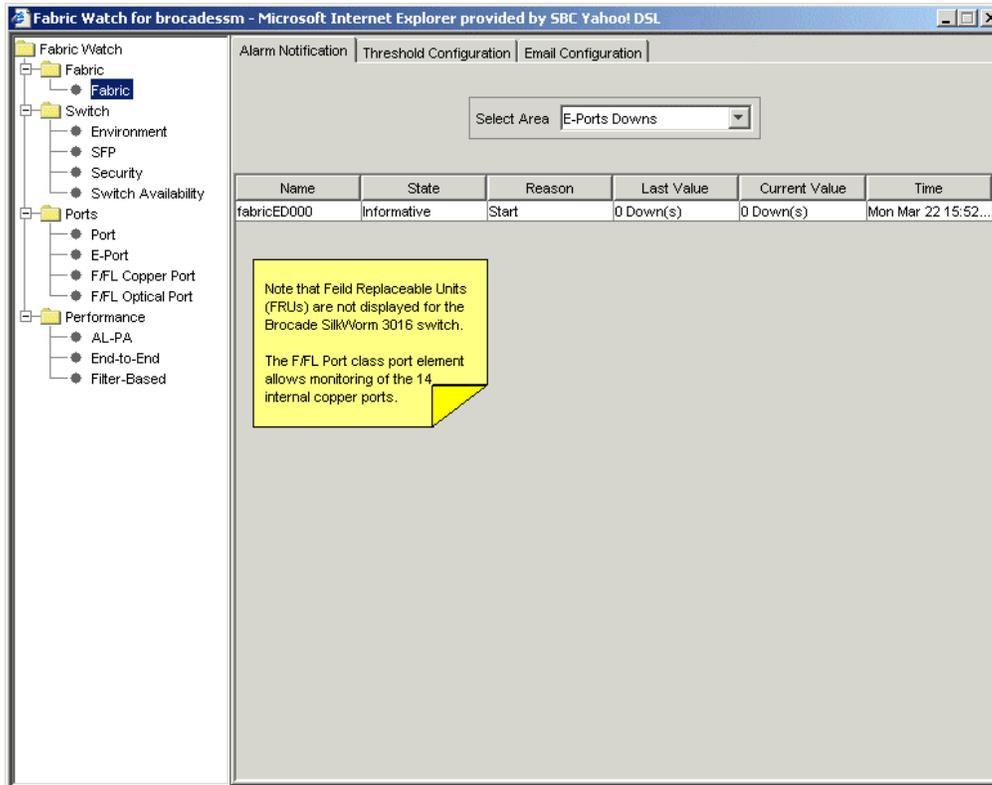
- No fan or power supply information for the Brocade SilkWorm 3016 switch is displayed, as there are no fans or power supplies associated with the switch.
- An additional Fabric Watch element, the F/FL Port Class, has been added to allow the monitoring of the 14 internal copper ports.
- Field replaceable units (FRUs) and related functions are not displayed for the Brocade SilkWorm 3016 switch, as there are no FRUs associated with the switch.

Figure 5: Fabric Watch Dialog for the SilkWorm 3016

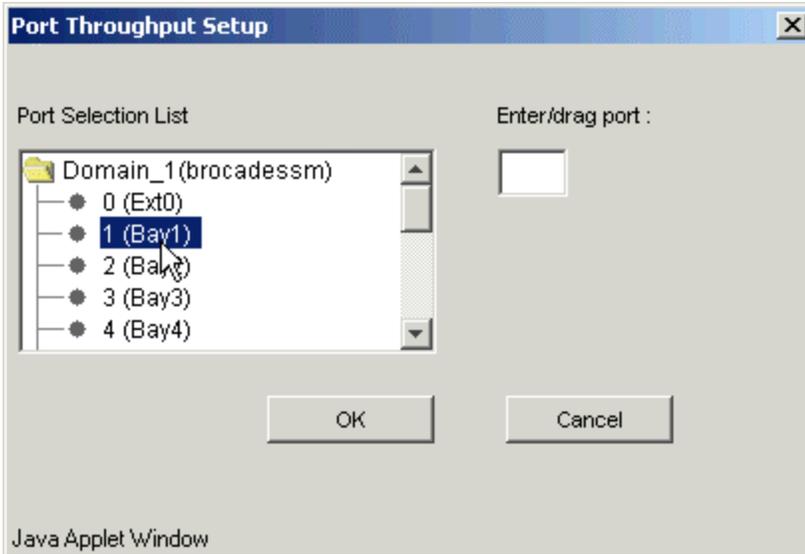
All setup of performance monitor graphs display port names in addition to the port number for the SilkWorm 3016 switch (see **Error! Reference source not found.**).

Figure 6: A Performance Monitor Graph Setup Dialog Listing Port Names
