DECsystem 5100 PrestoServe/NVRAM Option Information

Order Number EK-NVRAM-OM-001

The *DECsystem 5100 PrestoServe/NVRAM Option Information* manual describes how to install, operate, and troubleshoot the PrestoServe/NVRAM option.

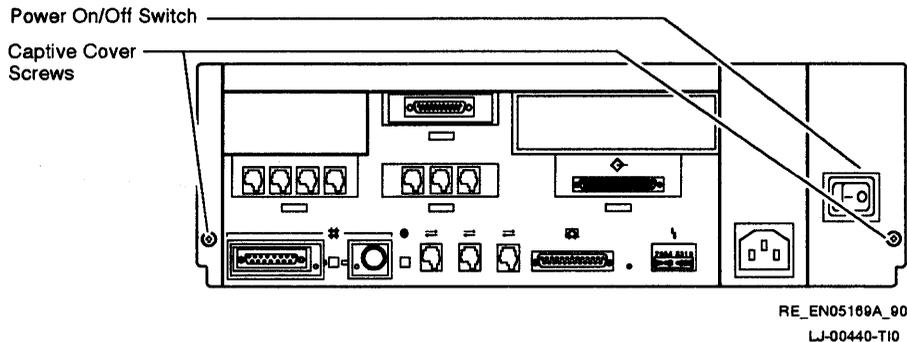
Figure 2-1 Location of On/Off Switch and Cover Screws

1. Remove the system unit cover by performing the following steps:
 - a. Turn the system power off (O). See Figure 2-1.
 - b. Label and disconnect all the cables connected to the system unit.
 - c. Loosen the two captive cover screws on the back panel of the system unit (Figure 2-1).
 - d. Slide the cover forward, and up from the system unit.

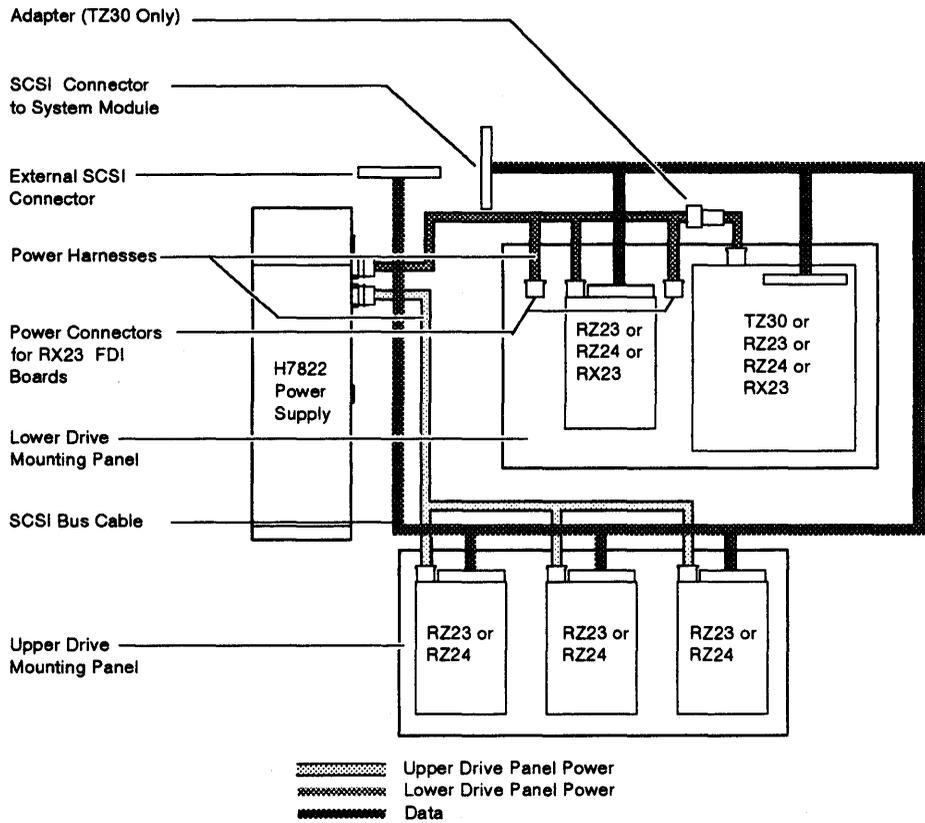
Figure 2-2 Drive Mounting Panel Power and Signal Cabling

- a. Disconnect the power harnesses from the H7822 power supply and disconnect the SCSI bus cable from the drives on the upper drive mounting panel (Figure 2-2).
- b. Unscrew the four captive screws (Figure 2-3).
- c. Lift the upper drive mounting panel from the lower drive mounting panel and gently set it aside.
- d. Note the position of the metal partition, then remove it from the lower drive mounting panel.

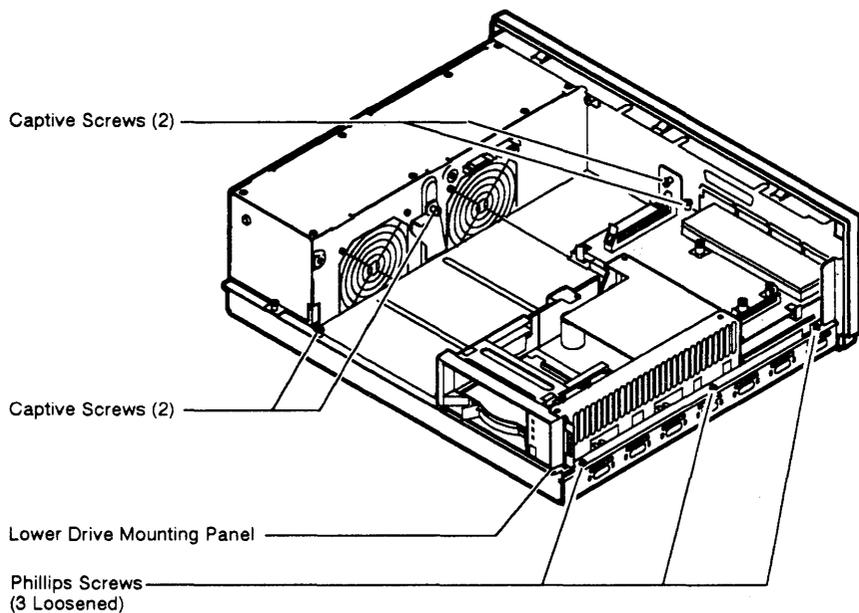
Figure 2-4 Releasing the Lower Drive Mounting Panel

- b. Unscrew the four captive screws and remove the three Phillips screws on the left side of the unit (Figure 2-4). Store the screws in a safe place.
- c. Slide the panel forward (with the devices attached), then lift the panel from the system unit and gently set it aside.

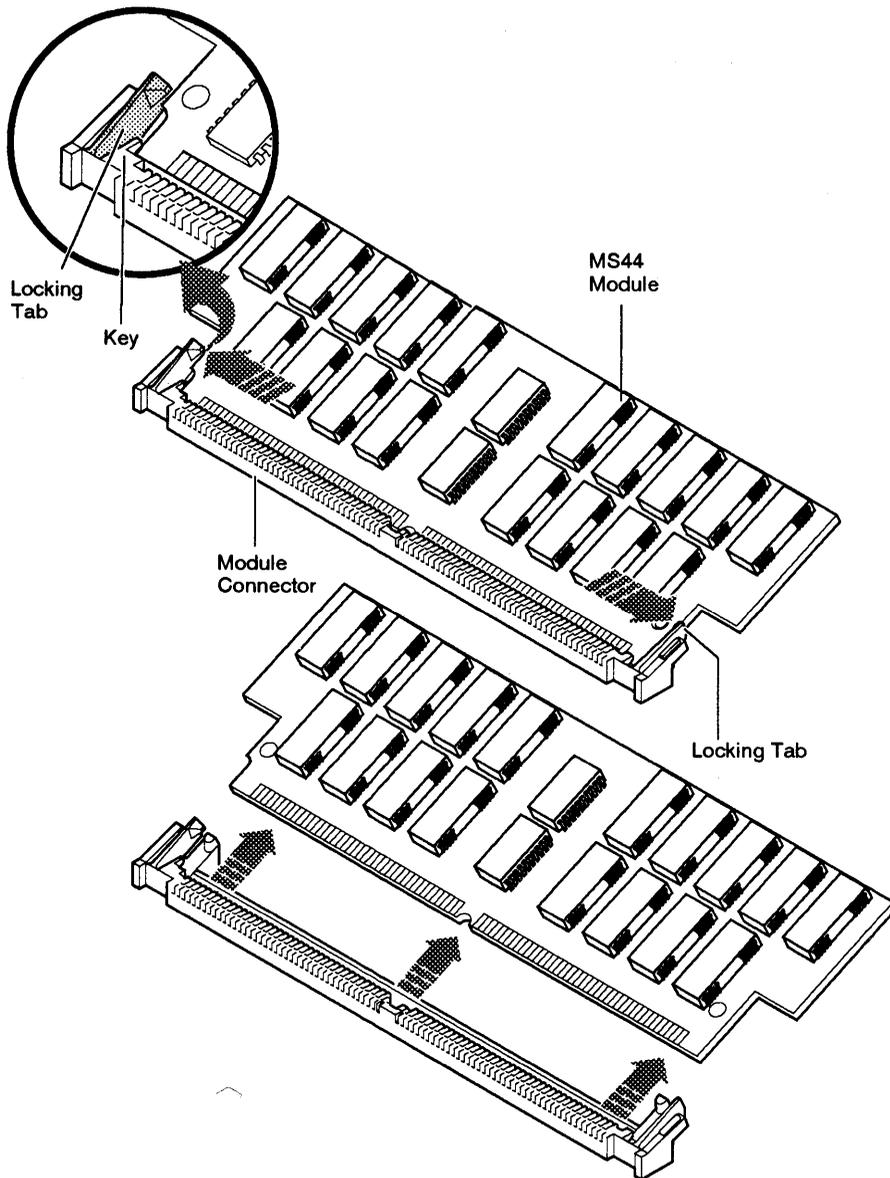
Figure 2-5 Removing NVRAM Module

To remove MS44 memory modules ensure that the two locking tabs are disengaged, otherwise damage to the connectors will occur. You must remove the modules contained in the highest available banks first, in order to access the locking tabs of the other memory modules (Figure 2-5).

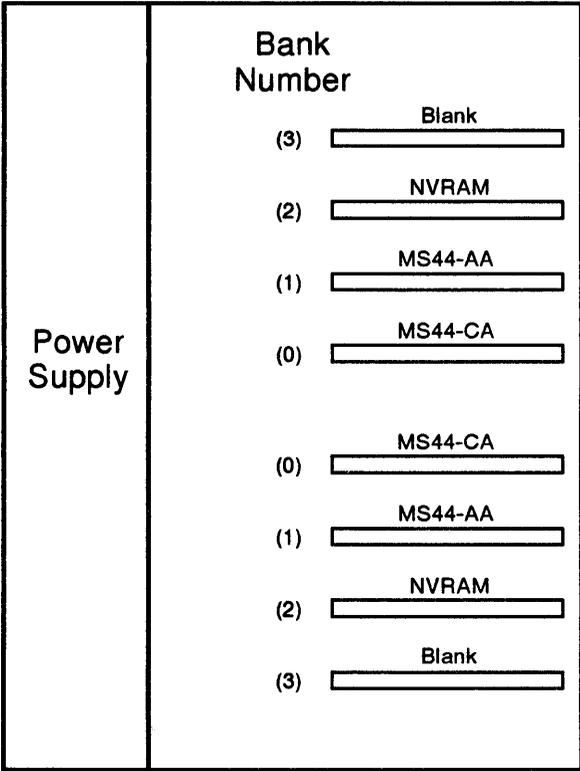
Figure 2-6 Location of Memory Banks

In a typical configuration, the DECsystem 5100 contains MS44 memory and NVRAM modules located in the following positions (also see Figure 2-6):

- Bank 0 has two MS44-CAs (32 Mbytes).
- Bank 1 has two MS44-AAs (8 Mbytes).
- Bank 2 has the NVRAM modules.
- Bank 3 is empty.

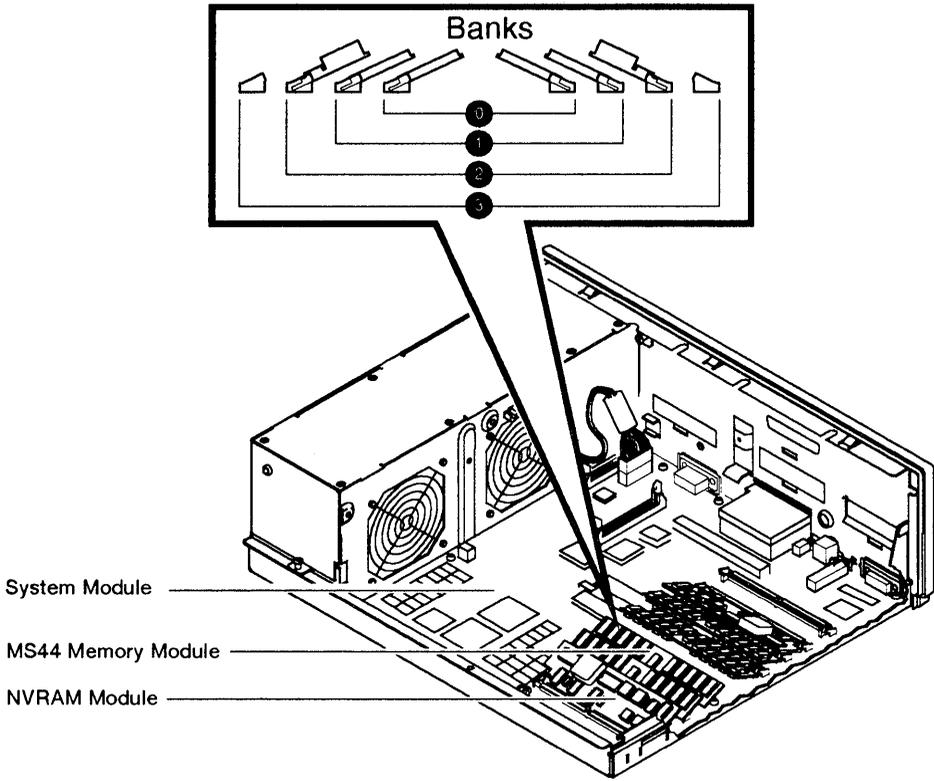
Figure 2-7 Sample Configuration

The DECsystem 5100 contains a total of 40 Mbytes of memory and 1 Mbyte of NVRAM. Notice that the two MS44-CA modules are installed in the lowest numbered memory bank (bank 0) before the two MS44-AA modules (bank 1). The NVRAM modules are installed in the next available bank (bank 2).

4. Identify the connectors of the memory bank in which you want to install the NVRAM modules. For bank locations, and memory module and NVRAM module configurations, see Table 2-1, Table 2-2, and Figure 2-7.

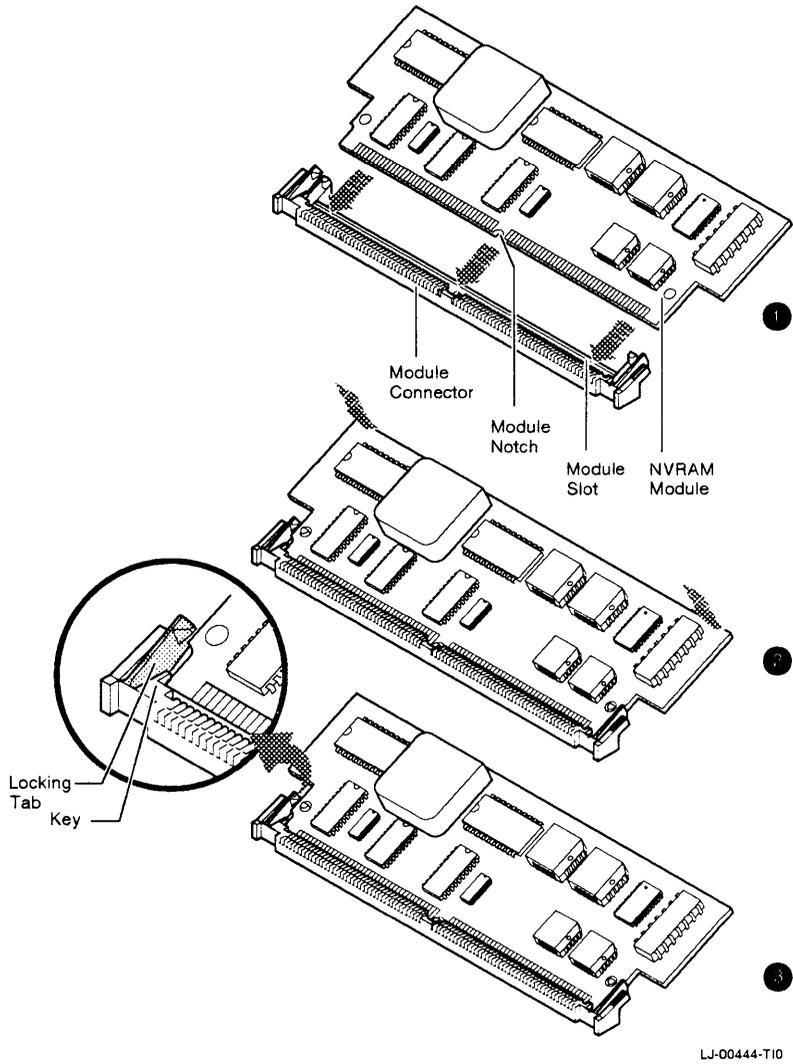
Figure 2-8 NVRAM Module Installation

- ❶ Align the module with the key.
- ❷ Insert the module, with the side containing the bar code label facing up, into the connector on the system module. Gently press down on the module.
- ❸ Verify that the locking tabs are engaged.

The connectors are keyed so that you can install the NVRAM module with the correct orientation. Do not force the modules into the connectors if the key in the module does not align with the connector.

5. To install the first NVRAM module, follow the steps shown in Figure 2-8:

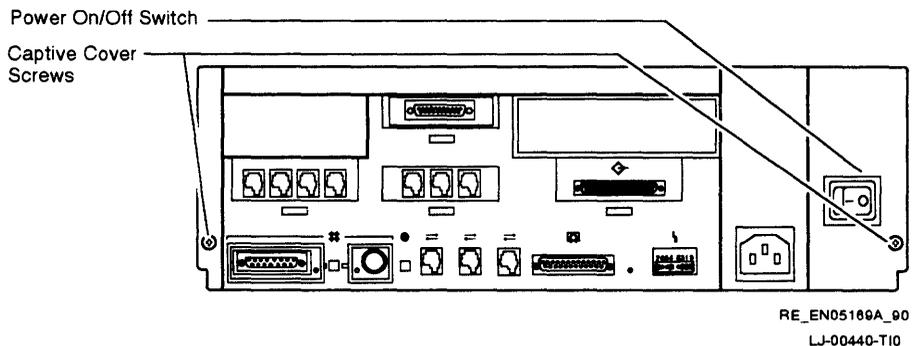
Figure 3-1 Location of On/Off Switch

To run the power-up self-test, turn the system unit's power switch on (|). Figure 3-1 shows the location of the system unit on/off switch.
